# Property Inspection Report

403 Old Southern Rd.  
Branson MO 65616

4 Arrows Ranch, LLC

## Gingles Inspections

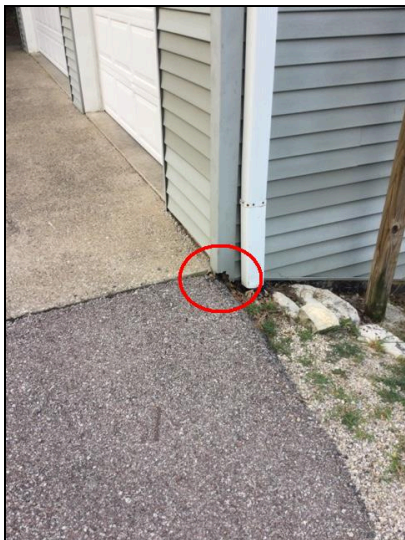
(1) **At the exterior siding, observations with the installation were made.** Damage was observed that may be the source of moisture intrusion, pest intrusion, or damage into concealed locations. The siding was dirty and in need of cleaning to improve its appearance. Some of the siding was faded or an incorrect color - this is more cosmetic in nature. I recommend a qualified siding contractor replace damaged siding as necessary.

1.0 Instance of damage

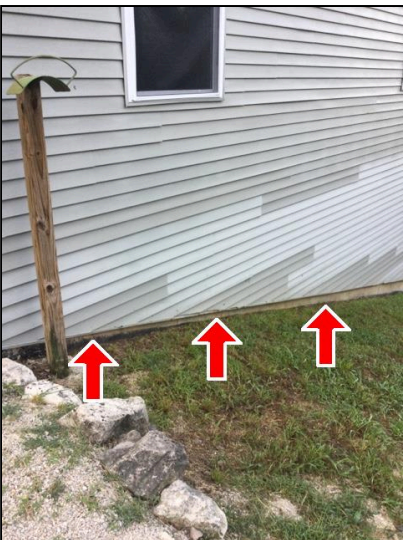
1.0 Instance of damage

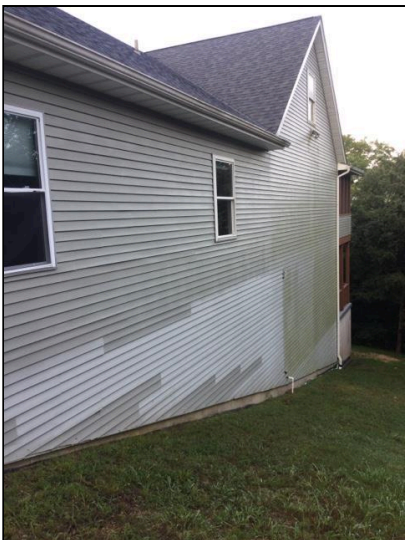
1.0 Mismatch color, faded

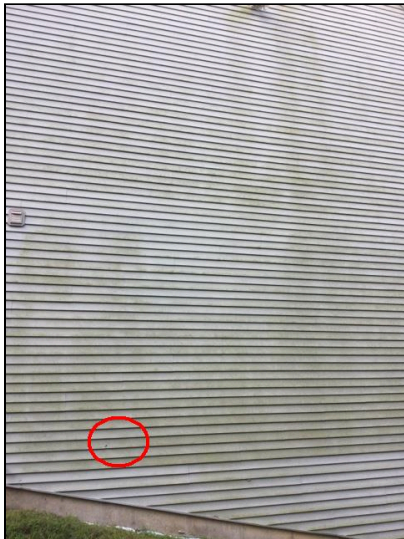
1.0 Instance of damage

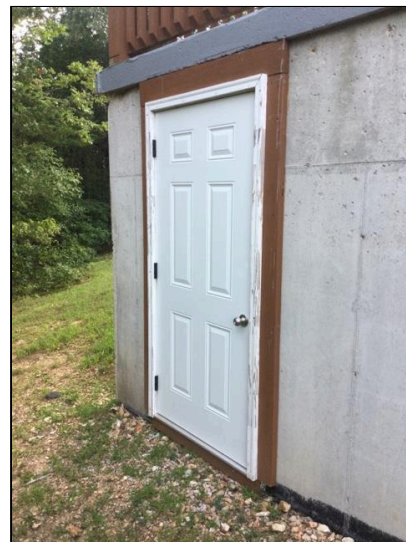
**(2) Caulk and paint maintenance at exterior surfaces was needed at this time.** Open seams and penetrations create the opportunity for weather and pests to enter the structure. *Maintenance will prolong the life of the materials. I recommend sealing penetrations and gaps that required sealant with a high grade exterior rated sealant. **I recommend making all repairs to the exterior as needed, prime, seal, and paint or stain as needed.***

1.0 Instance of maintenance needed

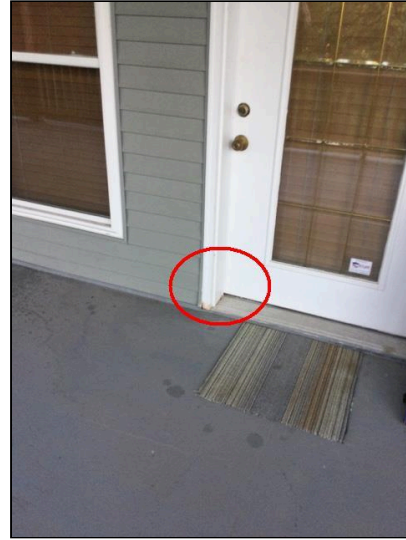
(3) **Decay, damage, signs of deterioration, incomplete construction, and/or repairs were needed to exterior surfaces.** -- *Repairs to these areas may reveal concealed moisture or pest damage to framing, insulation, finished surfaces, or damage to other systems near the locations. -- Unable to determine the condition of underlying materials. I recommend addressing moisture problems, if necessary and a qualified contractor repair the exterior surfaces as necessary.*

1.0 Instance of damage, repair needed

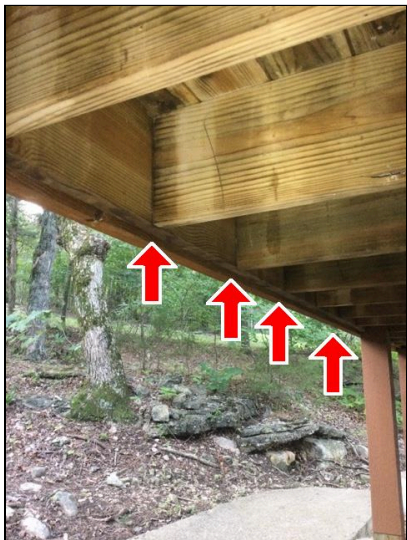
(1) At the deck, **The structure was inadequately secured to the structure.** Current requirements for attachment to the main structure includes through bolting or lag bolting the ledger boards. Nails or insufficient bolting are subject to withdrawal. *Failure can happen without notice or warning. Inadequate connections were present. Joist hangers were not present, or not present in some areas as required. Joist hangers improve the strength of the connections and*

1.3 Instance of joist hangers not installed

**I recommend a qualified deck contractor evaluate and repair in accordance with present standards.**

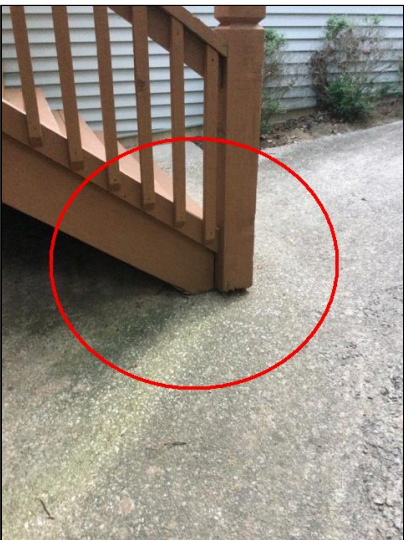
**The guard railing, in my opinion did not feel secure and may not withstand 200lbs of force.** Railing that is inadequately supported or secured to the structure can potentially fail to restrain occupants. Potential severe injury or fall hazard. **I recommend improvements to railing to promote restraint.** The hand or guard railing installation was inadequate or in need of improvements. A graspable hand rail was not installed. Potential fall hazard.

**At the structure, damage, decay, or deterioration was observed.** Subsequent deterioration or damage may occur if not corrected. Unable to determine the condition of underlying materials. *The structural integrity may be compromised.*

1.3 Instance of decay/ deterioration/damage, weak guard

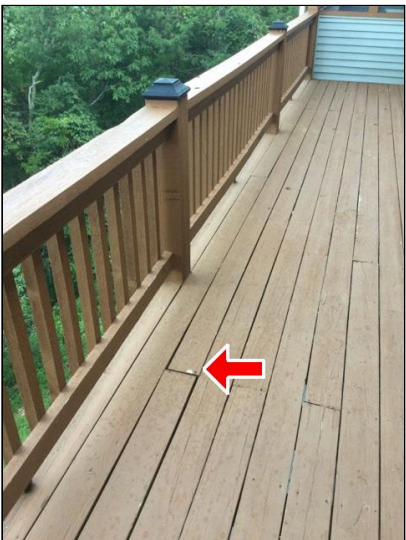
1.3 Instance of loose board

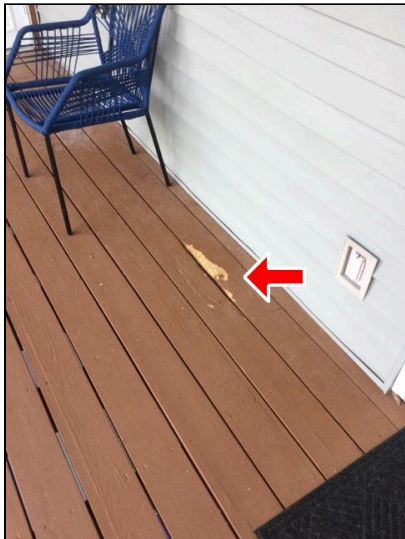
1.3 Finish in need of improvement

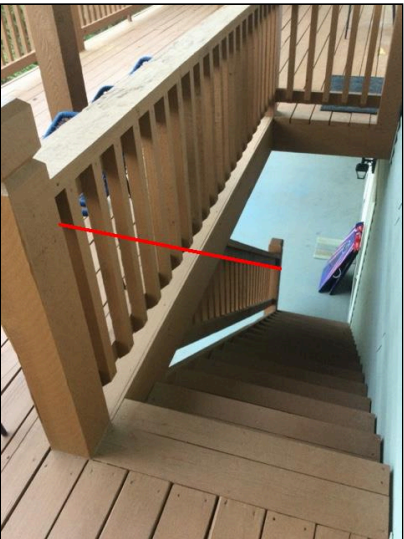
1.3 Graspable hand rail not installed

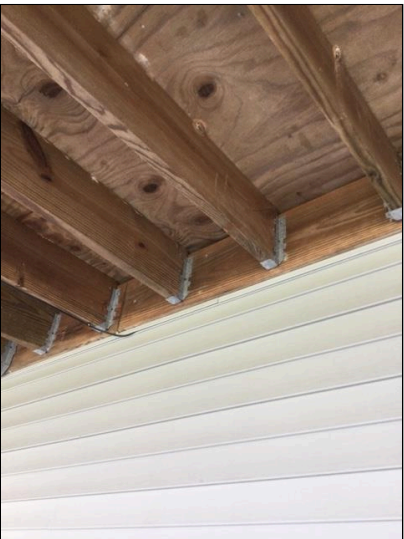
provide bearing. The installation of joist hangers are recommend. Joist hangers were improperly installed or not installed in accordance with typical manufacturers. Approved fasteners are required at all holes in a joist hanger. Some fasteners were improper, inadequately driven, withdrawn, or not installed. Improper installation of joist hangers result in a significant load reduction. Structural connections were damaged, not installed, or were inadequate.

1.3 Joist hangers lacked some nails where required

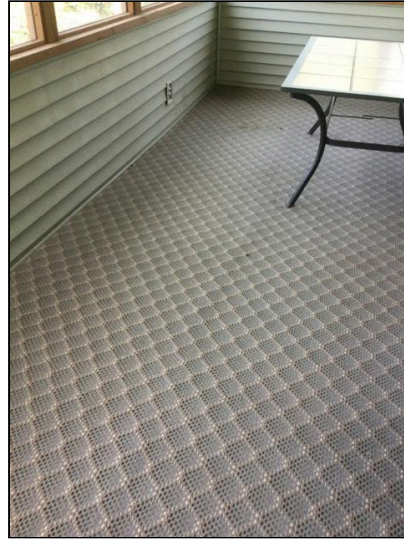
(2) *Maintenance needed at the carpet in the sunroom.* Loose flooring is a potential trip hazard and long term, can damage the flooring. *Stains, significant wear and/or damage at the flooring.* Worn, damaged or stained flooring may be the source of allergens, smells, poor interior air quality and is a cosmetic concern. I recommend stretching carpets, nailing base shoe, transitions, and/or thresholds, or replacement if desired.

1.3 Loose flooring, stains

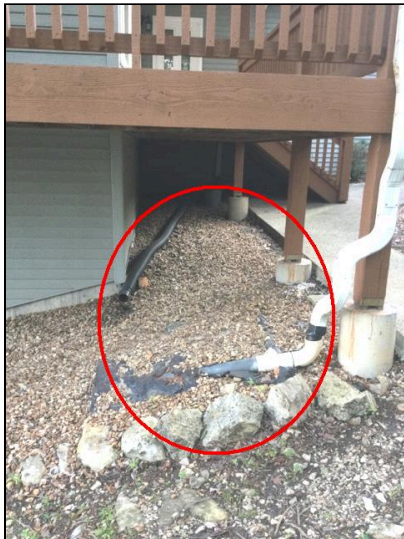
*Inadequate drainage from the structure, surfaces, or walkways promotes foundation problems, moisture intrusion, moisture damage, erosion, ponding or aggravate existing foundation problems.*

1.4 Instance of maintenance/ improvement needed

**I recommend improvements and maintenance to the grading, landscaping, and drainage as needed.** Routine inspection and maintenance of exterior grading, landscaping, and drainage is recommended.

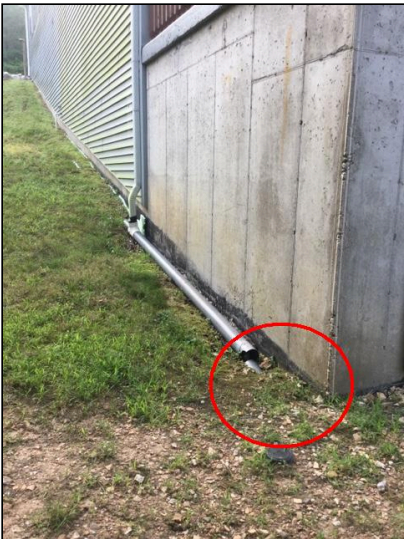
1.4 Instance of maintenance/ improvement needed

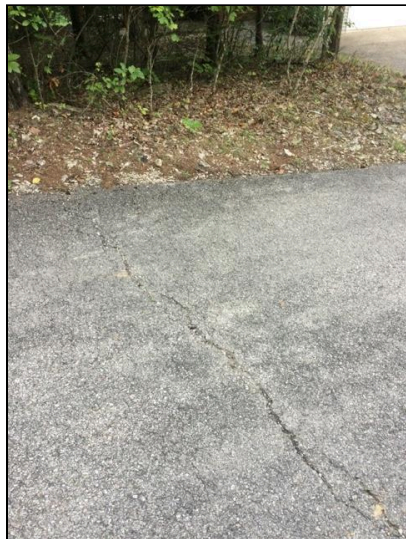
(1) **The driveway was in need of repairs.** *Cracks should be sealed to prevent subsequent cracking or damage. The surface was weathered and should be sealed to prolong its service life. I recommend sealing the cracks and the surface with appropriate sealer. Sealing the surfaces as needed is recommended to prolong the life of the surfaces.*

1.5 Instance of crack, weathered surface

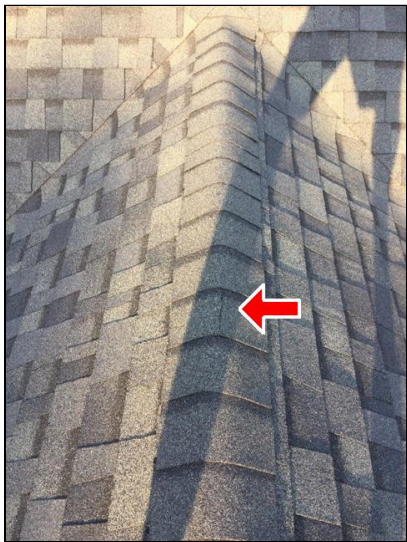
**Damaged roofing was observed.** *Cracks in one or more shingles were present - Subsequent damage may occur if not corrected.*

2.1 Cracked shingle

**At this time, maintenance is needed. I recommend a qualified roofer evaluate and repair as needed.**

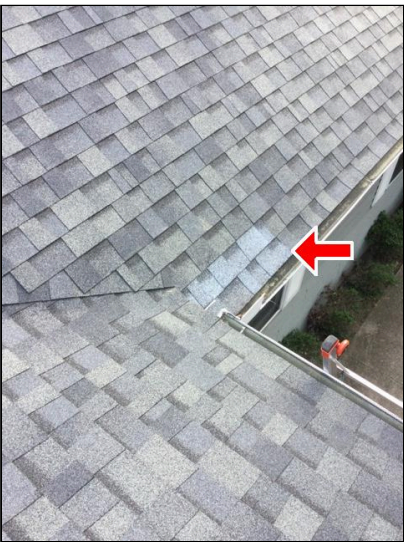
**The inspection of the roof revealed roofing of a different color.** *The installation may be an indication of prior repairs in response to damage or leakage.*

2.1 Mismatch shingle

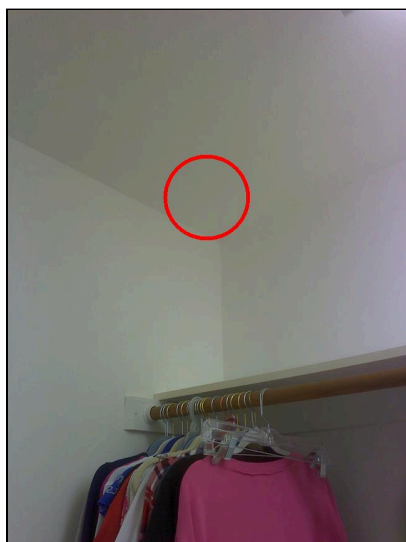
(1) **A thermal imaging camera was used and moisture was detected.** A moisture meter was used to confirm moisture content. Unable to determine the condition of underlying materials. Inspection in the attic revealed that there was duct work in the area. This moisture may be related to sweating duct work. Further investigation required to determine a corrective action. *I recommend repairing as needed.*

3.2 Wet spot - master closet

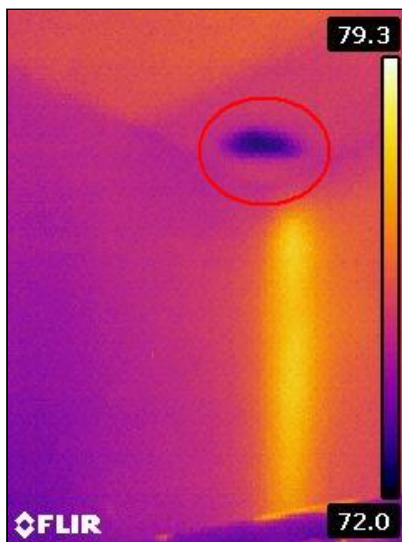
3.2 Thermal image, Wet spot - master closet

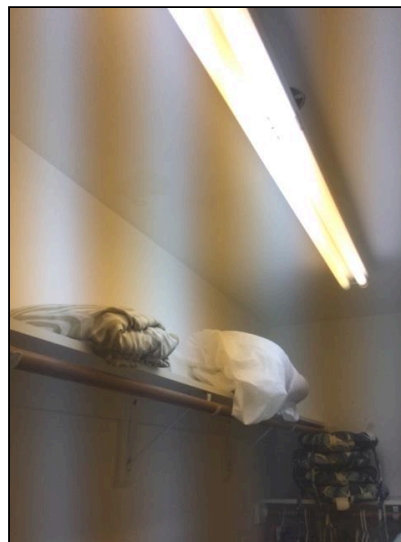
(2) *Moisture stains, moisture damage, indications of moisture, or repairs at suspected moisture stains were present at finished surfaces. The areas were checked with a moisture meter or a thermal imaging camera however at this time, did not detect elevated levels of moisture or thermal anomalies. At this time, I cannot confirm if prior moisture intrusion has been repaired or addressed. The conditions at the time of the inspection did not reveal moisture content. Changes in conditions such as temperature, weather, repeated use of plumbing, pest/vermin activity, or changes in occupant activity may reveal subsequent activity. I recommend inquiring with the seller/occupant for more information or repair details.*

3.2 Instance of stains - master closet

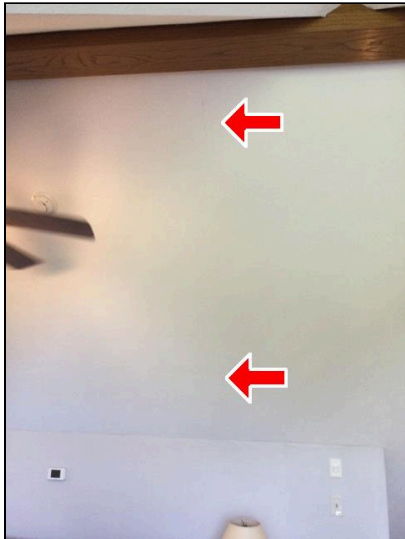
(3) *During the inspection, cracks, separation at seams, and/or nail pops observed at finished*

3.2 Instance of cracks/separations - upper loft

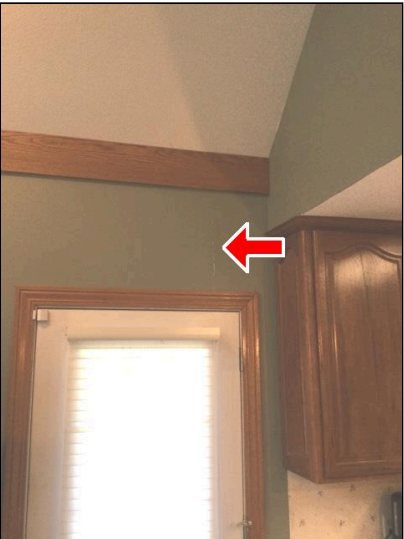
3.2 Instance of cracks/separations - living room/kitchen

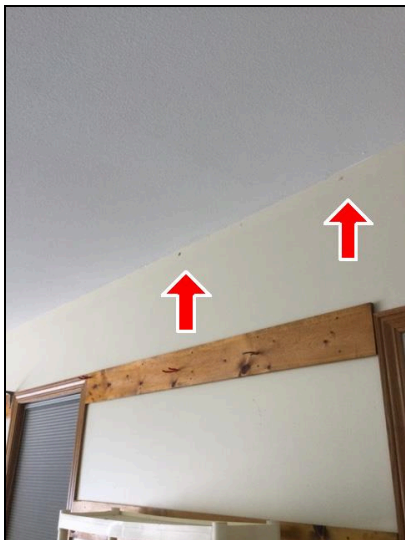
3.2 Instance of nail pops - garage

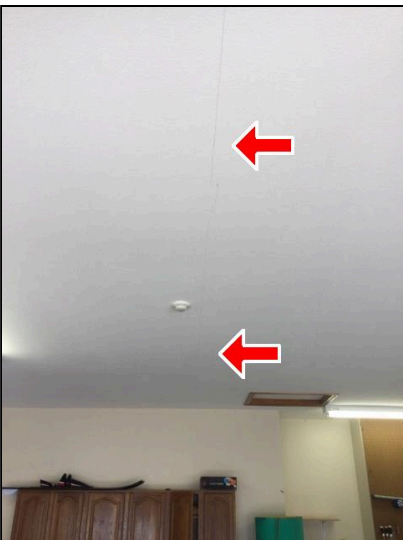
3.2 Instance of cracks/separations - garage

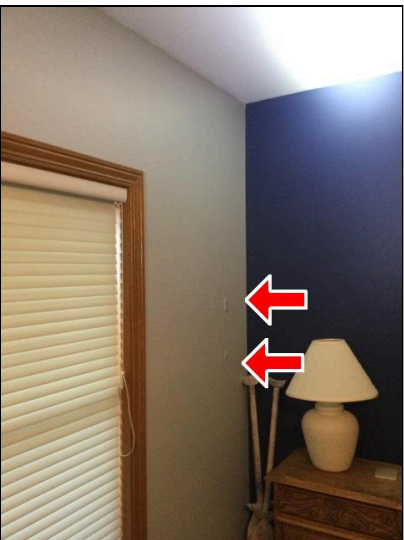
3.2 Instance of nail pops (behind painted wallpaper) - master bedroom

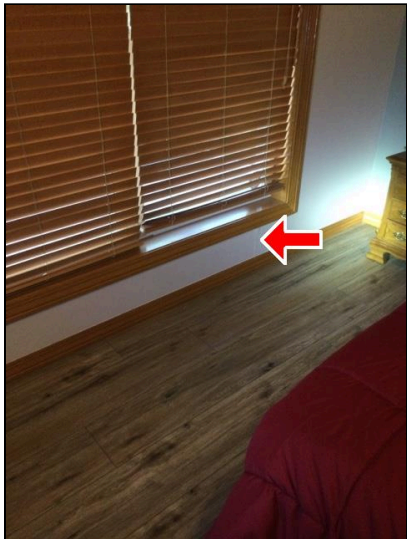
3.2 Instance of cracks/  
separations - lower level  
bedroom

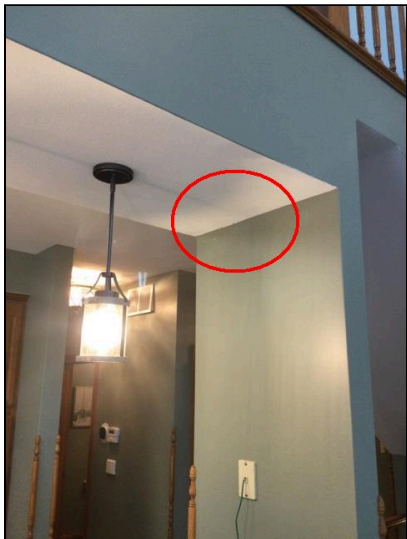
(4) **Repairs, or indications of repairs were observed at finished surfaces within the structure.** Repairs to finished surfaces may have been performed in response to prior poor finishing, prior leakage, improvements, damage, or structural movement. *Unable to determine the condition of underlying materials or systems at this time. No immediate concern at this time, I recommend inquiring with the seller/occupant for information regarding repairs.*

3.2 Instance of repair attempt  
- kitchen

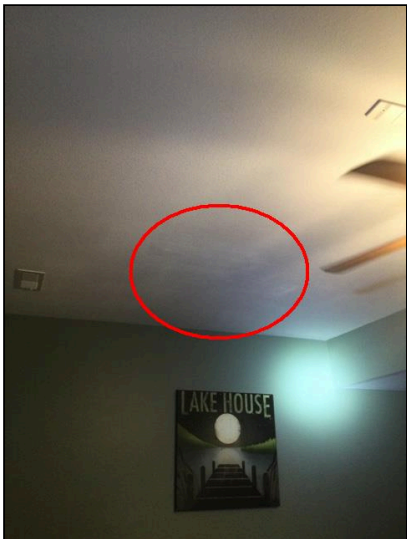
3.2 Instance of repair attempt  
- lower level

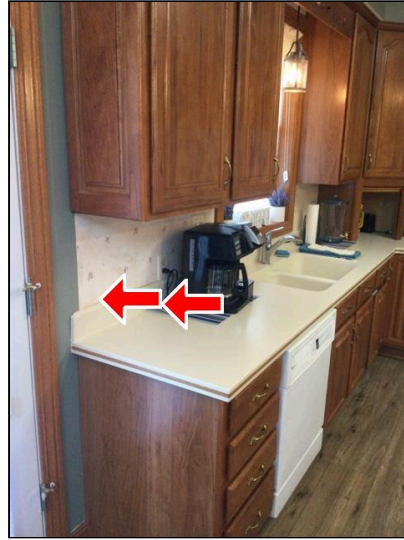
Grout and caulk/silicone maintenance needed. I recommend routine maintenance in this area.

3.4 Instance of silicone maintenance needed

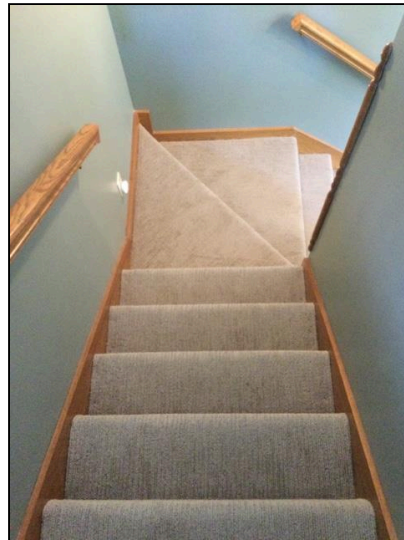
(2) **Stair steps within the structure called "winders" were present.** The winder treads in the home were non-conforming by present standards but were typical for homes of this age and construction. Reconstruction of the stairway may not be practical -- special care should be taken when using the stairway. Potential fall hazard.

3.6 Winders

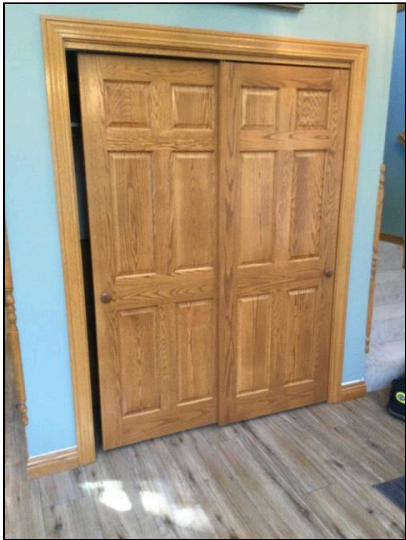
(1) **A representative amount of interior doors were inspected and adjustments are needed at this time.** *Tightening fasteners at hinges, latches, and handles or adjusting latches and striker plates needed. Doors that rub in jams may need planing at the edges or other adjustments. These repairs can be made during the course of routine maintenance.*

3.8 Instance of maintenance/ adjustments needed - front coat closet

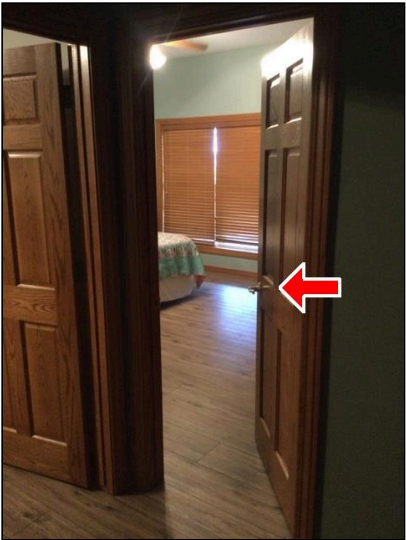
3.8 Instance of maintenance/ adjustments needed - lower bedroom

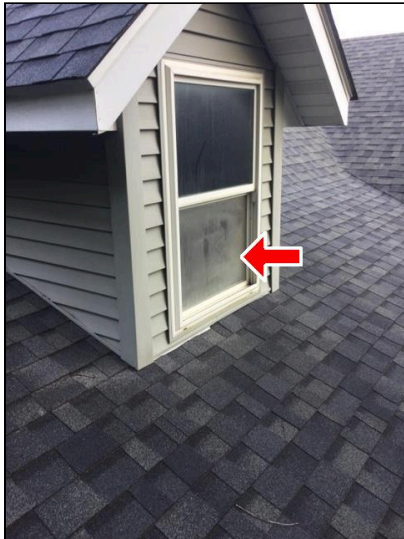
3.9 Instance of moisture/cloudy panes

**I recommend a qualified siding and window contractor evaluate all windows and repair or replace as necessary.**

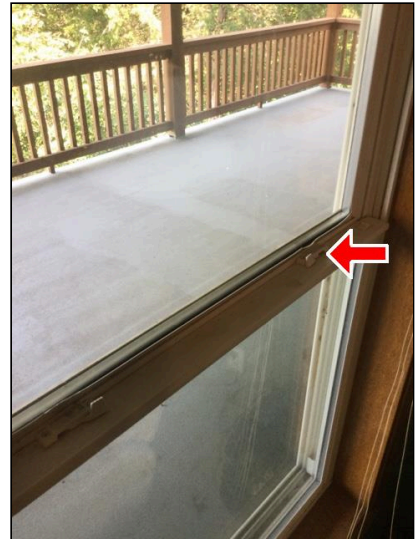
3.9 Instance of damage, hard to operate - lower level living room

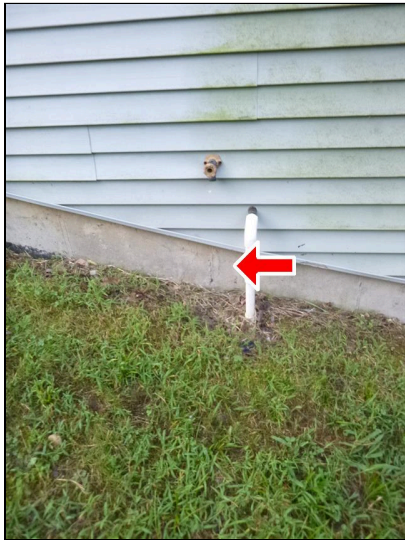
4.2 Instance of cracks/ separations

**I recommend improving the grading and lot drainage at the exterior as outlined in Section 1 to improve conditions of the foundation. Improvements to the downspouts and downspout extensions is recommended to move drainage away from the structure.** Routine inspection and maintenance of lot drainage, exterior grading, and gutter drainage is recommended to reduce moisture related problems and aggravating existing foundation problems.

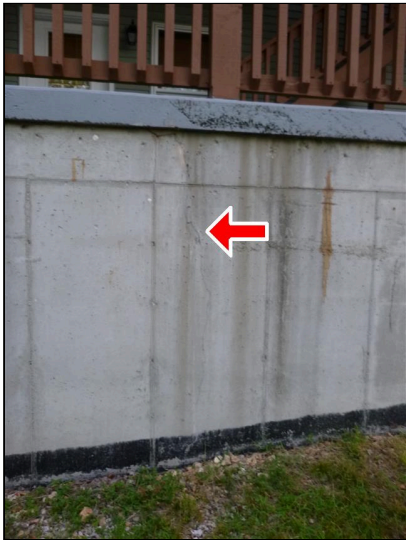
4.2 Instance of cracks/ separations

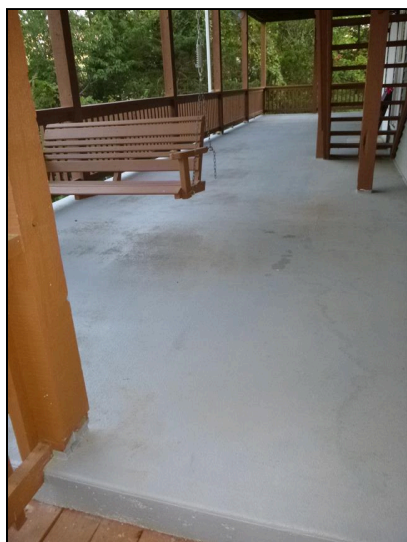
(2) A suspended concrete floor was present at the rear of the home. The metal decking that the concrete was poured onto was rusty and damaged. The concrete had a coating applied. In my opinion, there was significant moisture intrusion through the suspended concrete into the room below in the past. A metal structure was installed underneath the suspended concrete to support it. The construction of the metal structure was professional in nature. I recommend inquiring with the seller for more information regarding repair attempts.

4.6 Coating on concrete

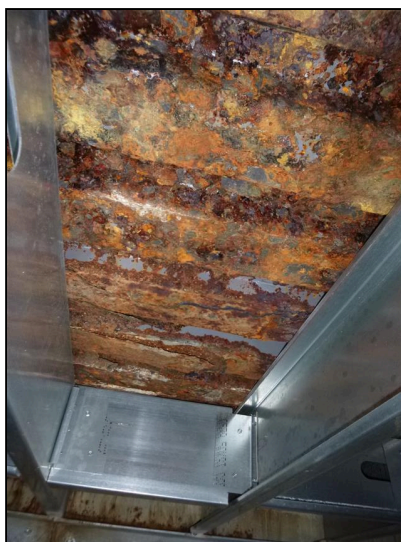
4.6 Rusty metal deck underneath the concrete

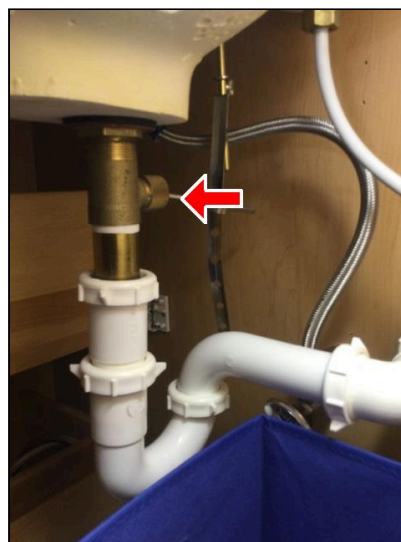
(1) **A leak was present at the right master bathroom sink drain piping.** The opportunity for deterioration at the cabinetry and organic growth is possible if left in disrepair. ***I recommend a qualified plumber evaluate and repair as necessary.***

5.6 Leak

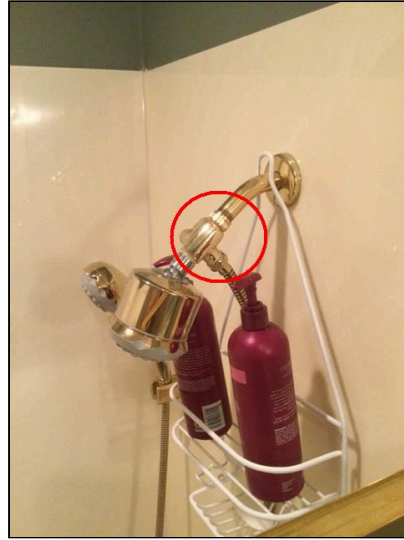
(2) **Repairs were needed at the lower level hall bathroom shower head (bathroom with the shower stall).** *The shower head dripped at the threaded pipe when in use. -- This may be a nuisance and wasteful. -- I recommend repair or replacement and confirming proper and leak free operation.*

5.6 Drip/leak

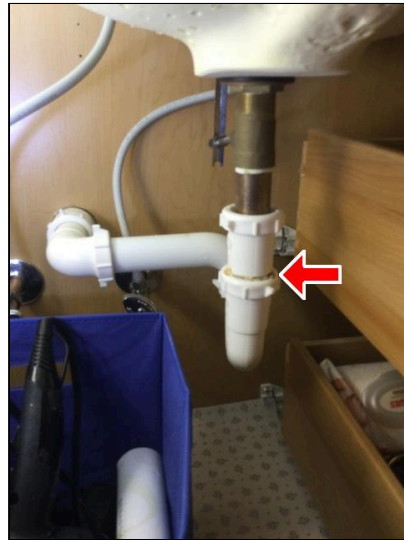
(3) **Corrosion was present at the left master bathroom sink drain system.** *This is an indication of a prior leak in the area. A leak was not observed in this area at this time. I recommend monitoring plumbing for leaks and repairing as needed.*

5.6 Corrosion

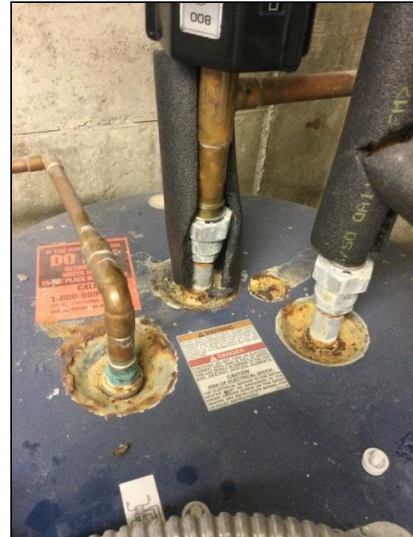
5.7 Rusty, prior leak

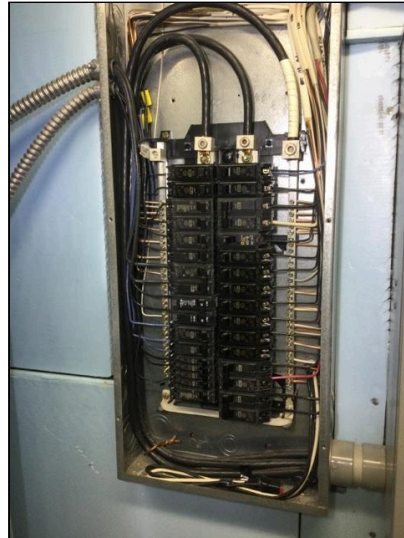
(1) An inspection of the electrical system revealed improvements or repairs needed at the panelboard. **The grounds and neutrals were bonded together.** This allows multiple paths for current to return to the main disconnect. This is not an allowed configuration. Potential shock hazard. A separate ground and neutral was not present at the feeders supplying power to the panelboard. Panelboards installed downstream of a main disconnect or main panelboard are required to have 4 wires in the bundle (feeders). **I recommend a qualified electrician evaluate and make repairs conforming to current standards.**

7.3 Grounds/neutrals bonded together

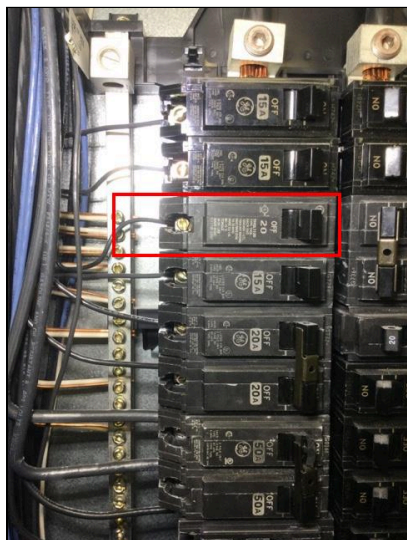
**One or more breakers were too large of a rating for the circuit.** Breakers that are rated for more amps than the wires are rated for is a *potential fire hazard.* *Notes: 20A breaker serving 14awg branch circuitry. **I recommend a qualified licensed electrician evaluate the panel circuitry and repair as necessary.***

7.4 Over amp breaker

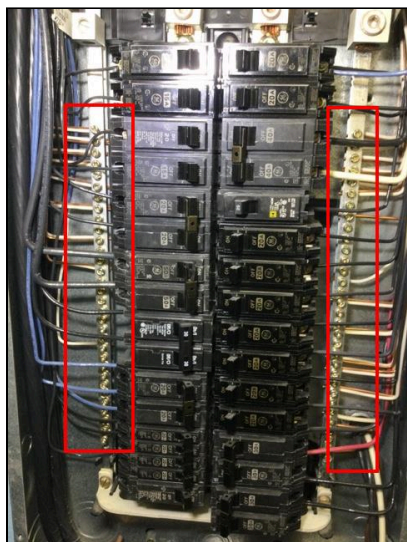
7.4 Double tapped neutrals

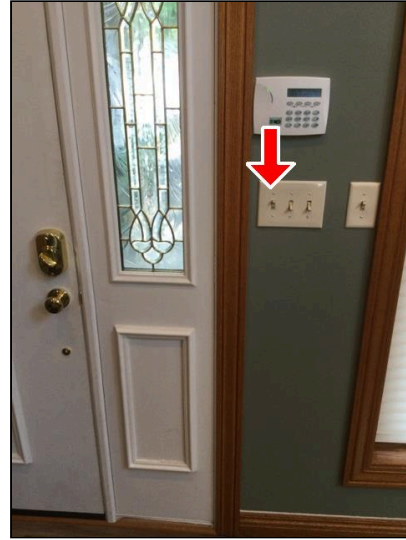
(1) There were switches and/or controls that did not easily or visually reveal a purpose. *Equipment or nearby lighting did not respond when switches were flipped on or off. Extensive investigation was not performed in the interest of time. Switches may have no purpose, may operate special functions within the structure, operate lighting or systems on opposite sides of the structure, or operate fixtures that are inoperable or have defective bulbs. I recommend inquiring with the seller/occupant to determine the function or repairing, if needed.*

7.6 Instance of function not identified - front entry

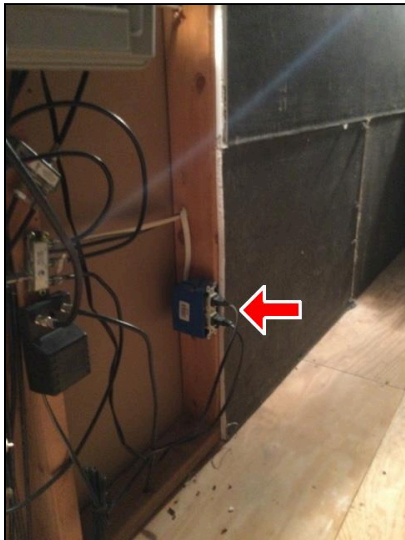
(1) **One or more outlets were in need of repairs.** Outlets should be tight to the surface and a face plate should cover the circuitry completely to prevent electrical shock. I recommend repairing loose outlets as needed and installing covers where needed.

7.7 Instance of cover not installed - upper attic access

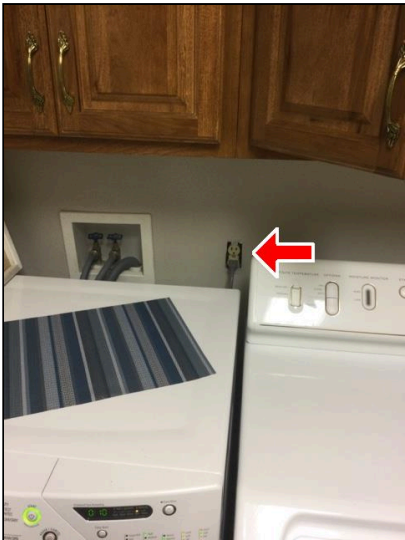
7.7 Instance of cover not installed - utility room

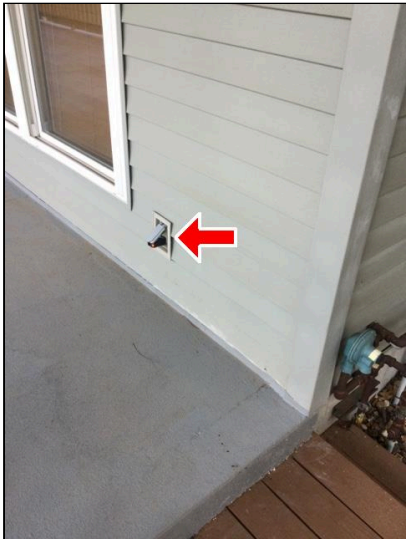
(2) **One or more outlets tested incorrect polarity.** Outlets that are incorrectly wired are a significant shock hazard! I recommend a qualified electrician test all receptacles and repair as needed.

7.7 Hot/ground reversed - lower rear exterior

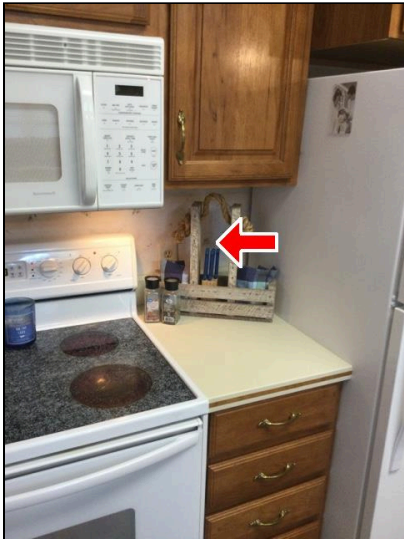
(1) **Some outlets were lacking GFCI protection.** GFCI protection prevents deadly shock around sources of water. *GFCI protection is recommended at all kitchen countertop surfaces, all exterior locations, laundry area, unfinished basement, and near sources of water (within 6 feet).* ***I recommend upgrading to current standards.***

7.8 Instance of outlet lacking GFCI protection - kitchen

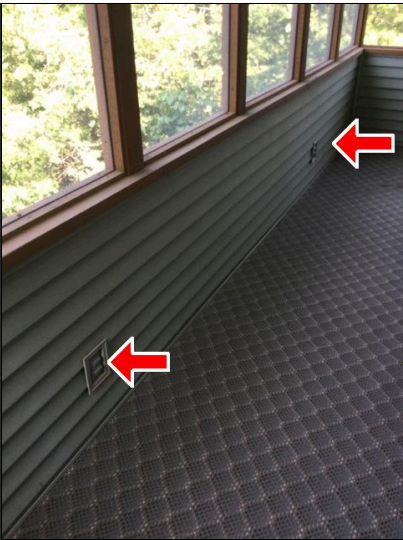
7.8 Instance of outlet lacking GFCI protection - rear covered deck

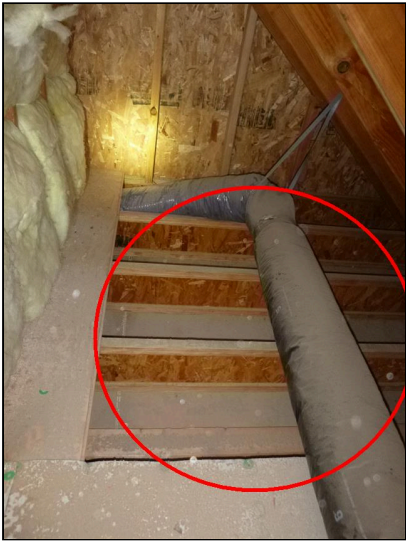
*Inadequate or non-performing insulation is less effective at reducing the transfer of heat. Results of insulation that has been displaced or moved, compressed or trampled from traffic, or damaged include discomfort, increased energy costs, wasted energy, or potential ice dam formation (in winter). I recommend restoring insulation in to its proper thickness where necessary.*

8.2 Very little insulation above master bathroom area

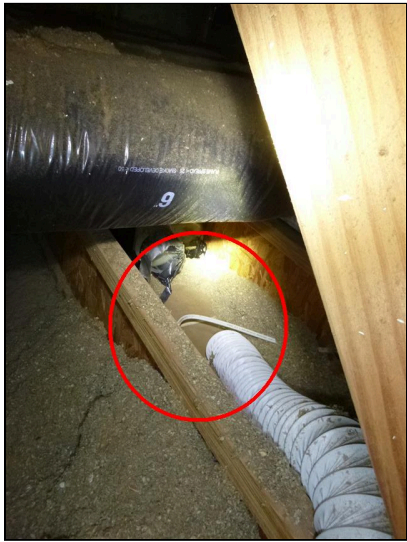
(2) **Exhaust terminations were either present or suspected to vent into the attic.** *Ventilation that terminates into an attic or the does not directly vent to the exterior promotes excessive moisture in the area, which could lead to potential moisture or mold problems. I recommend terminating the all exhaust terminations to the exterior in accordance with present standards.*

8.3 Bath exhaust vent termination

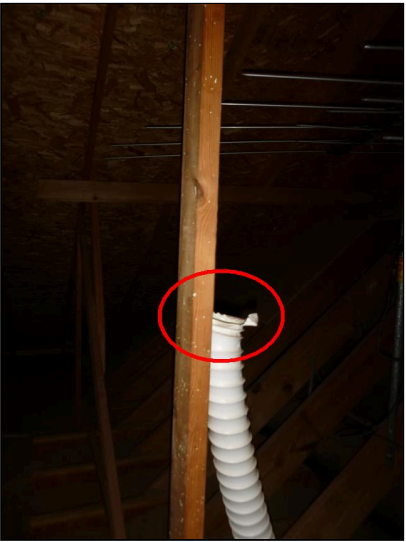
8.3 Bath exhaust vent termination

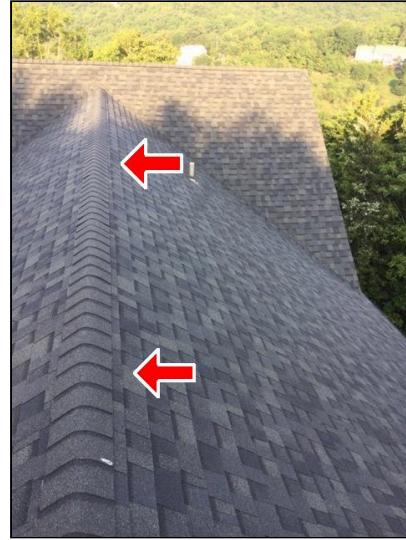
8.3 Ridge vent not installed

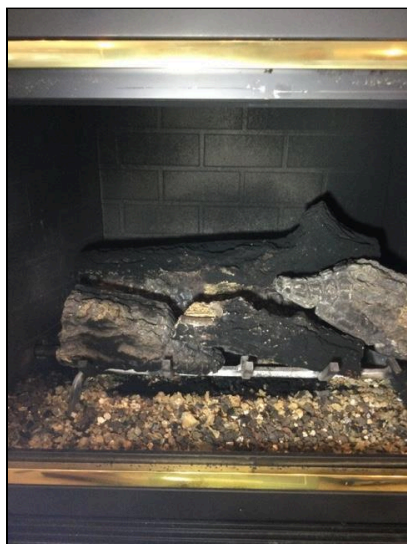
9.2 Sooty

**I recommend a qualified fireplace contractor evaluate repair or replace as needed.**

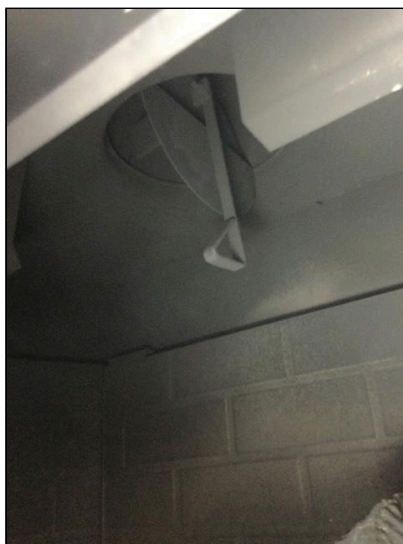
9.2 Clamp not installed on damper
