## YOUR INSPECTION REPORT

**201 W 2nd Street  
Hermann, MO 65041**

**Prepared By: Jason Ratliff**

**Inspected Date: 10/15/2025  
Report ID: 1112893**

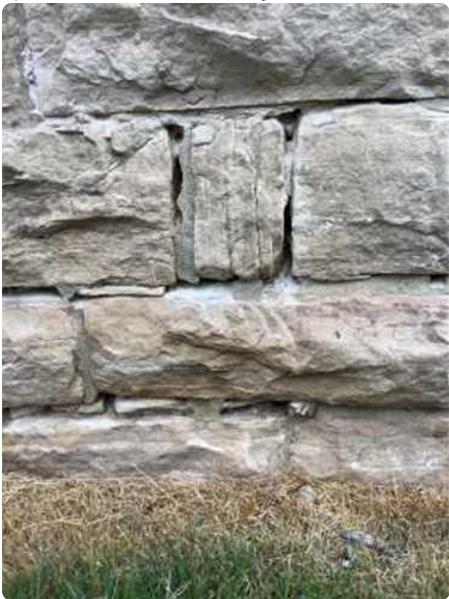
There are several places the stone foundation needs to be tuck pointed. Recommend a professional evaluate and tuck point where necessary.

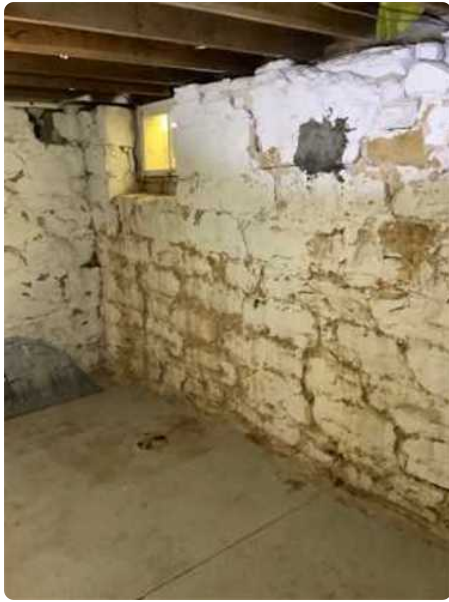
- There is only visual access to the crawlspace at the opening. The opening is to small to enter.
- The right wall of the foundation has evidence of leaking common with stone foundations. Recommend correcting the grading along the foundation and install downspout extensions. Tuck point where necessary, if more moisture is wicking in than desired contact a foundation specialist to install a tile system.

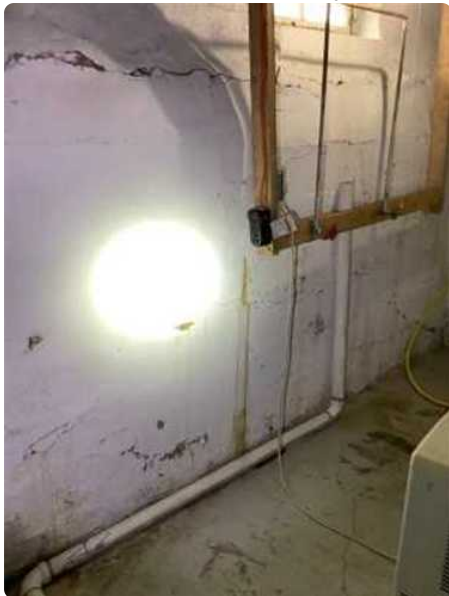
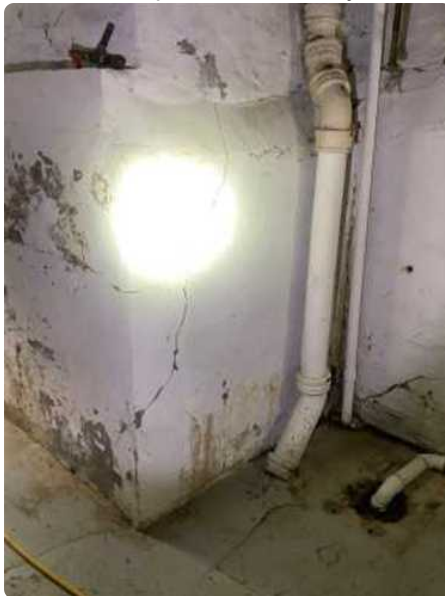
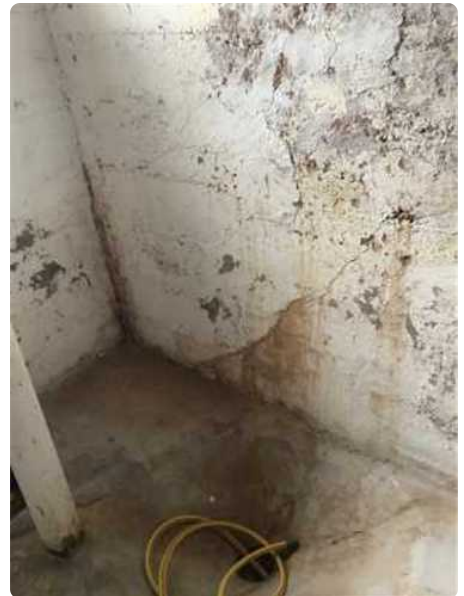
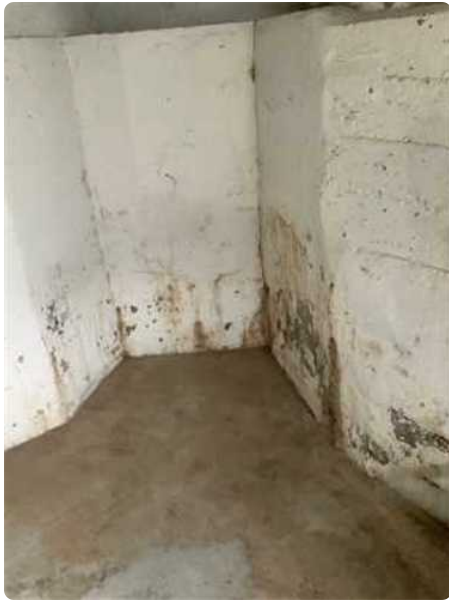
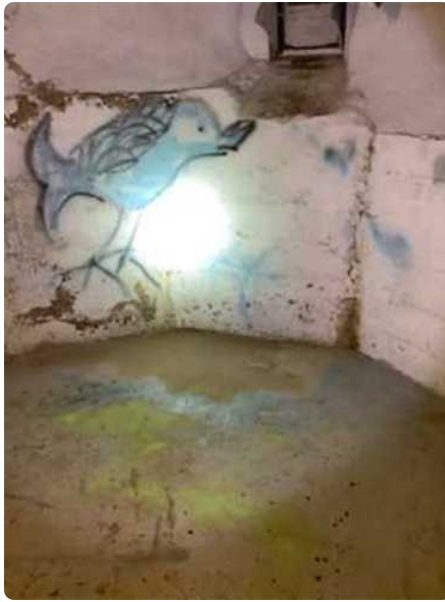
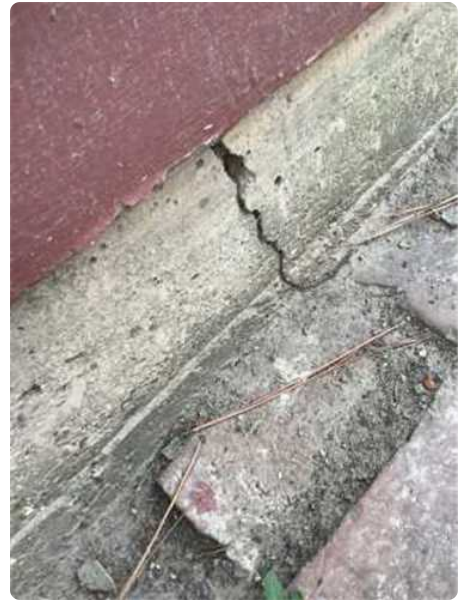
- The left, front and right front foundation walls have concrete walls poured along them to help keep the stone walls from moving. The left concrete wall is cracked in a couple of places and has been leaking. The front left inside corner and right wall has evidence of leaking. The back wall of the kitchen there is a crack that is offset, evidence of movement. Recommend a foundation specialist evaluate and repair as necessary.

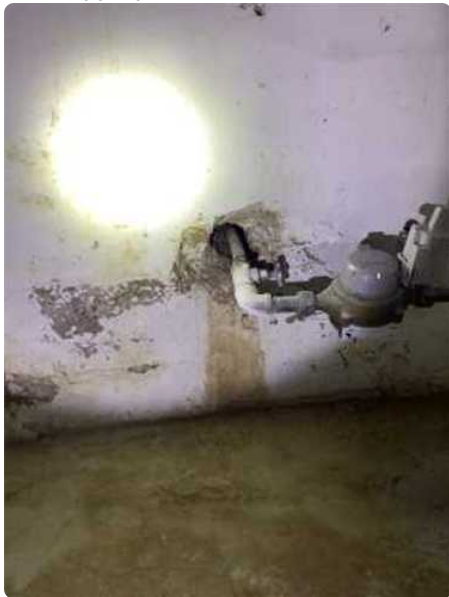
- Where the main water line enters the basement it is not sealed and water is getting in. Recommend a professional seal with appropriate sealant.

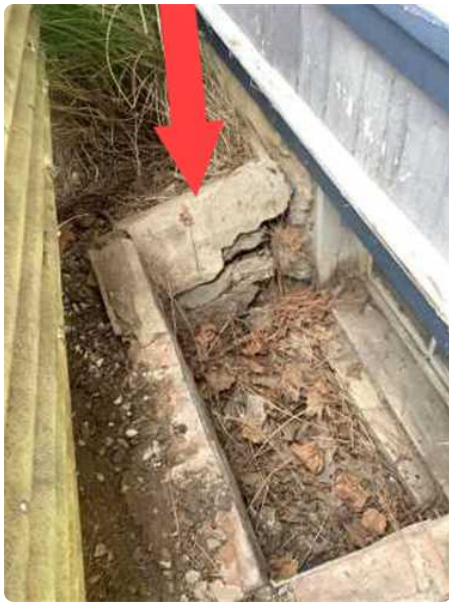
- The right back window well is coming apart. Recommend a professional repair/replace as necessary.

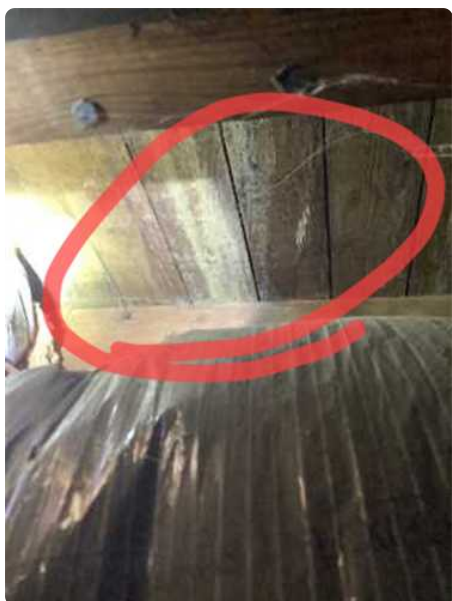
- In the basement at the bottom of the stairs above the ductwork there is possible mold on the subfloor. Recommend a mold professional evaluate and mitigate if necessary.

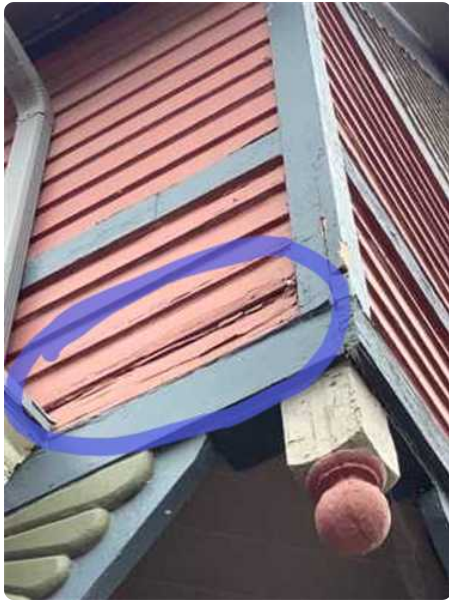
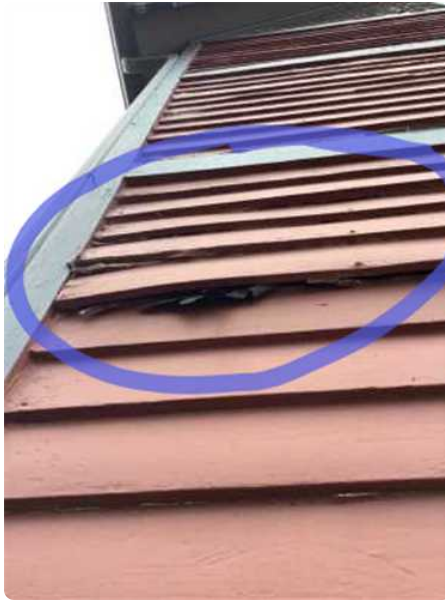
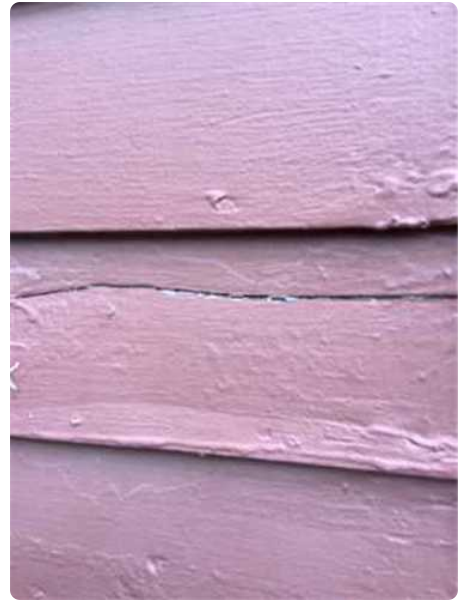
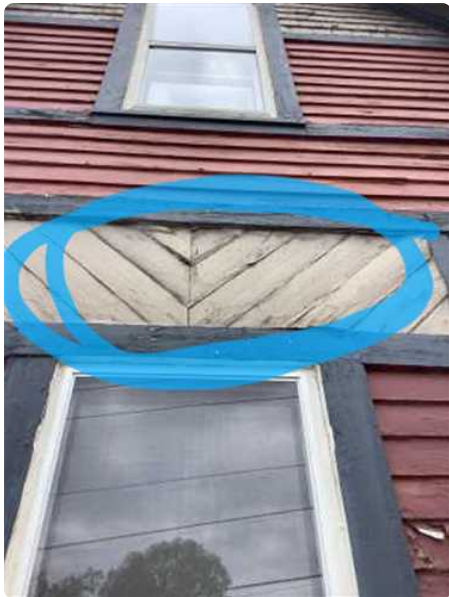
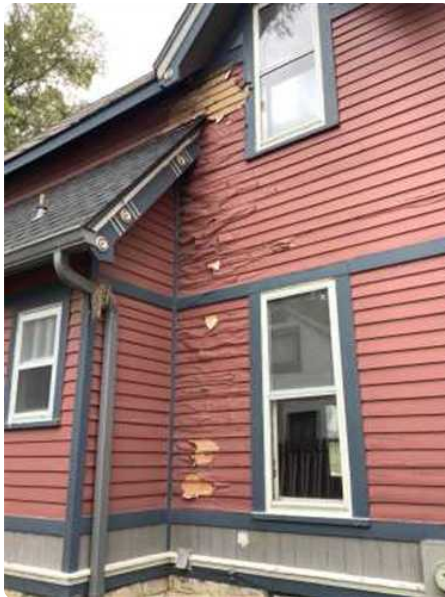
- Reseal windows/doors where necessary.
- The siding paint is bubbling in several places on the home. The siding could be soft/rotted in those areas. The left side of the home there is a section the paint is missing / coming off. It appears to have gotten hot. There are boards that are cracked/split. The front left corner the siding is pulled away. Recommend a contractor evaluate entire home and repair/replace as necessary.

Siding pushed out

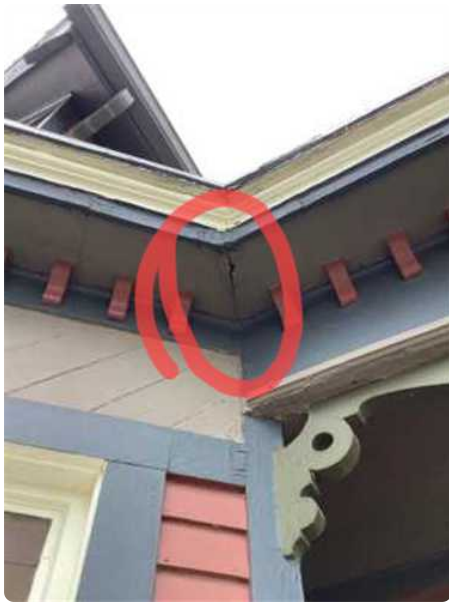
- From the ground the materials appear in typical condition.
- 🔑 ■ The soffit above the front porch stairs appears to be soft/rotted. Possibly the built in gutter is leaking. Recommend a qualified professional evaluate and repair/replace as necessary.

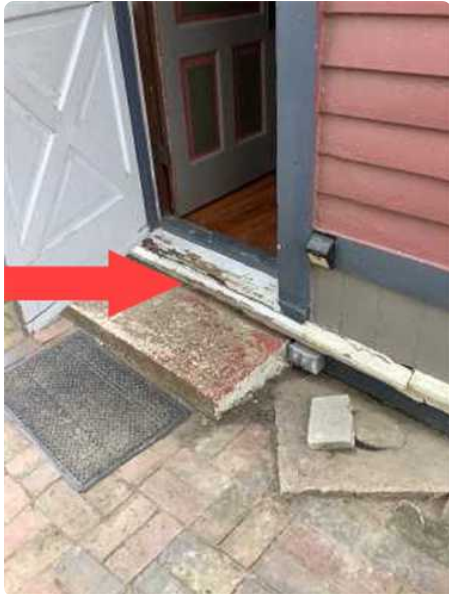
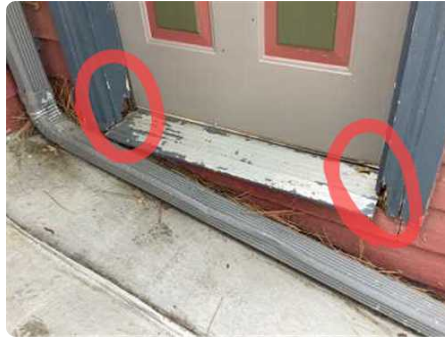
- The back exterior door the wood along the bottom of the door is soft/loose. The back upper door the casements are rotted at the bottom. Recommend a qualified contractor evaluate and repair/replace as necessary.

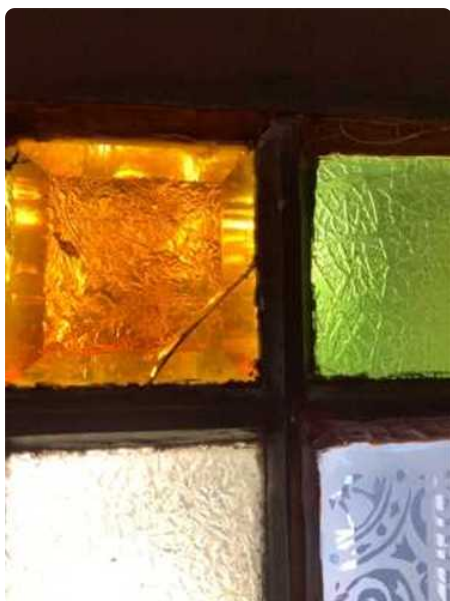
- Entries not protected with a roof often leak at the trim joints and threshold surrounding the doorway during certain weather conditions. Check these joints regularly and caulk and seal as necessary. Chronic leaks can cause wood decay at the trim above the door and the bandboard/joists below the threshold. Concrete patio slabs can also move because of frost action, creating a gap at the door threshold and possible wood decay. Monitor and seal as needed. Adding storm doors may help, but an extended roof always provides the best protection against the elements.
- The front door a piece of the stained glass in cracked.

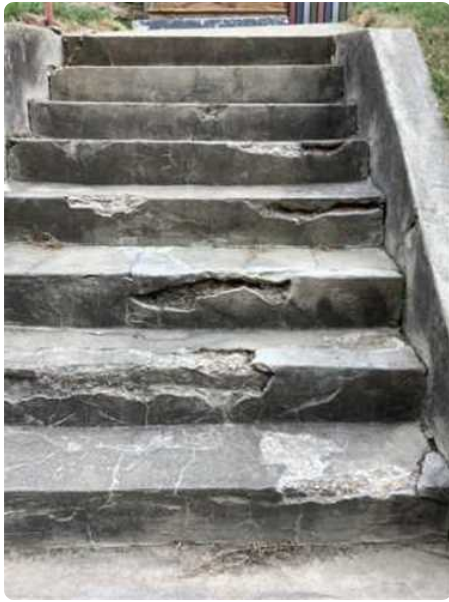
- The front steps from the sidewalk to the home are popping/flaking apart. Recommend a contractor evaluate and repair/replace as necessary.

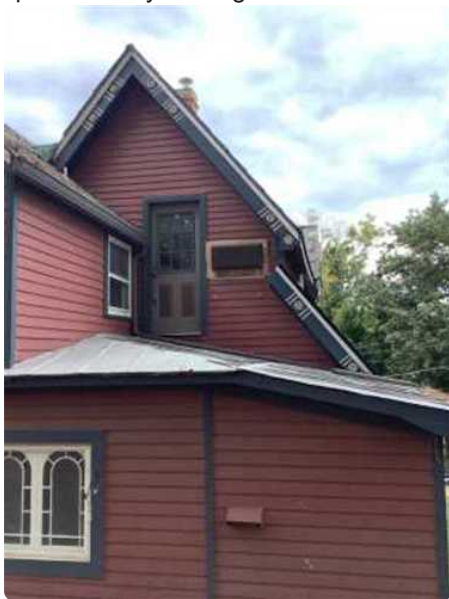
- The back lower roof there is a door from second floor onto the roof. Recommend either installing a guardrail or permanently closing off the door.

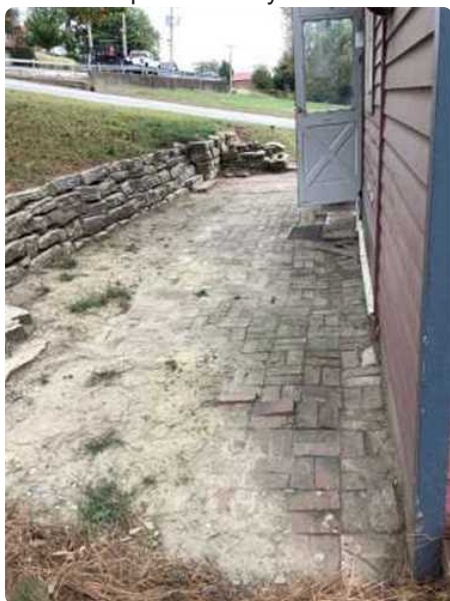
- The brick patio is wavy and there is evidence of water sitting. Recommend evaluation and repair as necessary.

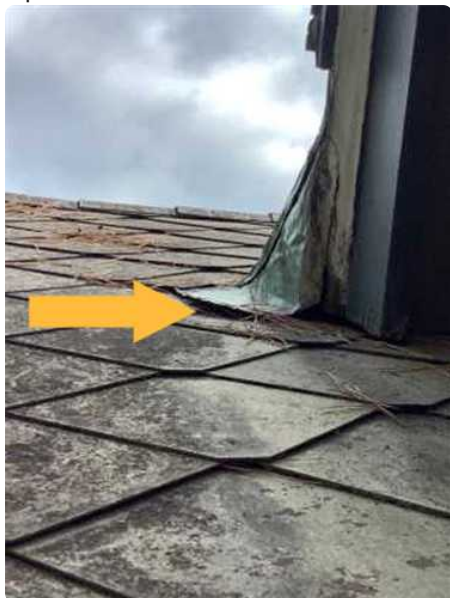
- The back left section of the main roof the flashing at the bottom of the valley is not secured down. Recommend a qualified contractor evaluate and secure/seal if necessary.

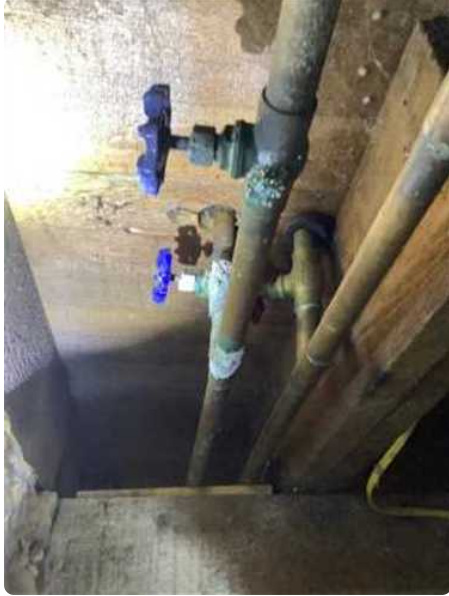
- There are a few shut off valves in the basement that are corroded, evidence of previous leaking. Recommend a licensed plumber evaluate and repair/replace if necessary.

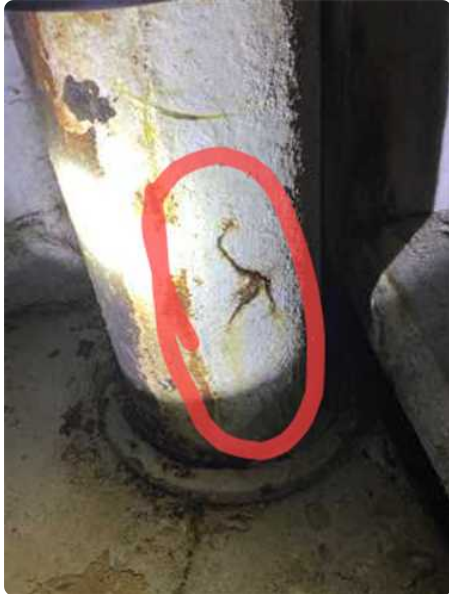
- The Cast Iron plumbing stack behind the stairs in the basement there is a crack on the pipe down by the floor. Recommend a licensed plumber evaluate and replace as necessary.

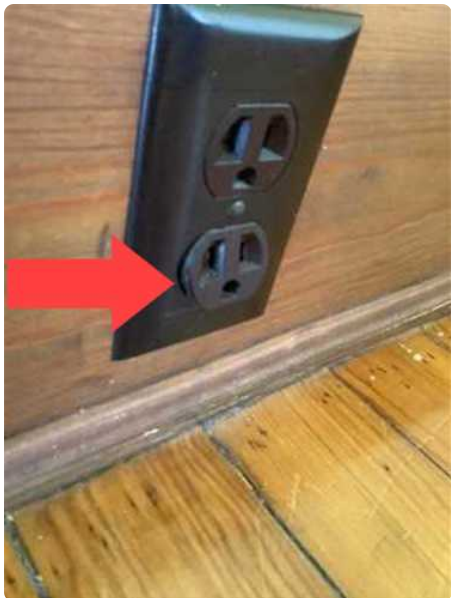
The front left room the front outlet is broken. Recommend a licensed electrician replace.

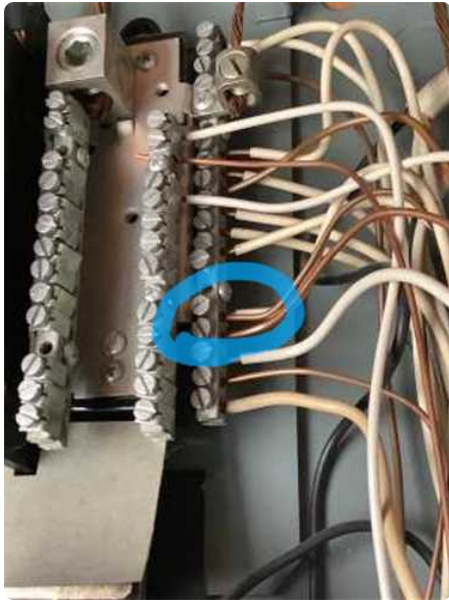
- 🔑 ▪ There is a ground wire in the same terminal hole as a neutral wire. Recommend a licensed electrician separate.

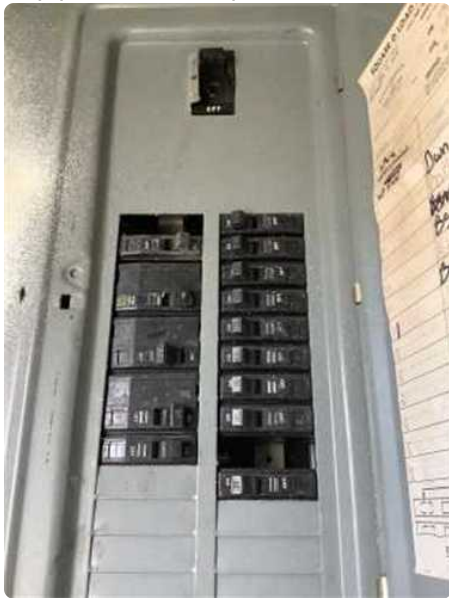
- Noted incomplete indexing at the electrical panel box. Recommend proper labeling of circuits.
- To avoid possible inadvertent shock, fill the open knockouts that are in the panel's access door and any in the sides or top portions of the panel box, with inserts designed for that purpose.

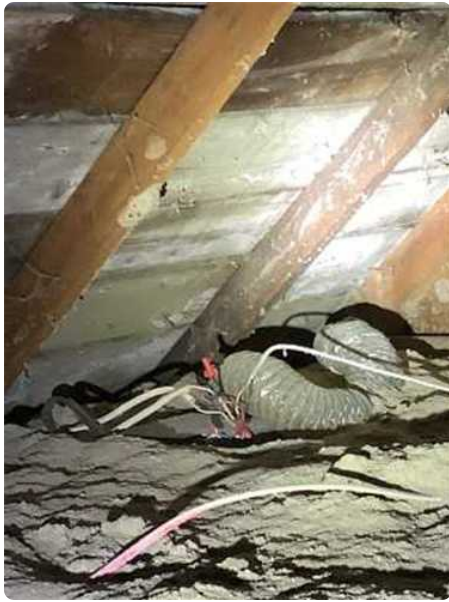
- The bathroom exhaust fan connection in the attic is not in the unit/ a junction box. Recommend a licensed electrician correct.

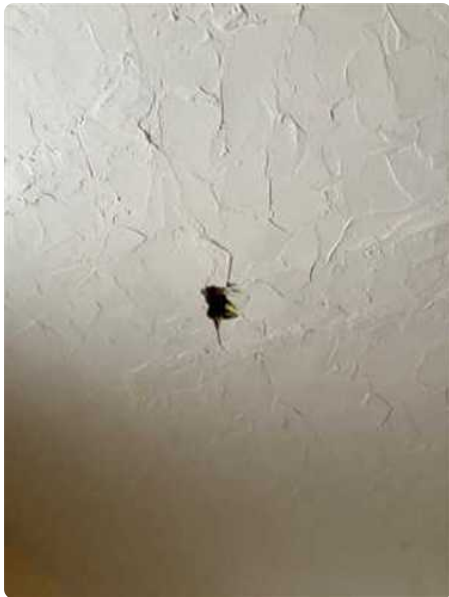
- Above the stairs there is a hole on the ceiling you can see wiring with wire nuts. Recommend a licensed electrician further evaluate.

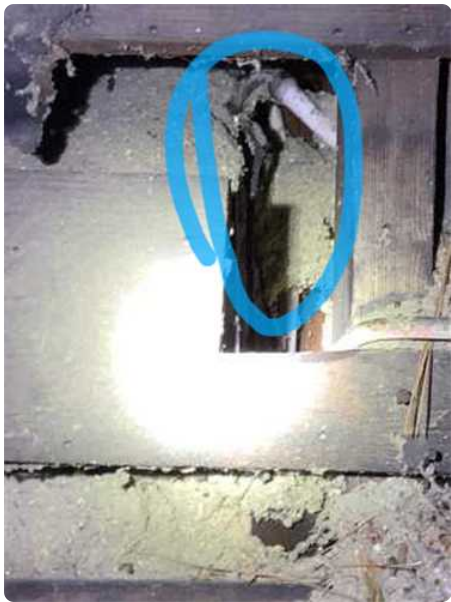
- There is knob and tube wiring in the attic some of it is off and some is still on. Above the upstairs hall door there is knob and tube wiring on. There could be more knob and tube wiring hidden in the walls or attic. Recommend a licensed electrician evaluate and replace as necessary. Check with your insurance provider to see if they cover knob and tube wiring, most insurance companies are not covering knob and tube anymore.

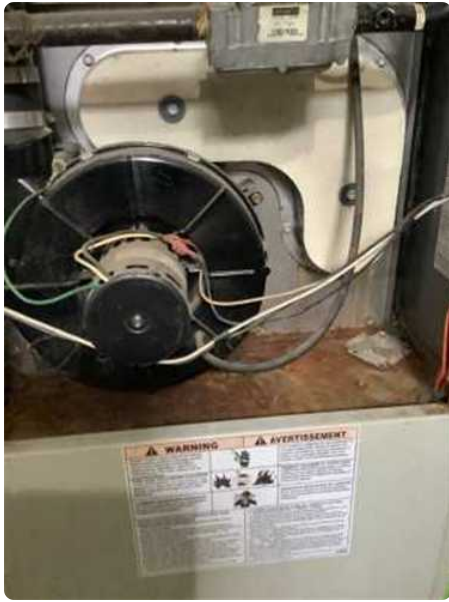
- 🔑 The furnace cabinet has rust in it. The furnace came on and one of the burners had a orange flame, not typical. The furnace only ran for a few minutes then only the fan was on. Pushed the thermostat to the off position but the fan stayed on. Recommend a HVAC tech evaluate and repair/replace as necessary.

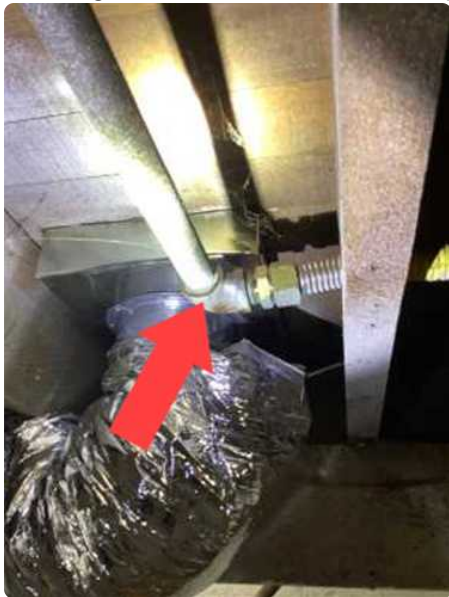
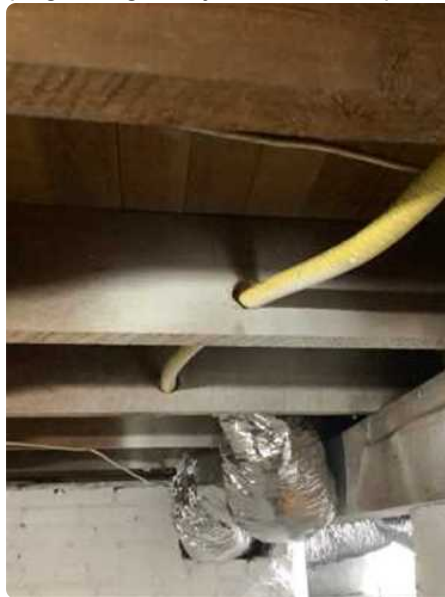
- The CSST gas line is not bonded and the gas line runs through the floor joist. Recommend a HVAC tech bond the CSST gas line and either install solid piping through the joist or install a protective sleeve.

CSST not bonded

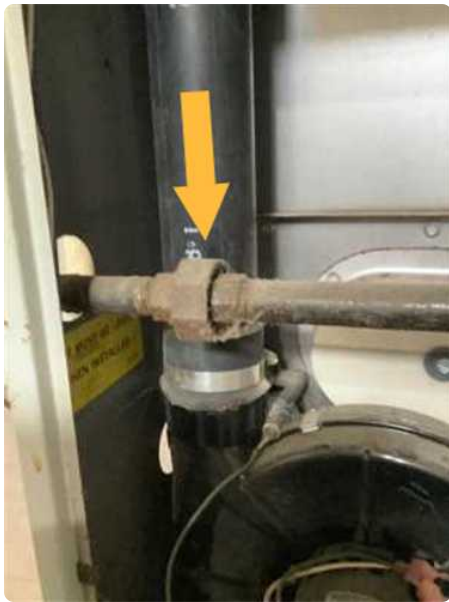
- The furnace gas line there is a union in the furnace cabinet, not proper recommend a HVAC tech correct.

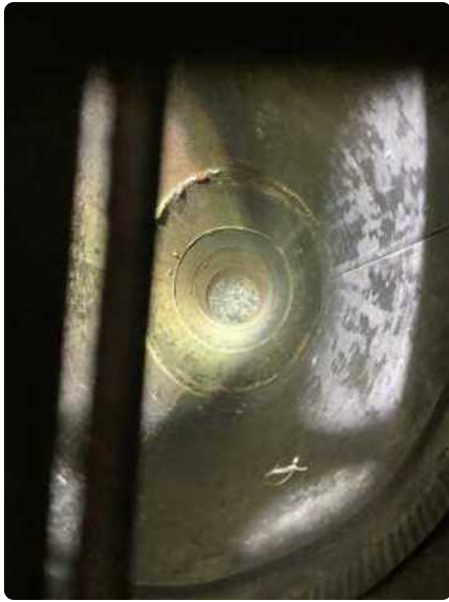
- The viewed heating distribution system looks in typical condition. Every section of the ductwork was not inspected.
- Regular furnace filter cleaning or replacement is one of the most important homeowner responsibilities. The interval varies by the type of filter. Some recent products suggest replacement only two to three times a year. Standard fiberglass, however, needs changing every four to six weeks year round.
- There are not registers in the front bedrooms.
- 🔑 ■ The main register in the upstairs loft there is debris at the bottom of the register. Recommend cleaning the ductwork/registers as necessary.

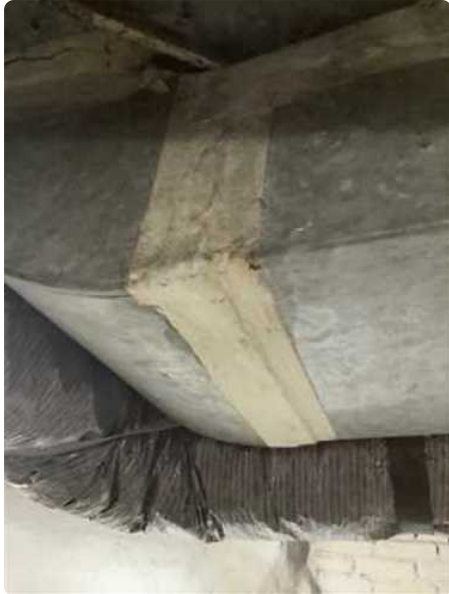
- This was not an asbestos inspection but it was noticed that the white/gray tape visible on the distribution ducts in all probability contains asbestos. Most reports on asbestos indicate that, when the material is properly sealed by wrapping and/or painting, little health hazard exists.

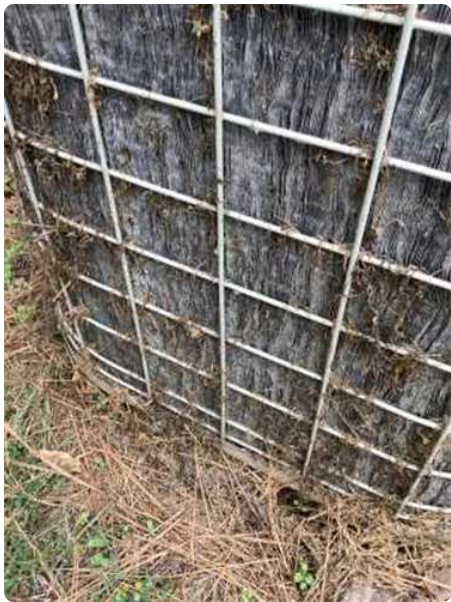
- The air conditioning system did not respond to the thermostat. The AC unit fins are damaged, recommend a HVAC tech evaluate and repair/replace as necessary.

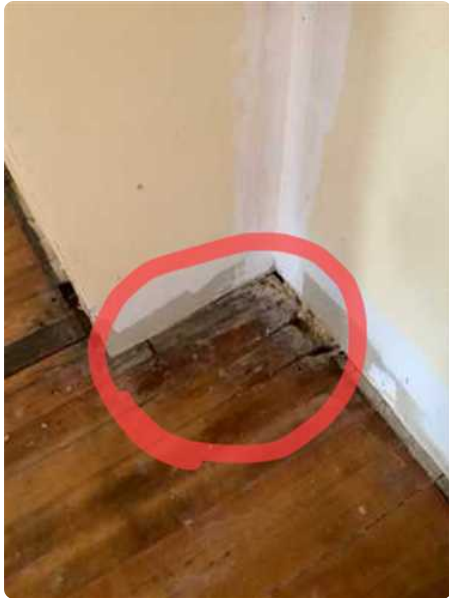
- The kitchen floor along the West wall at the inside corner the floor is soft/spongy. Recommend a contractor further evaluate and repair/replace as necessary.

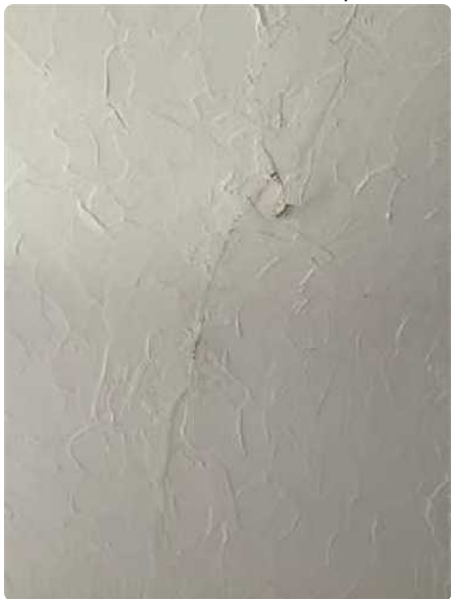
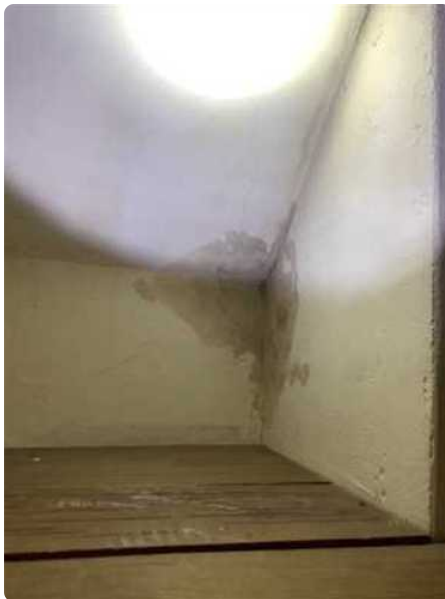
- There are stains on the front left bedroom ceiling and master bedroom East closet ceiling. Both areas tested dry with a moisture meter at time of inspection.

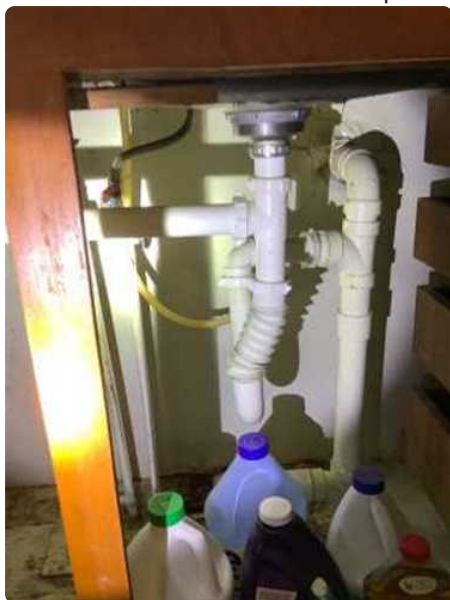
- 🔑 ▪ The kitchen sink drain configuration is not proper and a piece of the drain is flexible piping prone to clogging/ having issues. Recommend a licensed plumber replace as necessary.

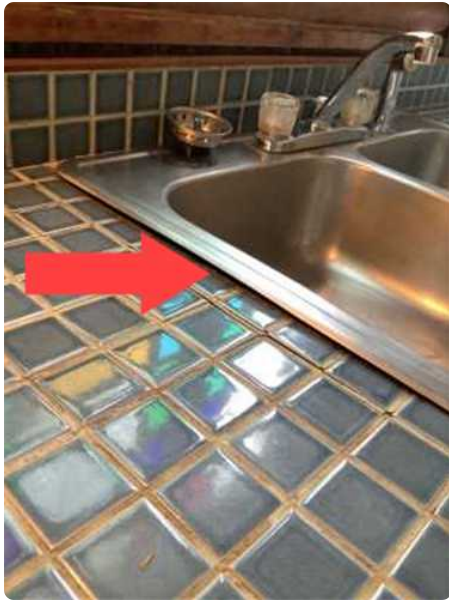
- 🔑 ▪ The kitchen sink is not down tight to the counter top. Recommend a professional evaluate and correct.

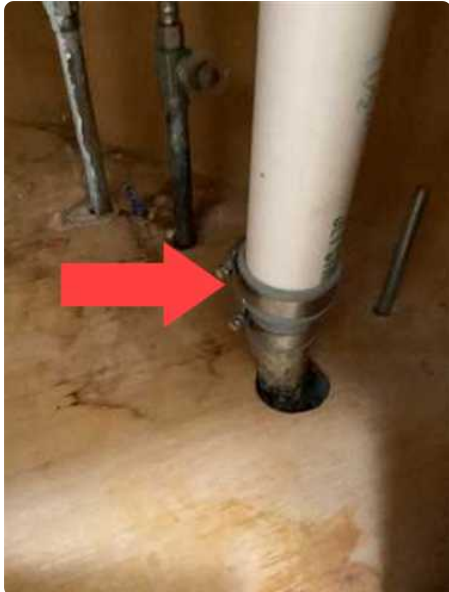
- Unable to test the bathroom sink due to the water was shut off at the sink.
- The bathroom sink drain has a non typical rubber connection. Recommend monitoring for leaking.

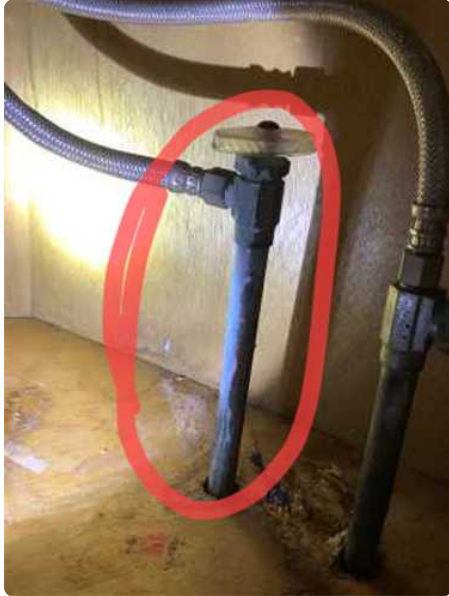
- The bathroom sink supply line shut off is corroded. Recommend a plumber evaluate and repair/replace if necessary.

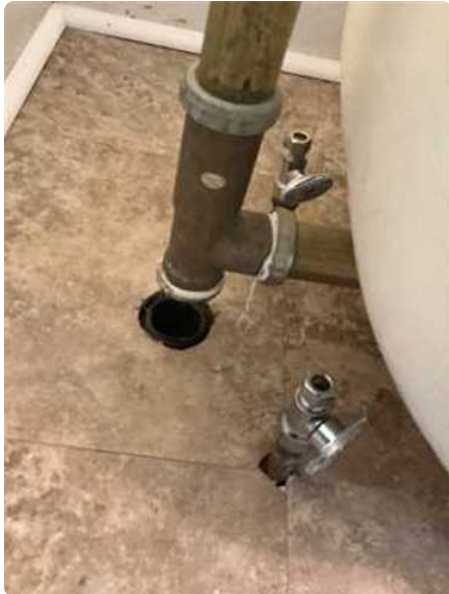
- Unable to test the tub due to the supply lines and drain were cut/ disconnected.
