# Inspection Report

418 Elizabeth Ave  
Palmyra MO 63461

**Integrity Home Inspection**

<b>Date:</b> 8/21/2025	<b>Time:</b>	<b>Report ID:</b> 2025/8/21pm
<b>Property:</b> 418 Elizabeth Ave Palmyra MO 63461	<b>Customer:</b> Mark & Jim Woodall	<b>Real Estate Professional:</b> Jason Chinn Trophy Properties and Auction

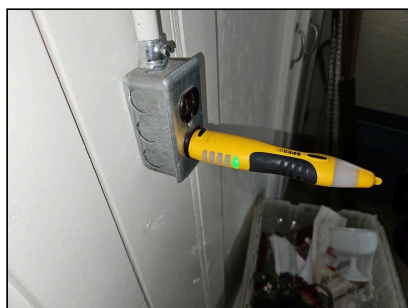
No GFCI requirements existed prior to 1971. The common accepted practice is to upgrade the receptacles to GFCI as renovations occur. GFCI protection was required starting in 1978 for garages. No GFCI protection was observed in the garage. Suggest upgrading in the near future.

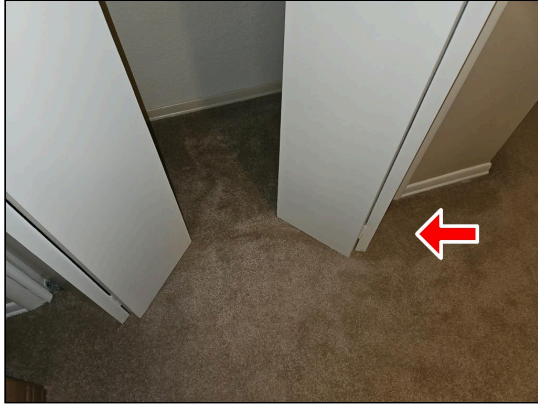
Nw bedroom closet door

(1) One or more doors drag the floor when opening. Possible damage to flooring or door could occur. Suggest corrective measures be considered.

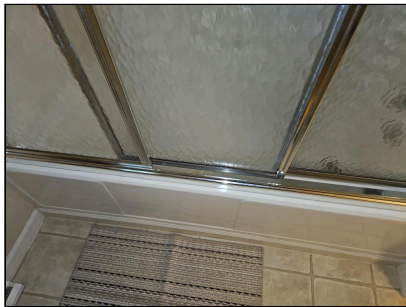
(2) Bypass guide for the tub shower doors is missing and should be installed.

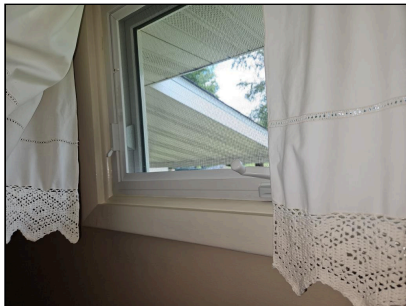
(1) The two awning windows would not open using reasonable force.

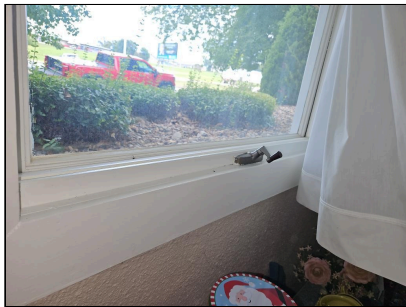
(2) Using reasonable Force the east basement awning Windows would not open.

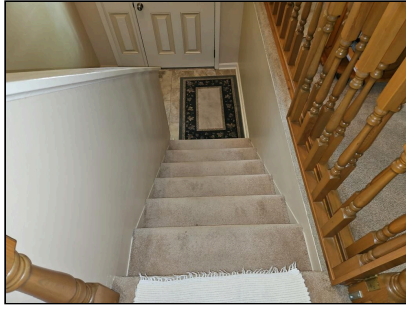
The hand/guard rail for the upstairs is missing. A fall or injury could occur if not corrected. A handrail should be installed for safety.

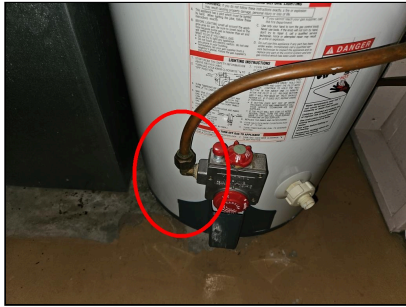
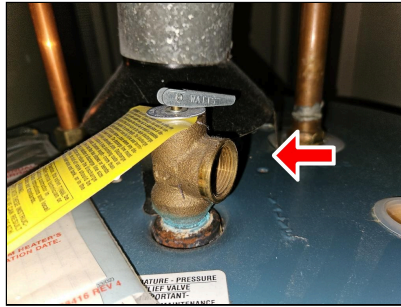
The T&P (Temperature and Pressure) valve on water heater needs a 3/4 pipe to extend within 6 inches of floor for safety. (PVC is not approved for hot water use). I recommend repair by a qualified person.

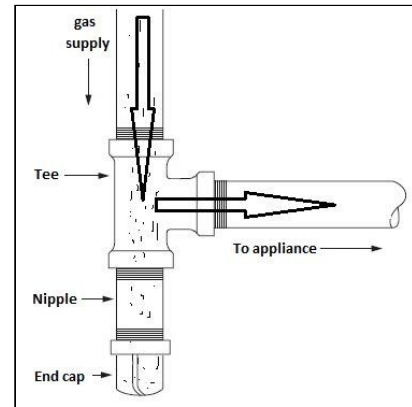
The water heater lacks a properly installed drip leg. A drip leg should be installed prior to the gas control valve.

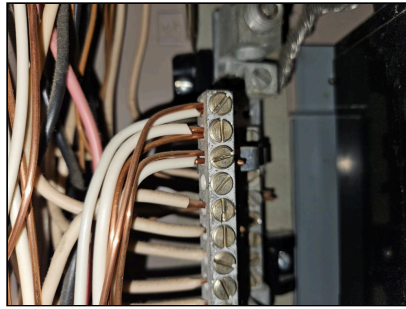
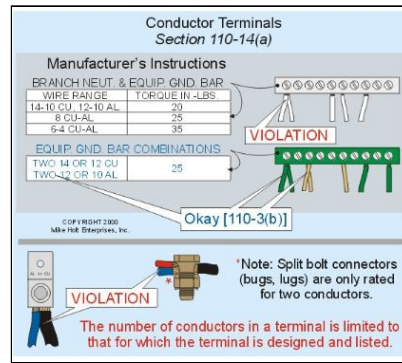
double tap ill.

Double tapping in the panel was observed. Current requirements state Neutrals & Neutral /Ground combinations should not share the same connection hole/screw. Although many electricians do not follow this rule and local municipal inspectors "OK" this infraction, it is still considered unsafe. Suggest corrective measures be considered in the near future. It has been required by manufacturer's instructions and Underwriters Laboratories Standard 67 for panelboards for some time. See this link for a narrative description of the reason for single neutral wire - single screw.

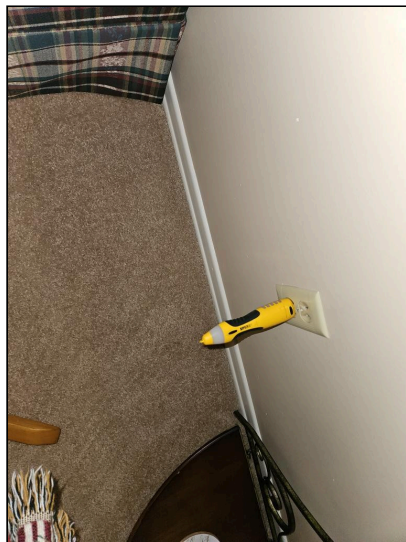
. Receptacles on the south side of the living room did not have power.

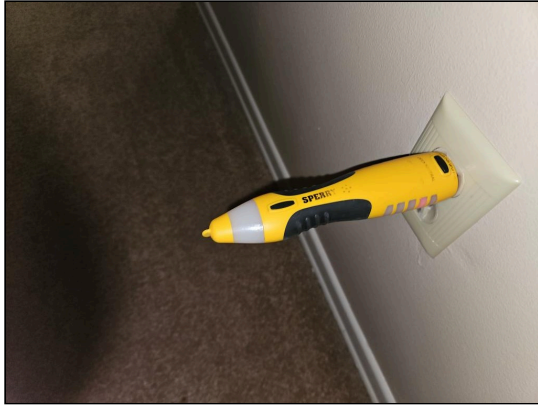
Living room

(1) Receptacles were the 3-prong type and some were ungrounded. If the receptacle is 3 prong and ungrounded it gives a false sense of safety. Grounding of all 3-prong receptacles, replacing them with a two prong receptacle or protecting them with ground fault circuit interrupters (GFCIs) and labeling them as not grounded is recommended for safety reasons. A whole house surge protector attached to the main panel could help in protecting electrical equipment. Areas that have open grounds are noted in the photos. Not every deficient receptacle is photographed. A qualified electrician should be consulted to further evaluate and determine which receptacles/wiring should be upgraded. Suggest upgrading when possible. Some locations or areas are indicated in the accompanying photos.

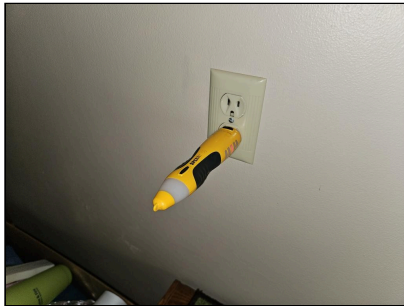
East side of kitchen

(2) Receptacle(s) were found with reverse polarity, (wired backwards) Recommend correction as needed.

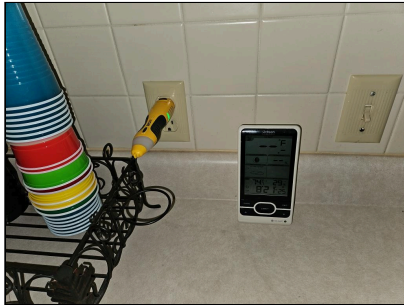
No GFCI requirements existed prior to 1971. The common accepted practice is to upgrade the receptacles to GFCI as renovations occur. The following dates indicate when the requirement for certain areas required GFCI. Exterior - 71'; Bathroom - 75'; Garage - 78'; Jetted or Hot tub - 81'; Kitchen (within 6' of the sink edge) & Unfinished basements - 87'. In 1996, all Kitchen counter top area and all bathroom receptacles must have GFCI protection. Areas that lack GFCI protection are noted in the photos. Not every deficient receptacle is photographed. A qualified electrician should be consulted to further evaluate and determine which receptacles should be upgraded. Suggest upgrading when possible. Some locations or areas are indicated in the accompanying photos.
