PAUL BENDYK & ASSOCIATES LLC

Inspection Report

July 14, 2025

Site Address:
20305 Highway M
Curryville, MO.63339

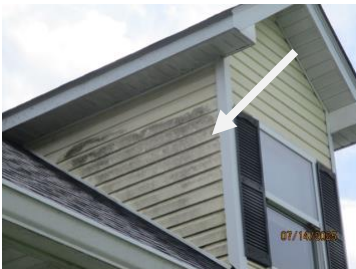
The vinyl clad exterior was found to have been professionally installed and well maintained. Power washing is needed at the dormer areas.

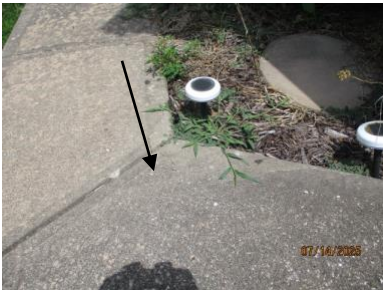
The poured concrete drive, rear patio and front porch slab were found to be in sound condition with no settlement noted. A crack was noted at the front walk which can be sealed and or replaced. This is a common occurrence in most homes.

Seal Crack(s)

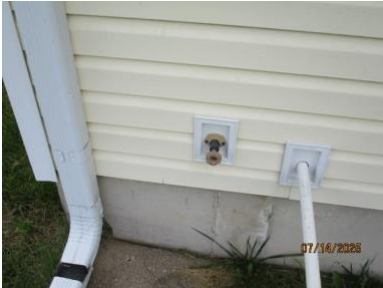
Two freeze water spigots are provided. Both were stuck due to the lack of use assure these are tested.

Handle Is Stuck

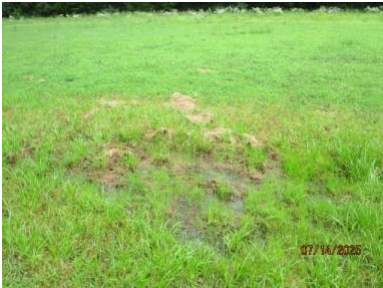
Elevation was somewhat flat at the north elevation and may hold water during heavy rains. A sump pump drained emptied and this are and standing water was noted. Eventual improvement of the grade maybe needed to divert the water from this area.

Standing Water From Sump

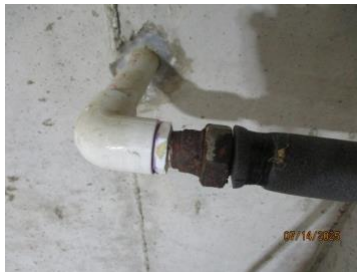
The main water line is an inch PVC Schedule 40 plastic line routed through the front foundation wall. We tested this valve and found to be in working order. We did note some rust at the union, not active leakage was noted but eventual replacement will be needed. The remaining water lines are copper and were found to have been professionally installed, these were also tested and found to be in good working order. We also tested a number of shut-off valves and also found them to be in good working order tested except as noted at the exterior water spigots.

Corroded Fitting

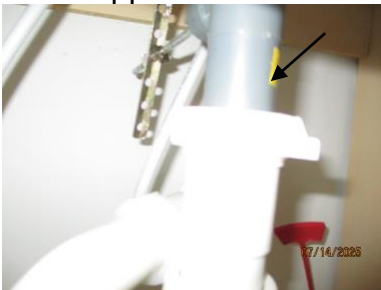
The waste lines consist of PVC Schedule 40 plastic lines and p-traps the man stacks due contain clean-outs and directed out the west wall of the foundation. We tested all fixtures and found all to have been professionally installed although a leak was noted at the second-floor bath and is need of attention. We noted all sink stoppers in the are in need of adjustment to open fully.

Leaking Trap

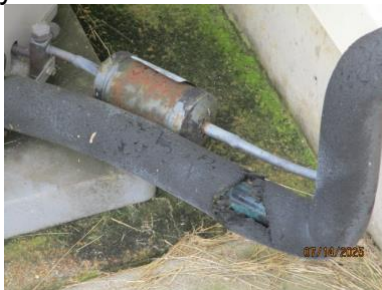
The updated air conditioner is a Carrier brand system rated approximately 3 tons of cooling capacity. The condensing unit is located at the north elevation of the home and was found to have been professionally installed. Freon lines and the electrical components were found to be in good working order. Reinsulating the Freon line is recommended. The system was tested and an acceptable temperature drop was noted between the supply and return lines. Temperature drop was minimal from the first floor to the second floor which is impressive. The system appears to be approximately original to the home but was found to be in operating condition and very well maintained.

Reinsulate Freon Line

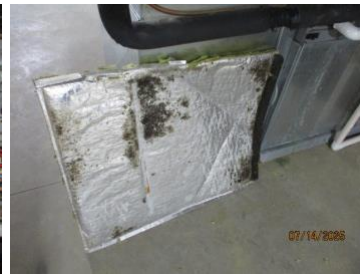
Insulation Off Of Door

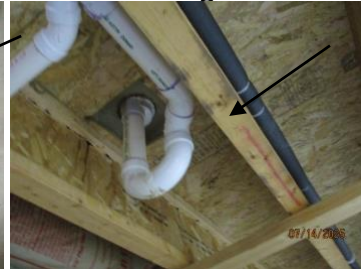
The 4x12 inch engineered joist 5x8 inch steel beam with four-inch supporting post were found to be in sound condition with no concerns noted. The OSB plywood decking has been glued and nailed and found also to be in good condition with no structural concerns noted. Fire-flashing has not been installed at the at the plumbing runs and we recommend it be installed. The poured concrete walls were found to be in sound condition with a minimal of shrinkage cracks which are common with poured concrete. No indication of settlement or active water leakage was noted. It had rained the previous day. A professionally sump pump with an exterior drain has been installed at the north the west floor area. Two pumps are installed one in use with the circuits of the home and one for use with a generator. You will note the outlet for the system is a GFCI protected outlet and if tripped during a storm the pump will not operate. The pump using the home's circuit was test and found to be in working order.

Missing Fire-Flashing(s)

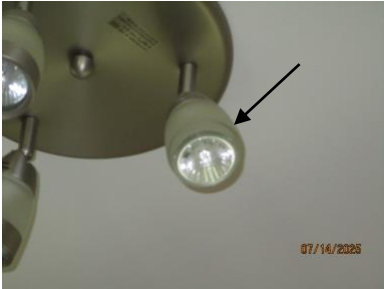
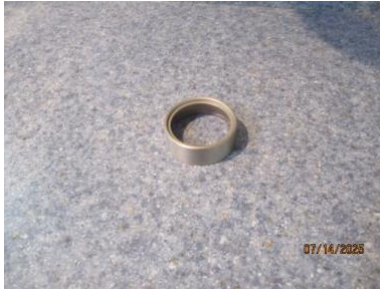
The kitchen contains custom wood cabinetry and laminate counter tops. We did note the laminate to the right of the sink was raised due to water infiltration. This is cosmetic and can be dealt with in a timely manner. We did test appliances which included the electric range, micro-wave oven with recirculating fan, dishwasher and disposal and found all to be in working order. Grounded three-pronged outlets, as well as GFCI outlets, were tested and found to be in working order. We tested all plumbing fixtures and also found them to be in good working order, water pressure was acceptable. The ring for the light fixture was on the floor and can be reinstalled when time allows.

Missing Ring

Ring

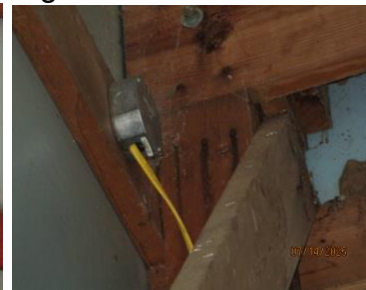
The first metal constructed building is supplied by a 200-ampere main circuit breaker style located on the east wall. A main disconnect was installed in panel. The main over-head service and meter are also located at the north elevation was found to have been professionally installed with no concerns noted. We removed the cover of the panel and noted all circuits were throng pronged grounded copper with the main feed being aluminum which is a common practice. This Square D brand panel contained; 16 total circuits, 2-220 ampere circuits that were not in use 12 additional 110 ampere circuits. Expansion is available. We tested the majority of light fixtures and outlets and noted all to be in working order and GFCI protected. We did note a circuit on the front wall that was serviced by and extension cord, missing and a Romex connector at the metal junction box and the use of extension cords at the light fixtures.

Supplied By An
Extension Cord
Missing Connector

Replace extension cords with permanent wiring in both buildings.
Install a Romex connector at the metal junction box. Pg.14

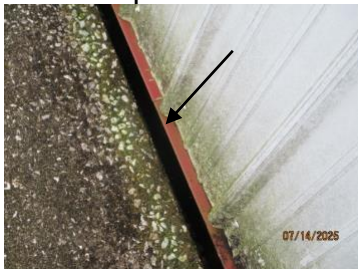
All structural components were found to have been professionally installed with no indication of settlement or structural concerns. All concrete showed no evidence of movement and minimal shrinkage. Water stains were noted on the supporting post which is common when the posts are not situated on piers elevating the post from ground water. These were probed and found to be in sound condition. You will note especially at the second building on the west side, it appears the framing is in contact with the soils and sanding water is present. The framing that is present at ground level is part of the wood "forms" that were used for the concrete floors during construction and is not part of the framing of the building. Wood trim at the service doors is water damaged needing repair and or replacement.

Standing Water
Wood "Forms"

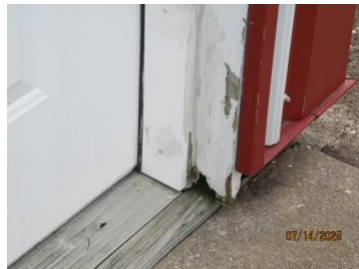
Water Damaged Door Framing
