Home Inspection Report

2187 Quaethem Drive
Wildwood, MO 63005

Date of Inspection: 07/27/2021

Inspection No. 551034-5952

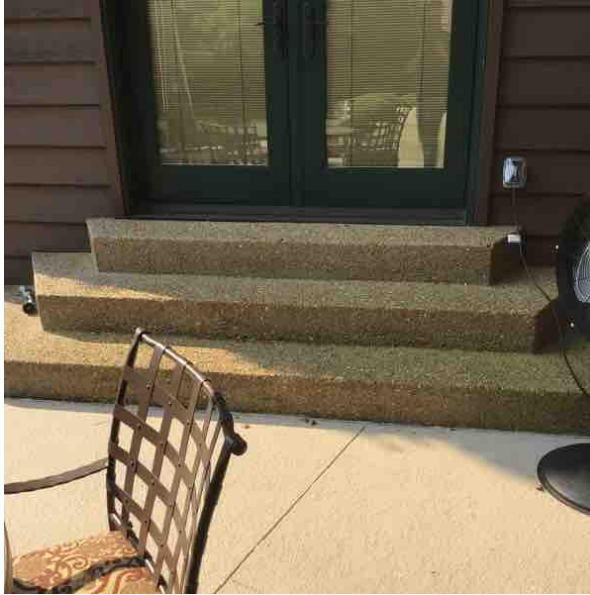
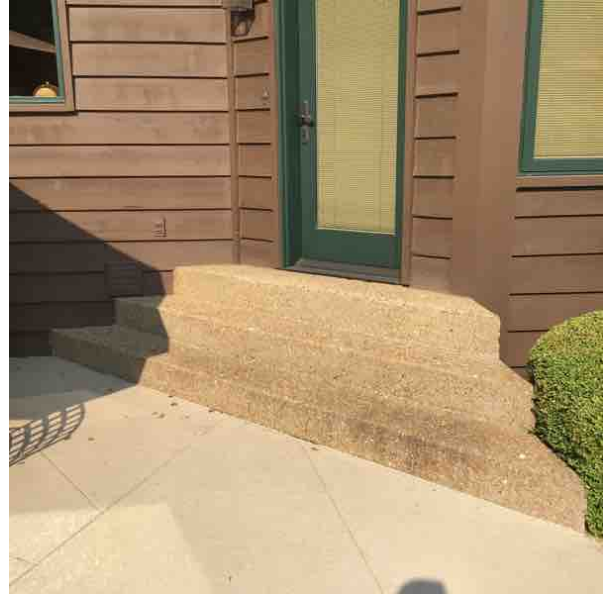
2.6.2 Install continuous railing to promote safety, 3 steps or 30" in height requires a railing. (Exterior Back)

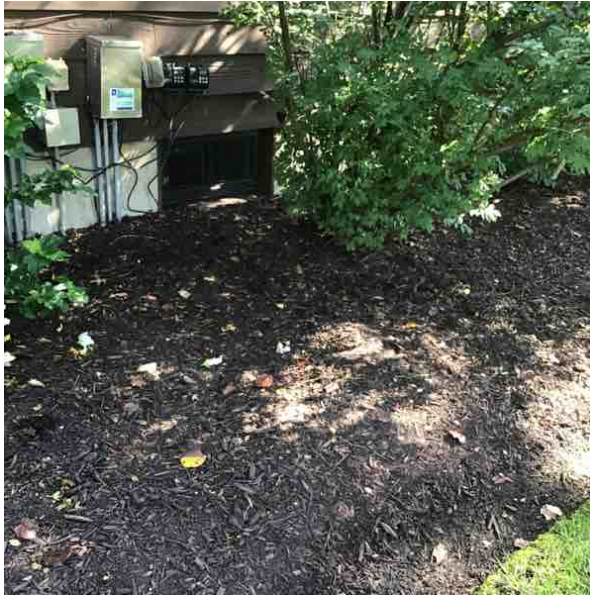
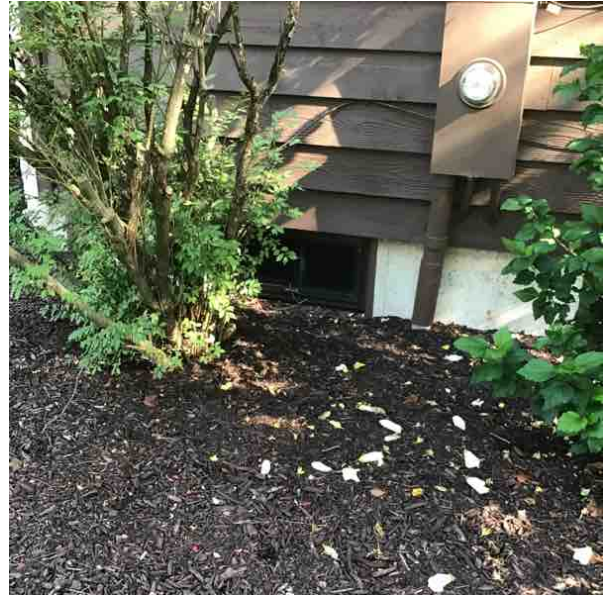
3.6.2 The grade is approaching the base of the basement window. Recommend lowering the grade or installing a window well limiting water entry and related damage. **(Exterior Right)**

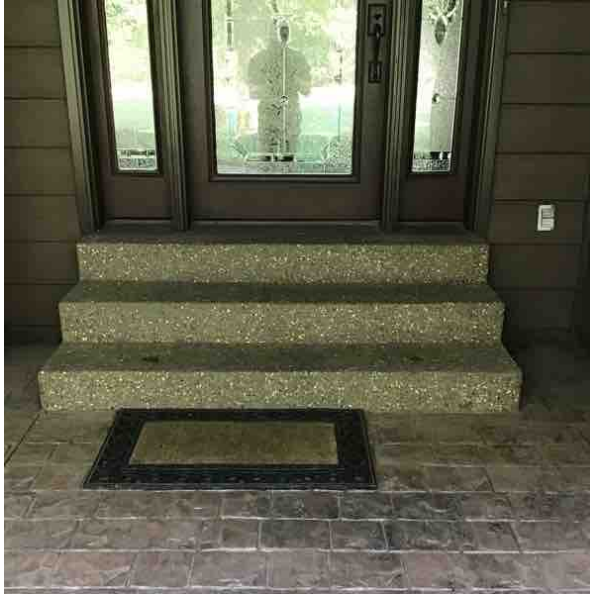
3.8.2 Install continuous railing to promote safety, 3 steps or 30" in height requires a railing. (Exterior Front)

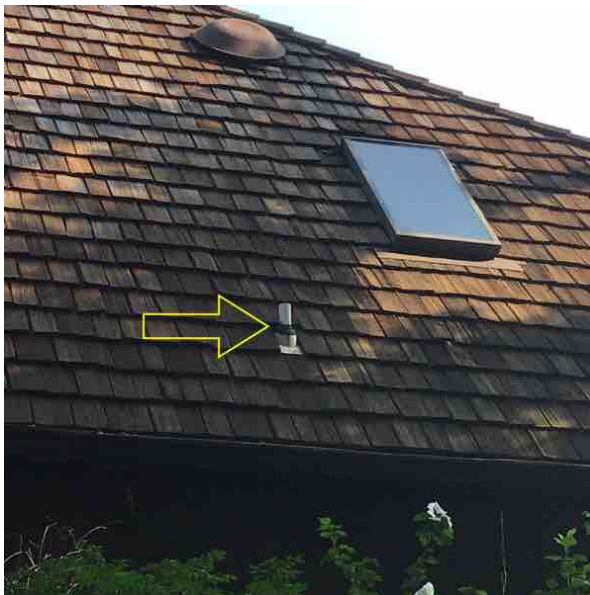
4.8.3 The short plumbing vent stack is susceptible to blockage and potential venting issues, however, this is a common condition in older homes. Consider properly extending vent pipe to ensure intended function.

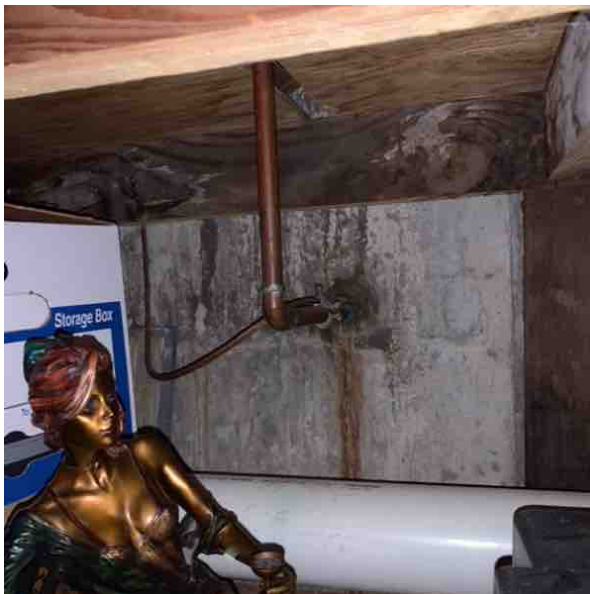
7.3.2 Evidence of previous water seepage around water main. Monitor for future leakage and repair (i.e. properly seal) as needed. (Basement)

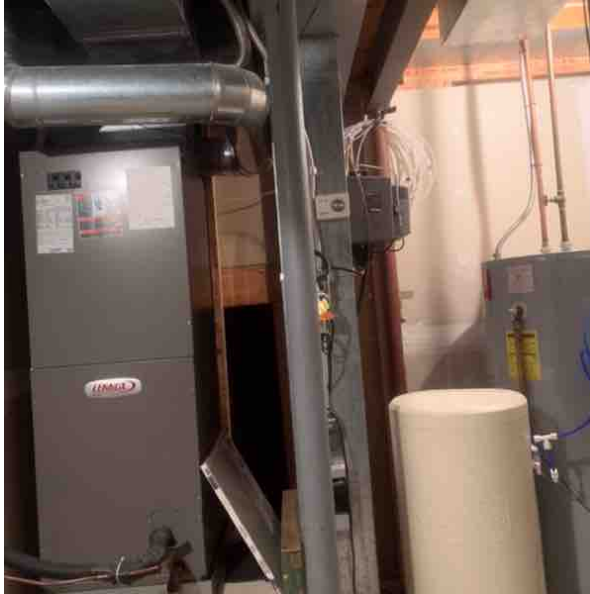
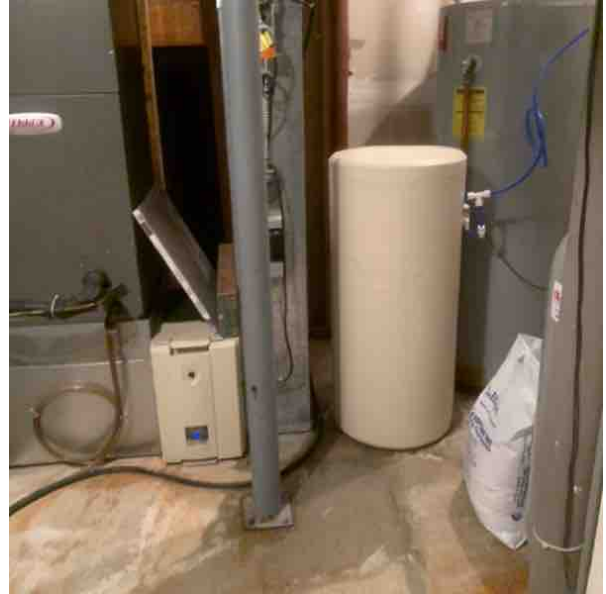
7.4.2 Additional support posts have been added and appear to be performing as intended. Inquire with the seller regarding scope of repairs and permits, if applicable.

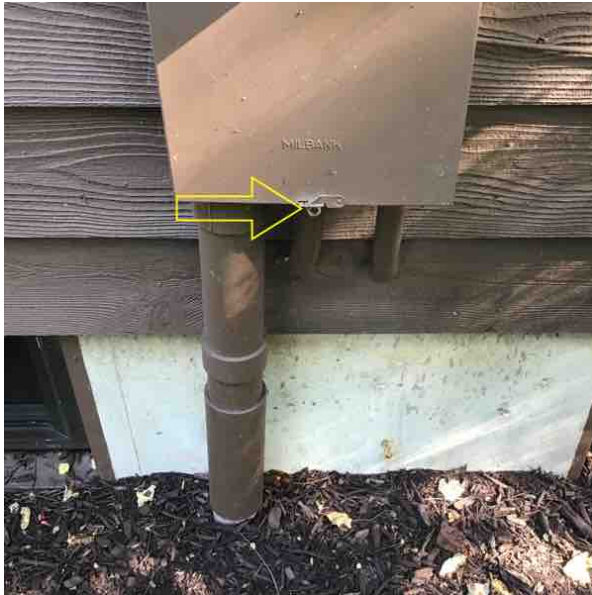
8.3.3 The security seal is missing on the exterior electrical meter base. Recommend contacting the Utility company for evaluation and to properly seal the meter base for safety. (Exterior Right)

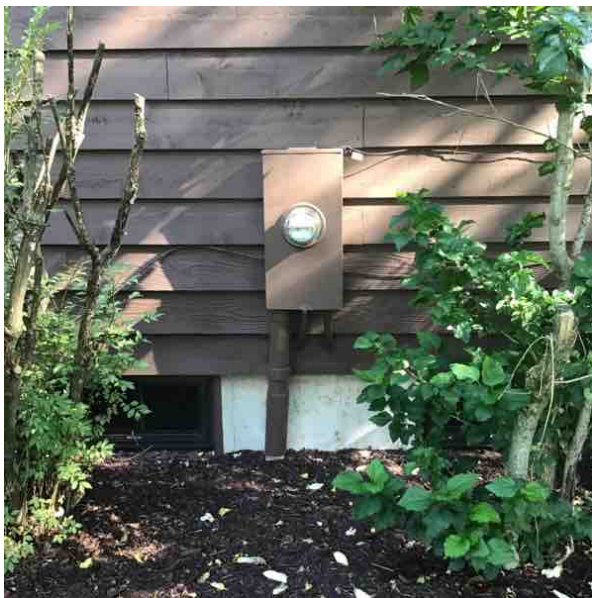
8.3.4 Loose exterior meter base. Meter base must be tight to the structure with no movement. Recommend repairs by a licensed electrician. (Exterior Right)

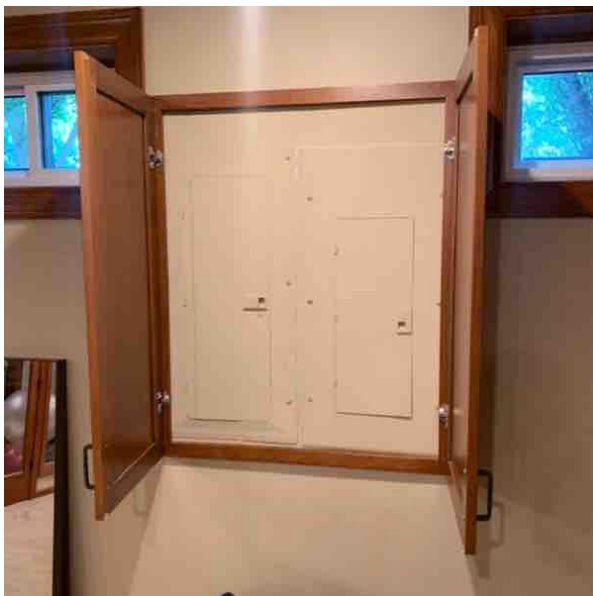
8.6.3 Improper clearance around the electrical panel. 36" clearance is required in front of the panel along with 30" in width. Recommend repairs by a qualified contractor for proper access to the electrical panel. (Basement)

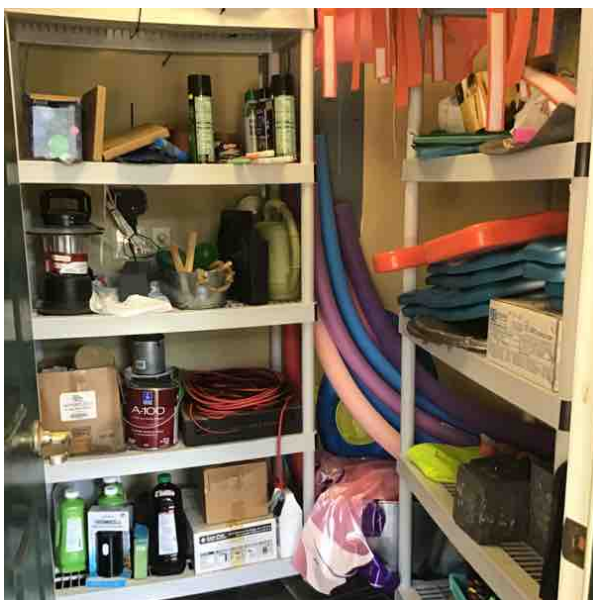
8.6.4 Improper clearance around the electrical panel. 36" clearance is required in front of the panel along with 30" in width. Recommend removal of the storage items for proper access to the electrical panel. (Pool House)

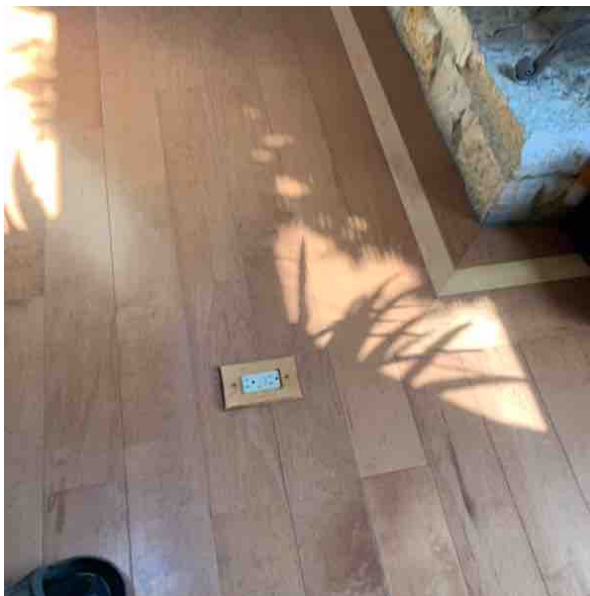
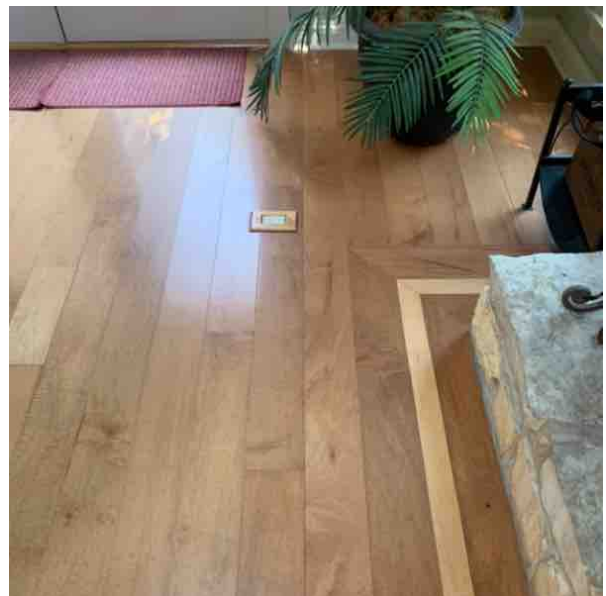
8.10.2 Floor receptacles must have secure covers. Recommend correction to limit safety hazard.
(Living Room)

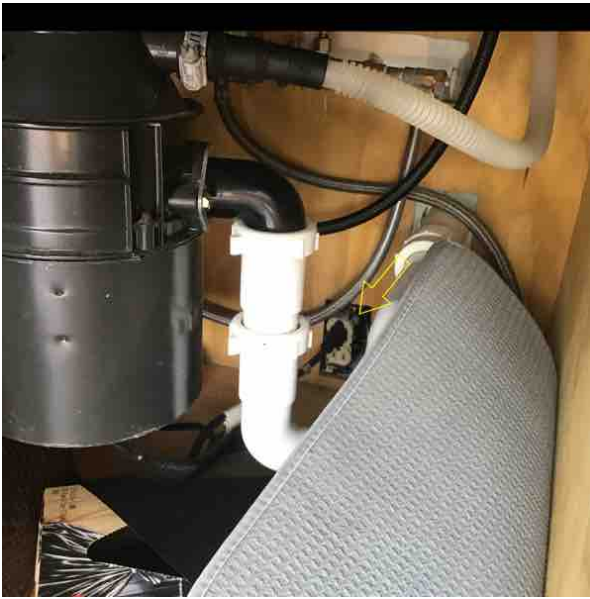
8.10.3 Receptacle covers are missing. Provide these to prevent electric shock injuries. **(Pool House)**

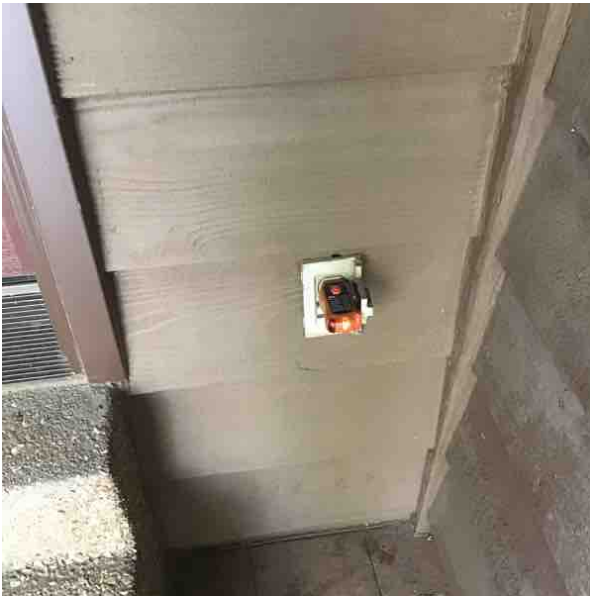
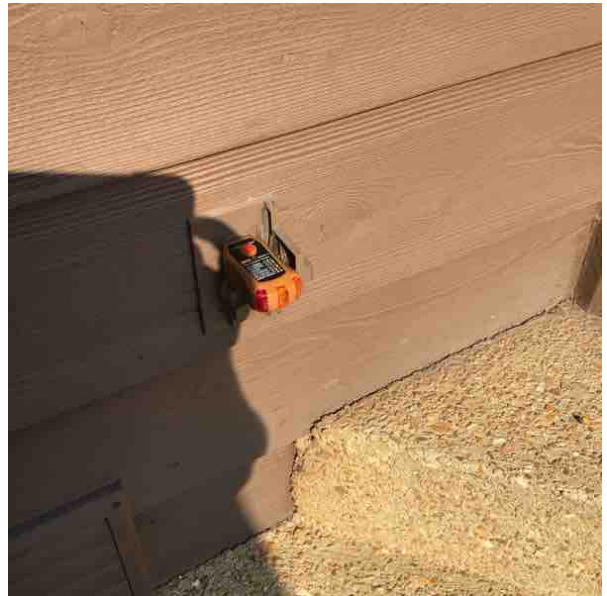
- Exterior Back
- Exterior Front

8.10.4 Have a qualified electrician install/ensure GFCI protection on all exterior receptacles for safety.

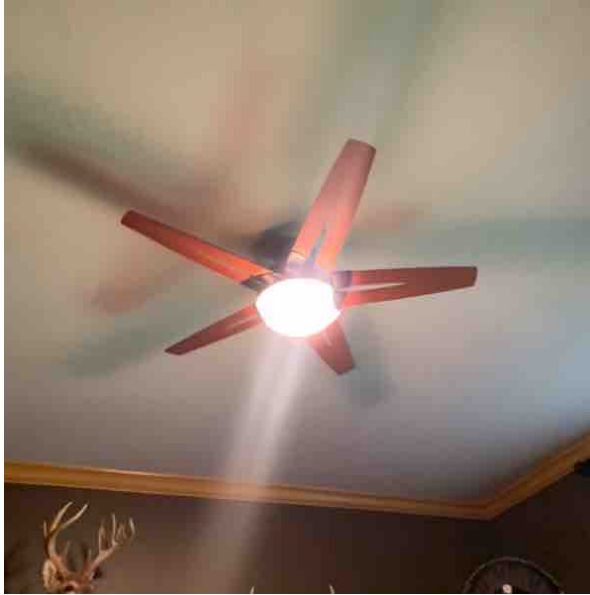
8.11.2 Ceiling fan is noisy which is an indication of nearing the end of its life or in need of repairs. Recommend repairs or replacement by a qualified contractor as needed. **(Study)**

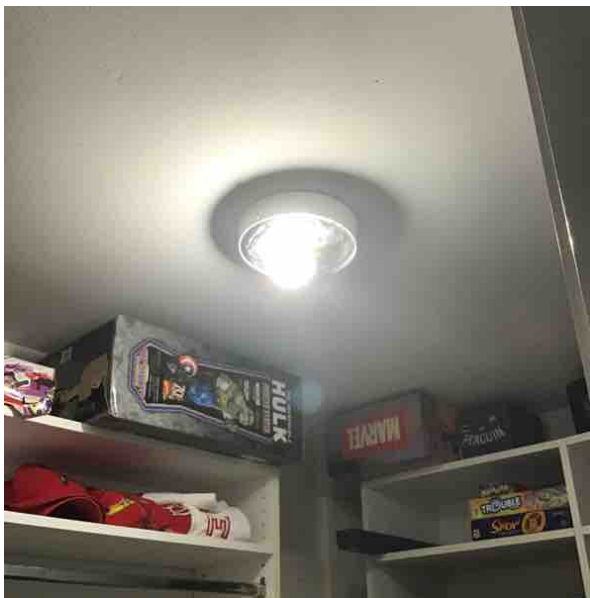
8.11.3 Install light fixture enclosure(s) on closet light(s) to limit potential damage to exposed bulbs. **(Rear Left Bedroom)**

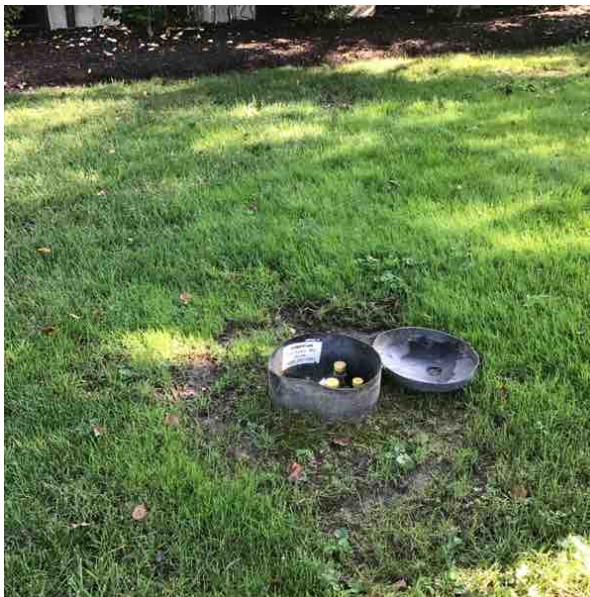
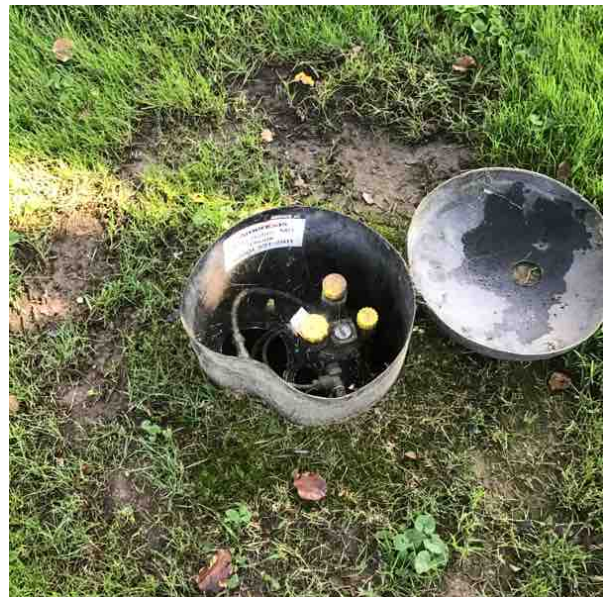
9.4.1 **CSST gas line identified. All CSST gas lines must be bonded for safety. Recommend bonding by a licensed electrician or HVAC contractor for safety.**

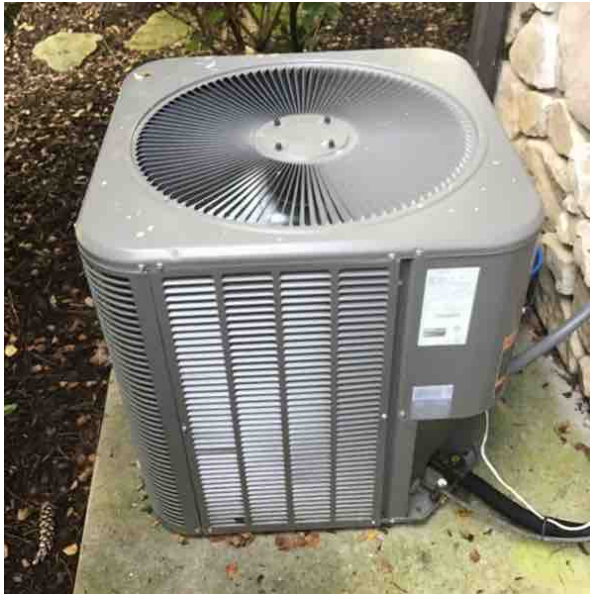
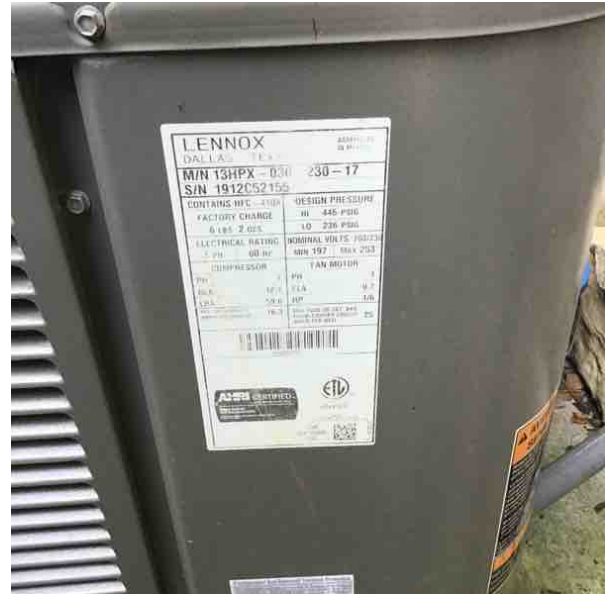
9.5.4 The 2006 air conditioner(s) has exceeded it's typical life expectancy. You may want to consider getting a home protection plan and/ or budget for the eventual replacement.

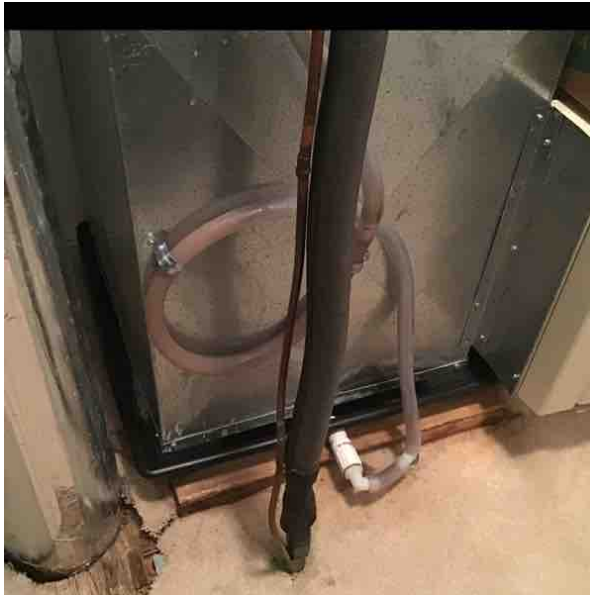
9.6.4 Have a qualified HVAC contractor install a float disconnect for the furnace drain pan. This will shut down the A/C condenser in the event of a drain line clog limiting flooding. (2nd Floor Closet)

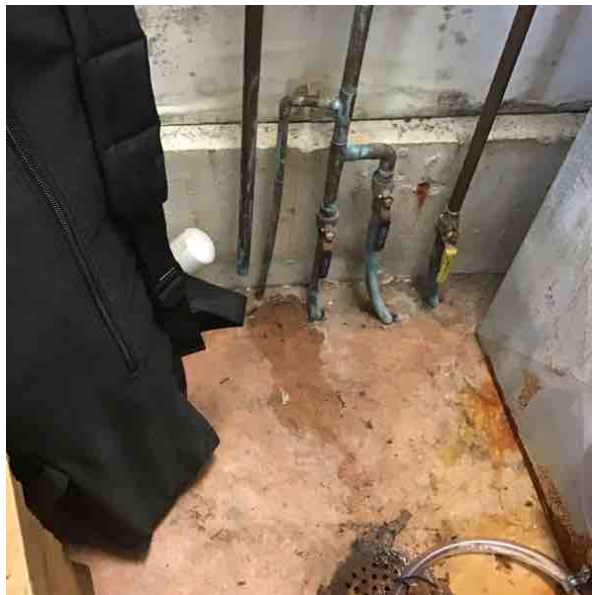
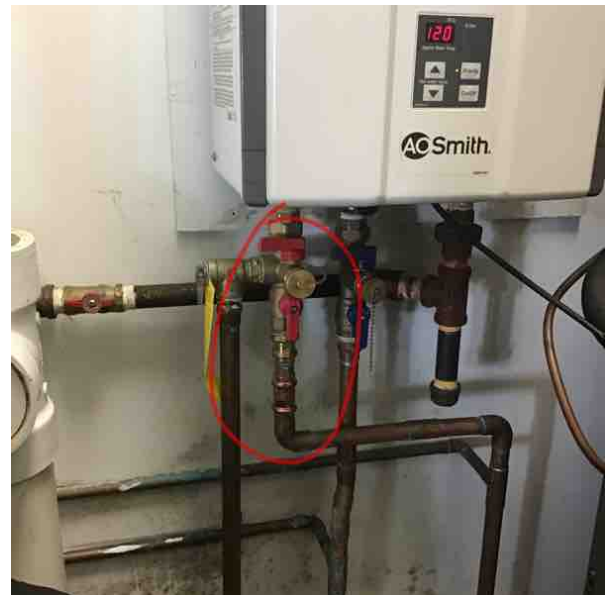
10.6.4 The tankless water heater is leaking. Have this repaired to prevent water damage. (Garage)

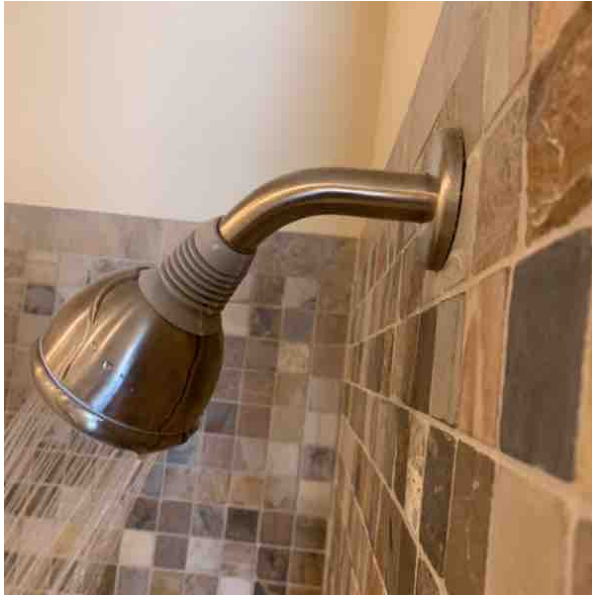
10.10.3 **Shower head is leaking at the stem connection. Recommend repairs for proper operation.
(Primary Bathroom)**
