MY HOME INSPECTOR PRO

MHIP DEFAULT RESIDENTIAL REPORT

67 N Dade 237
Walnut Grove, MO 65770

Waylon Martin
09/27/2024

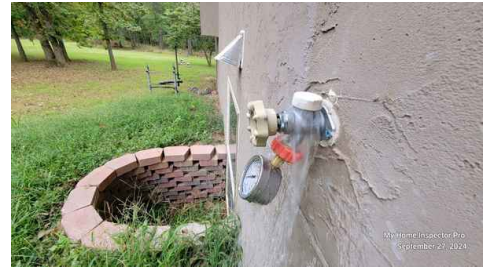
LEAK

The referenced spigot was leaking while under pressure. Repairs are recommended to be conducted as needed by a licensed plumber or other qualified person for proper operation.

Contact a qualified plumbing contractor.

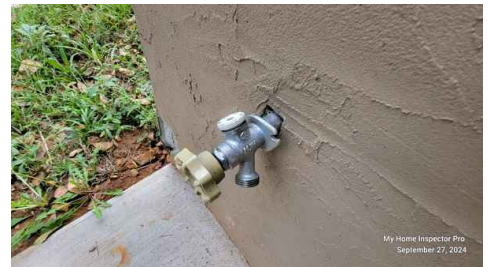
2.6.2 Exterior Spigots

The spigot was not secured to the wall. Properly securing the spigot to prevent damage to the water distribution pipe is recommended to be conducted by a qualified person.

Contact a qualified professional.

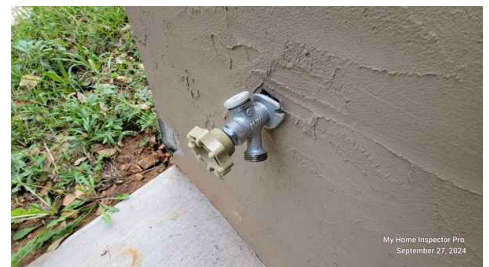
2.6.3 Exterior Spigots

FYI - The spigot was not functional at the time of inspection. I recommend consulting with the sellers as to its operation (as it could be as simple as a shut off valve being off), and/or evaluation by a licensed plumber if they have no information.

Contact a qualified plumbing contractor.

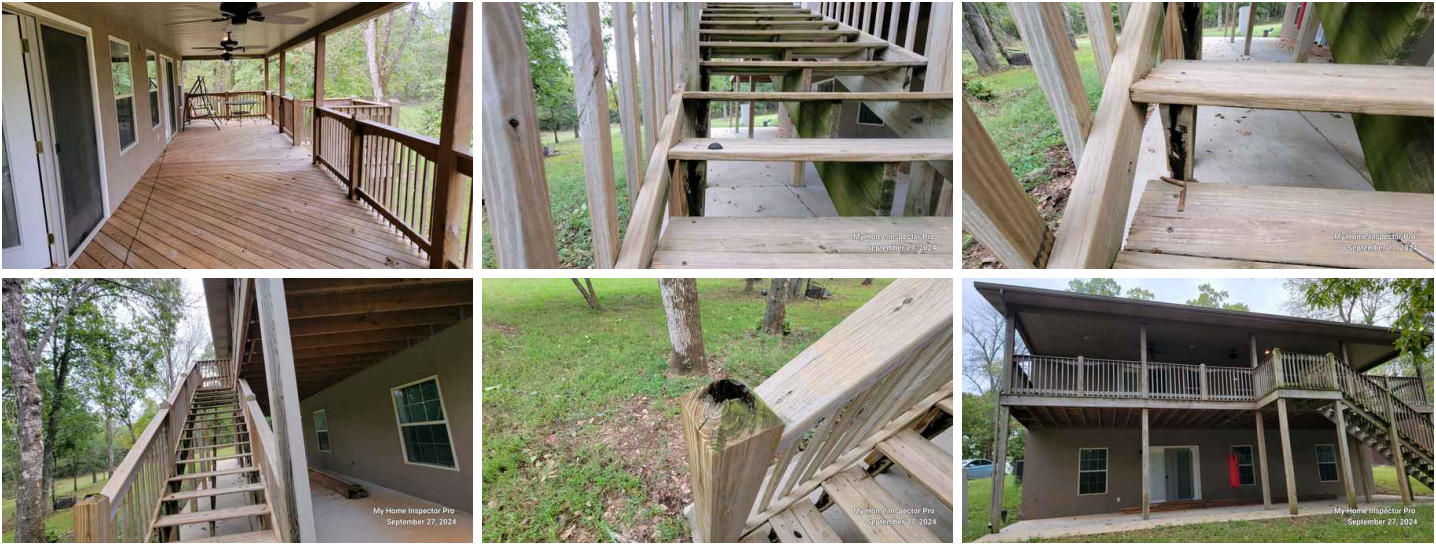
2.9.1 Decks

MULTIPLE DECK DEFICIENCIES

Due to multiple deck deficiencies being noted, a full evaluation of the deck(s) is recommended to be performed by a contractor specializing in decks. The listing of deficiencies found in this report in regards to the deck should not be viewed as an all-inclusive listing of deficiencies.

i.e. - wood rot on stairs, weathered wood, no graspable handrail, . Deck construction practices present that did not follow the standards of the DCA-6.

Contact a qualified deck contractor.

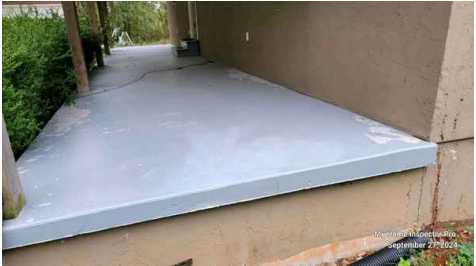
2.10.1 Porch(es)

MISSING RAILING

There is no handrail on the noted porch, recommend installing handrail by qualified professional.

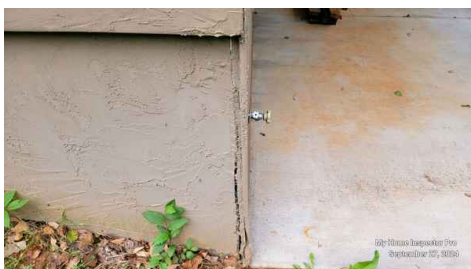
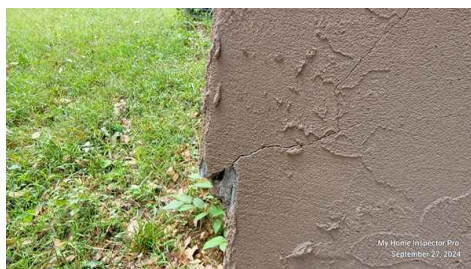
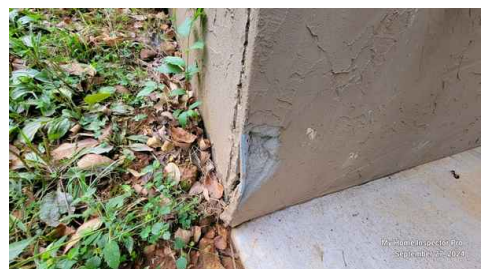
3.1.2 Wall-Covering, Flashing & Trim

CRACKS - MASONRY

Cracks and minor damage observed at stucco exterior wall, hidden damage may exist. Recommend sealing or tuck pointing cracks to prevent moisture intrusion and ice damage by a qualified mason or other contractor.

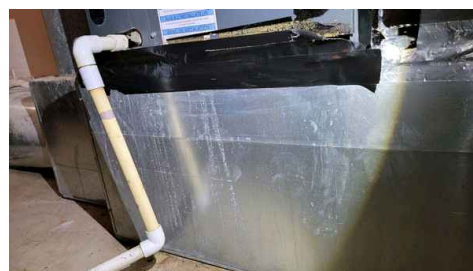
4.3.2 Interior Unit(s) - Split System 1

WATER STAINING AT BASE OF UNIT

There is Water staining present in the area of the interior HVAC unit. This is typically associated with a deficiency with the internal drip pan, allowing water to overflow this pan. Further evaluation with repairs to the unit as needed to prevent the spillage of condensate is recommended to be performed by an HVAC contractor.

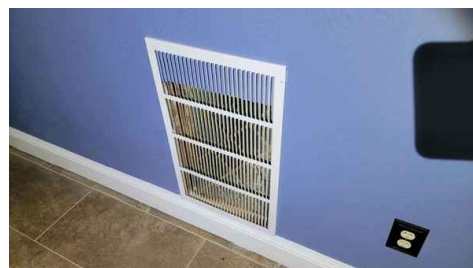
4.6.2 Air Filter / Return Plenum

BASEMENT, MASTER BEDROOM

A true air filter return was not present. Evaluation and the installation of a proper return air filter location is recommended by an HVAC contractor.

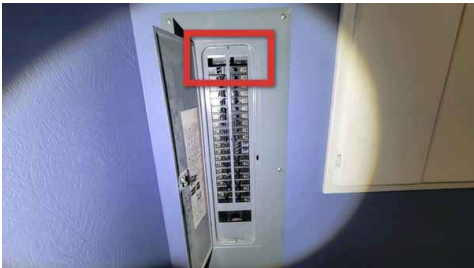
Open breaker slots (missing twist-outs) were present in the electrical panel. This is a safety hazard as this exposes the ungrounded bus and wiring connections. The installation of "blanks" are recommended to be conducted by a licensed electrician for safety.

Contact a qualified electrical contractor.

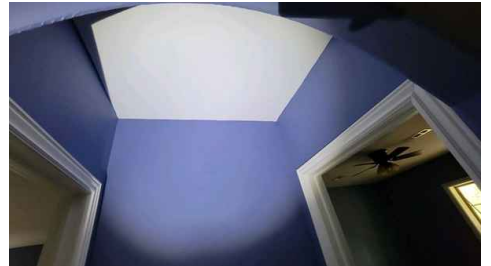
Smoke alarms were not present at locations required by today's standards, and those that were installed were aged or yellowing. Smoke alarms are recommended to be installed in each sleeping room, (1) outside of each sleeping room(s), and one per level including habitable attics and basements. The installation of smoke detectors is recommended to be installed at all recommended locations for fire safety by a licensed electrician. I recommend inquiring with local fire departments as many have free smoke detectors and will install them.

Contact a qualified electrical contractor.

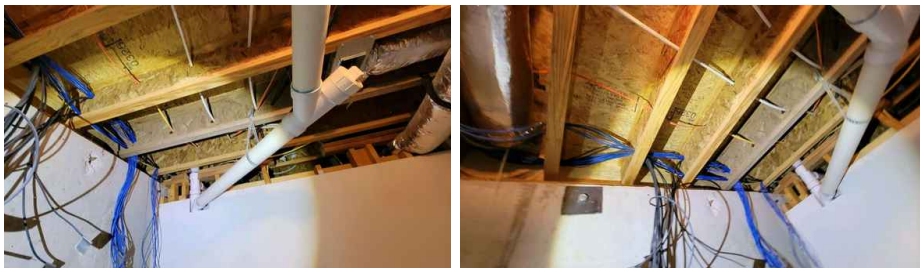
Wood I-Joists, Moisture Staining Under Bathrooms
