# Your Inspection Report

105 northview drive  
Rhineland, MO 65069

RE: Report No. 3588  
105 northview drive  
Rhineland, MO  
65069

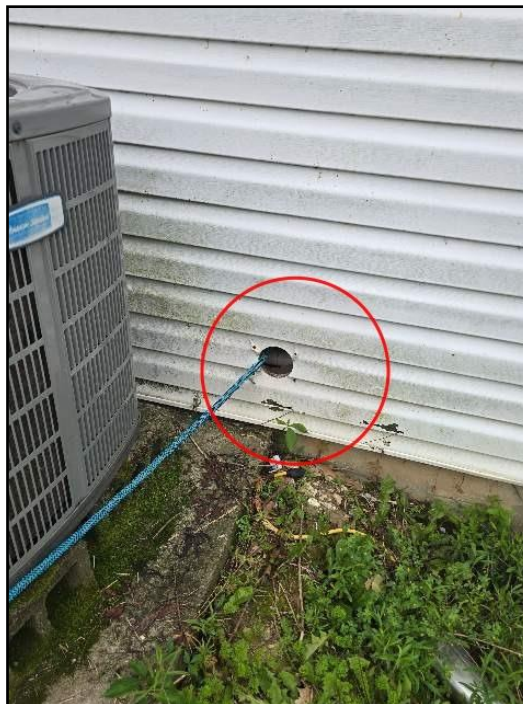
7. Other

1. Condition: • Other

Location: Right side near Ac unit

Task: Repair

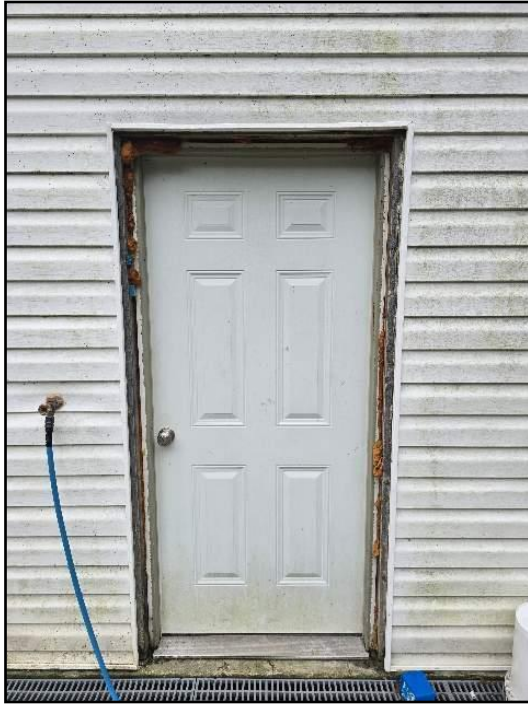
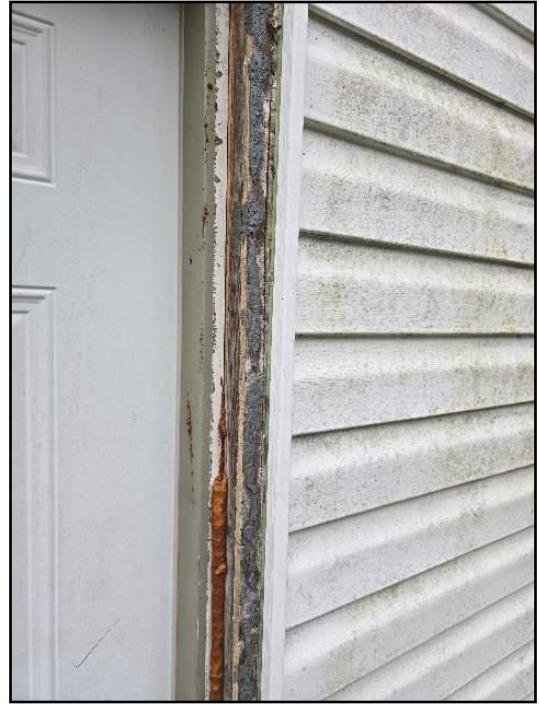
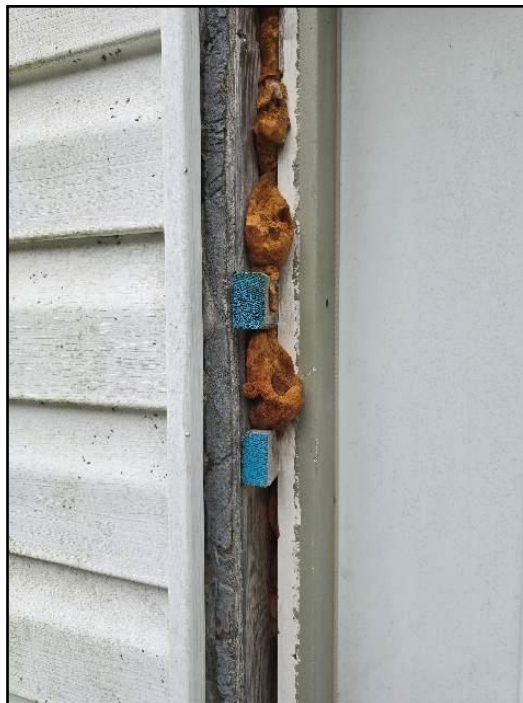
2. Condition: • The trim around the door is missing.

Task: Repair

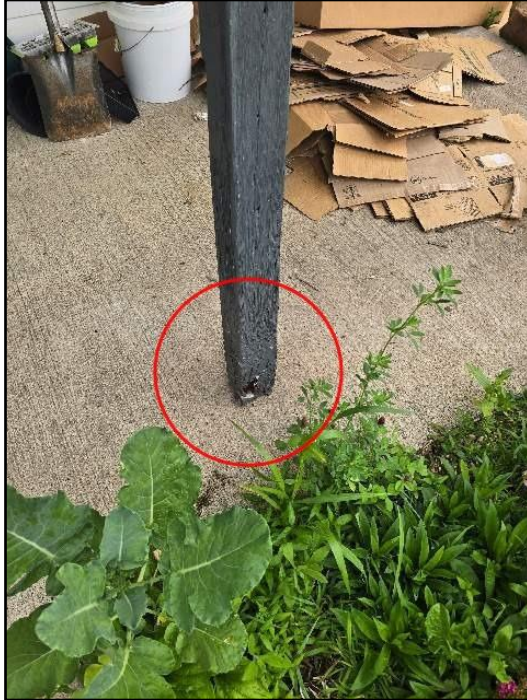
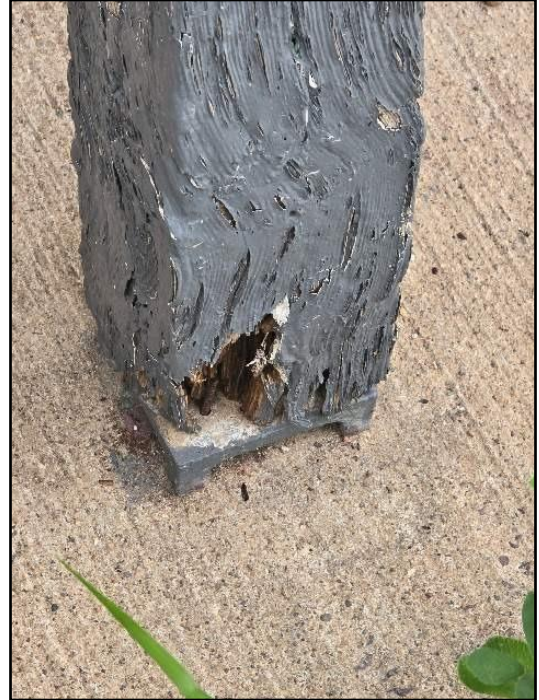
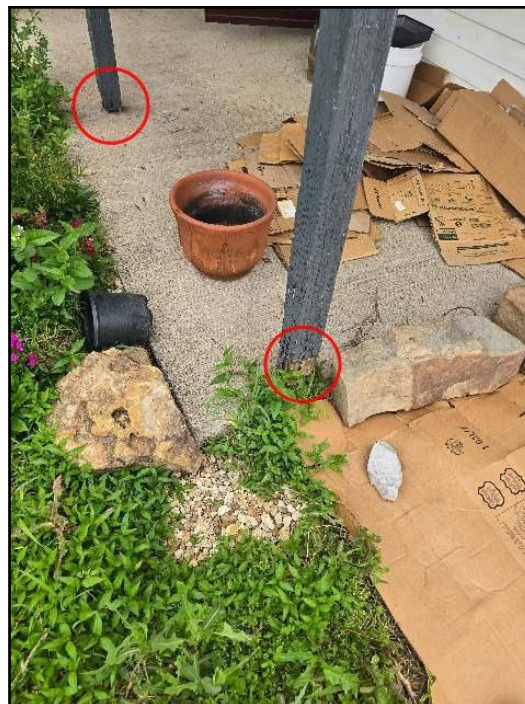
The posts are rotten at the bottom and will need to be replaced.

**Location:** Front porch

11. Rot

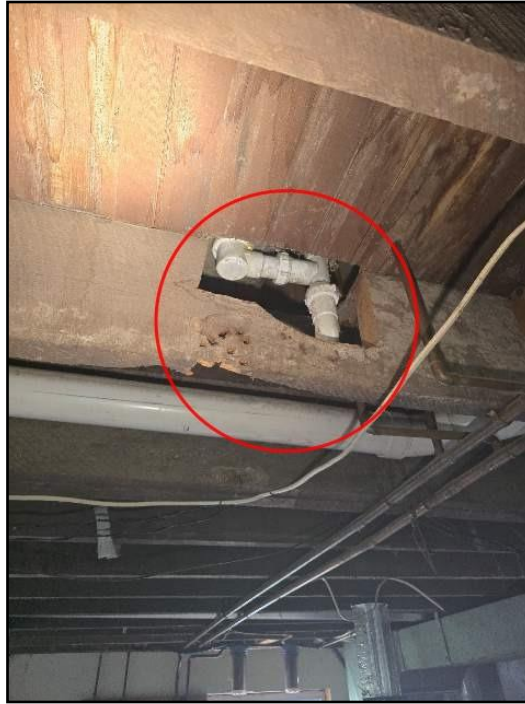
14. Notches or holes

Someone has notched out the floor joist too much and it will need to be properly repaired.

**Location:** Joists under tub

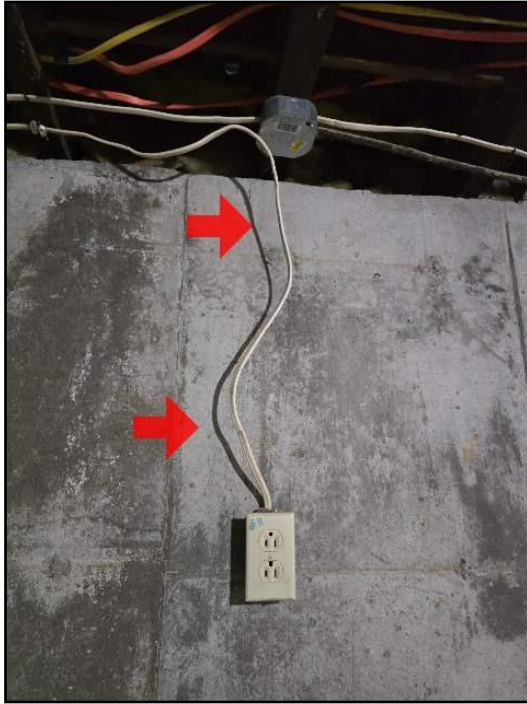
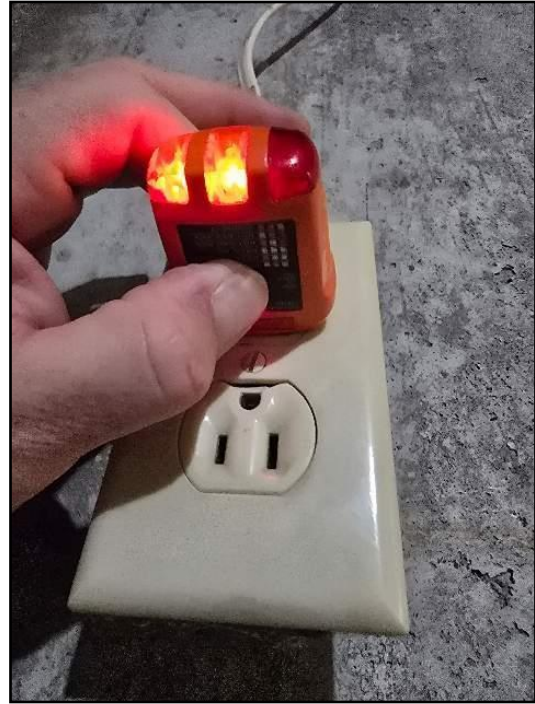
There are several receptacles where the romex wiring is running down the wall and should be in conduit.

**Location:** Basement

5. Condition: • Other

18. Other

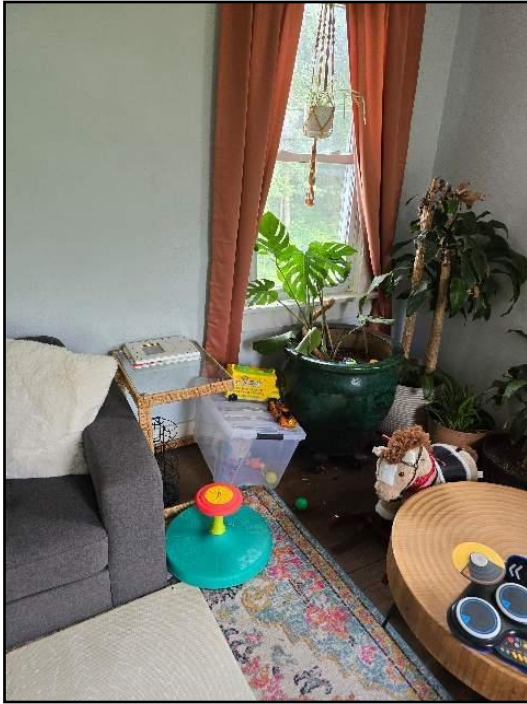
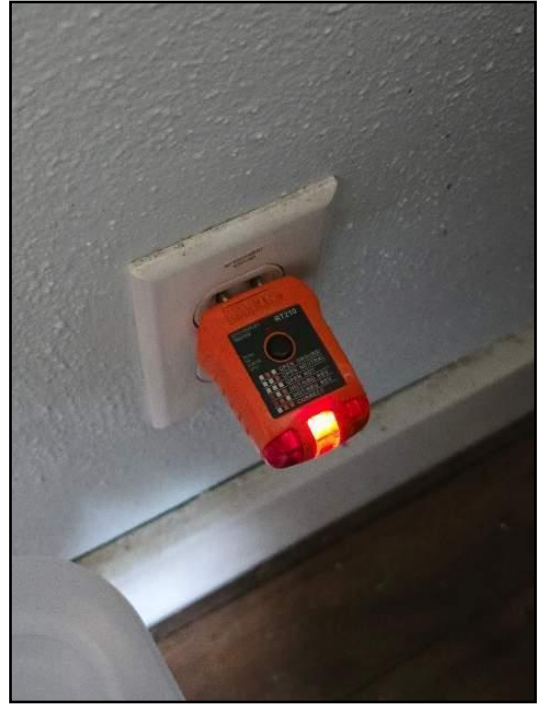
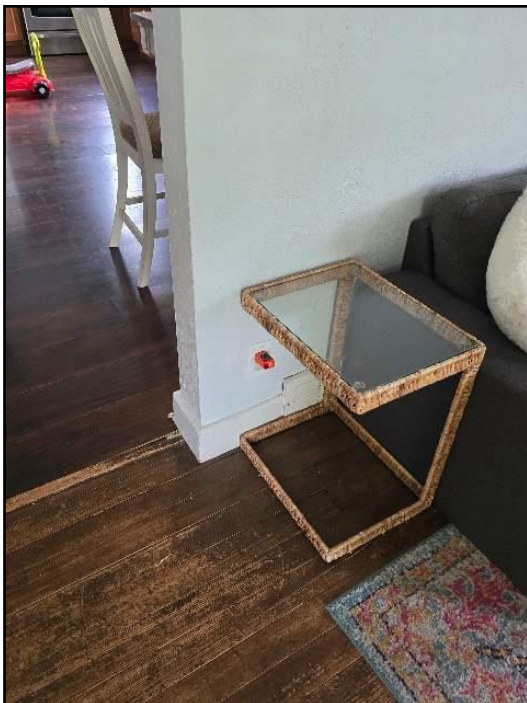
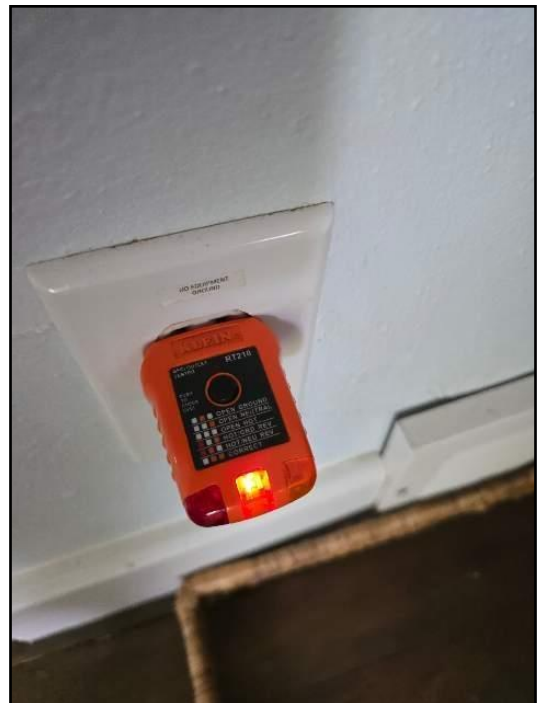
**Implication(s):** Electric shock

**Location:** Living room

6. Condition: • [Ungrounded](#)

20. Ungrounded

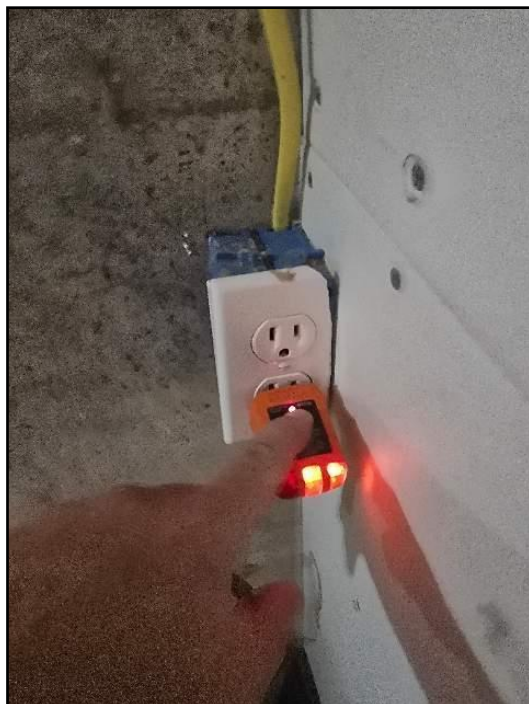
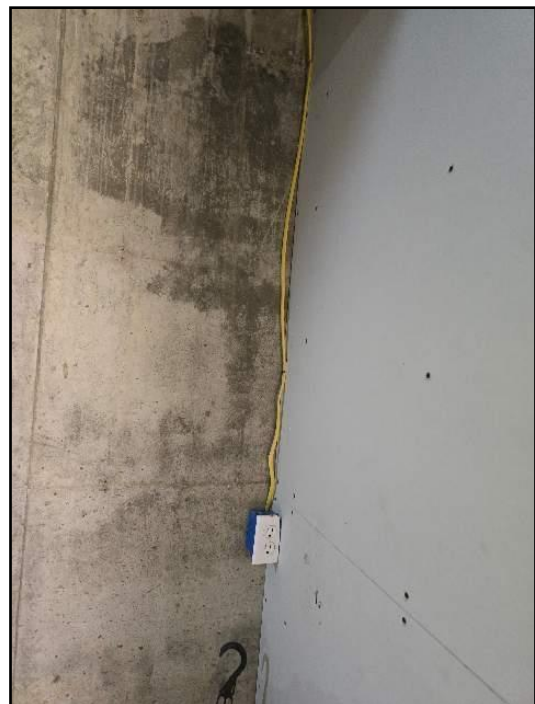
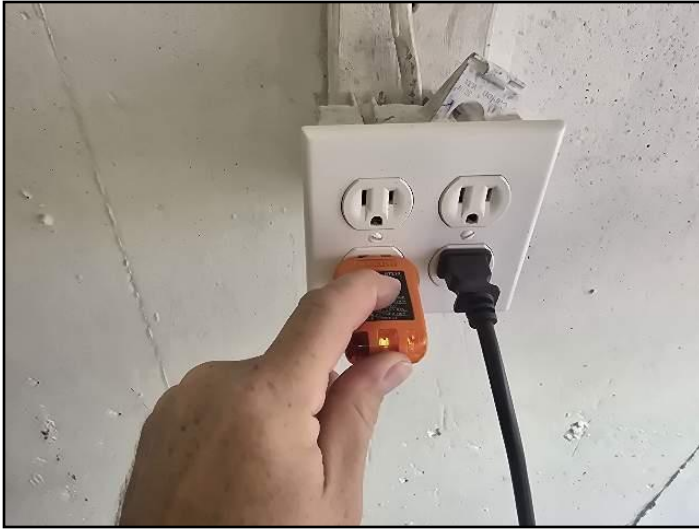
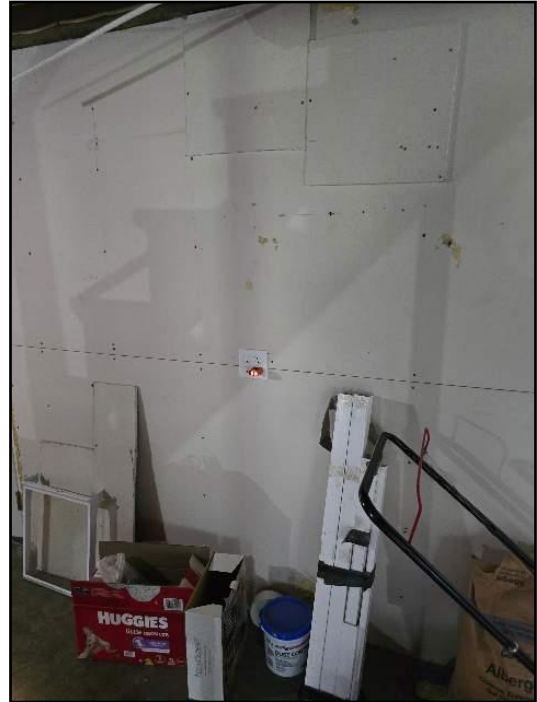
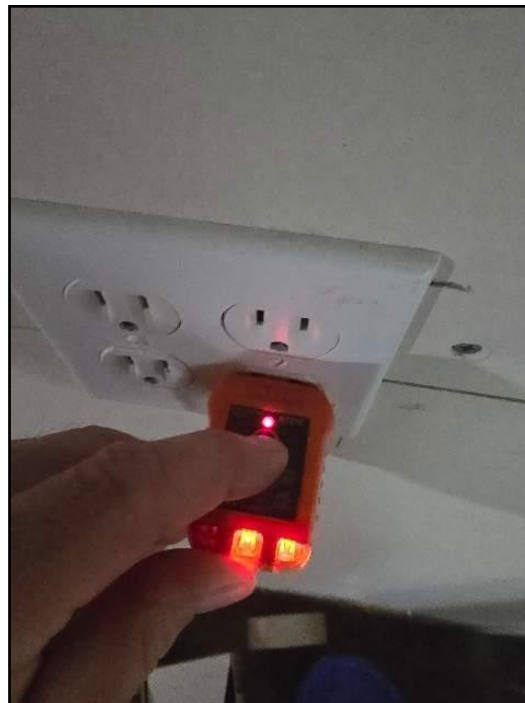
The receptacles aren't GFCI-protected. By code, any receptacle within 6' of a water source, garage, or unfinished basement area should be GFCI protected.

## 7. Condition: • [GFCI/GFI needed \(Ground Fault Circuit Interrupter\)](#)

**Location:** Basement

24. GFCI/GFI needed (Ground Fault Circuit In

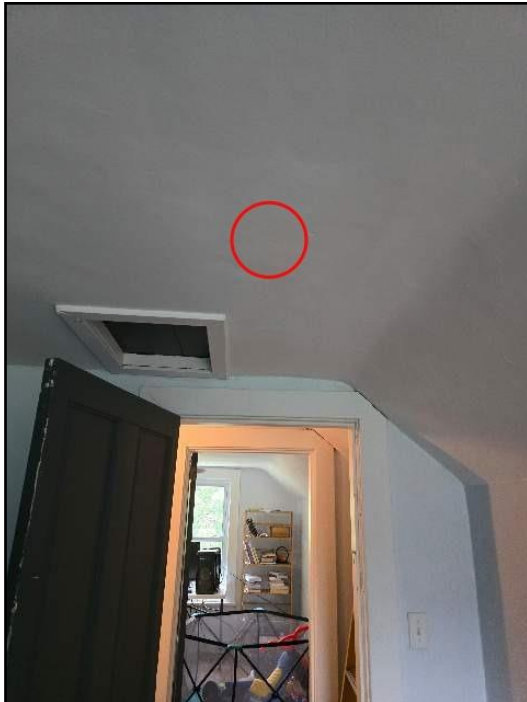
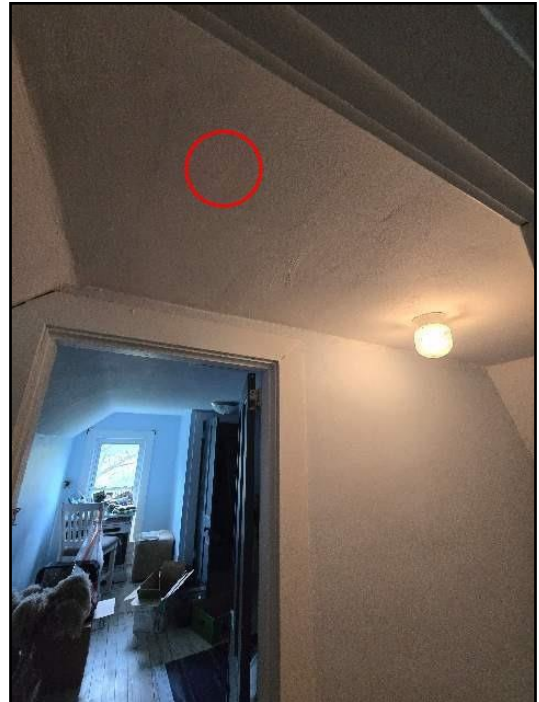
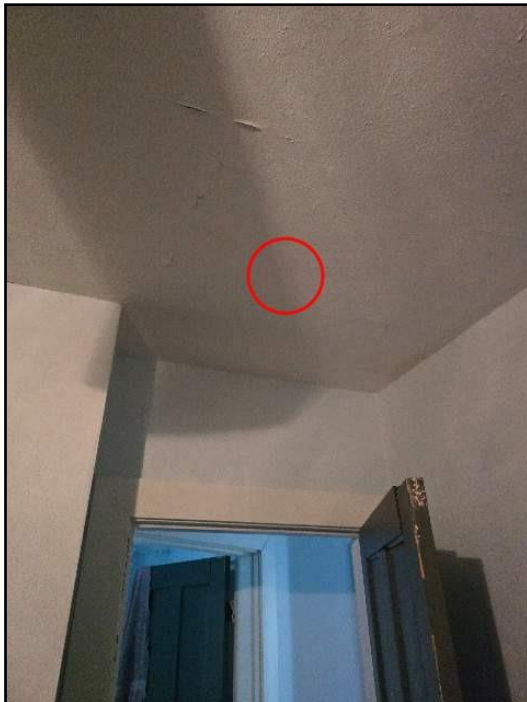
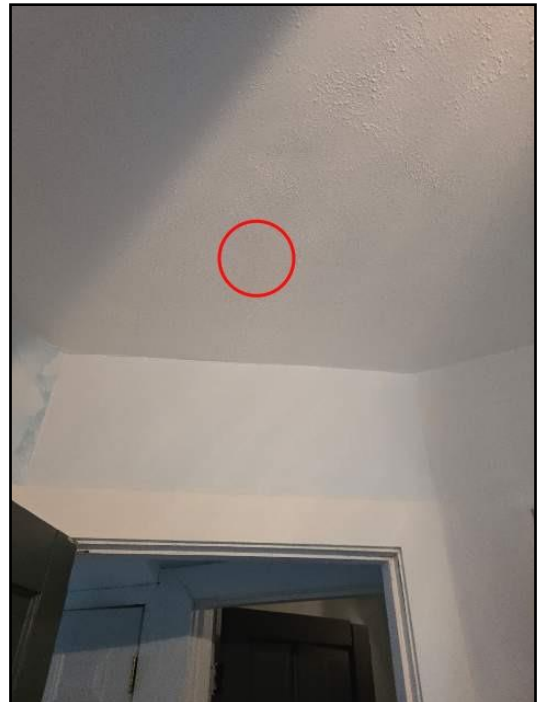
There are smoke detectors missing throughout the home. The smoke detectors should be installed with the NFPA

**Location:** Second floor bedroom and hallway

29. Missing

standards. I recommend installing smoke detectors equipped with 10-year batteries.

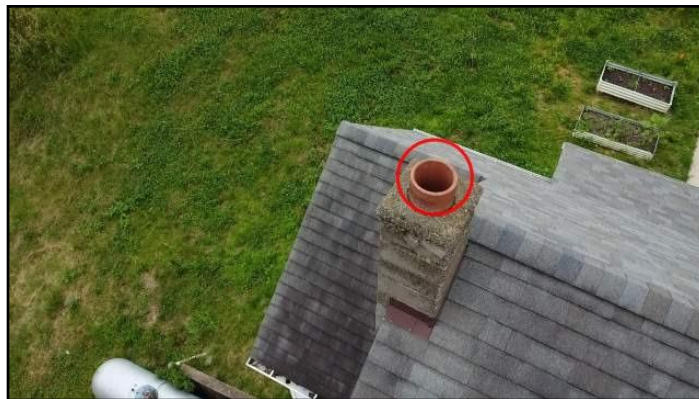
37.

**9. Condition:** • [Rain cap missing or damaged](#)

The chimney is missing its proper rain cap. This must be installed to prevent water damage to the chimney's internal structure.

**Location:** Chimney cap

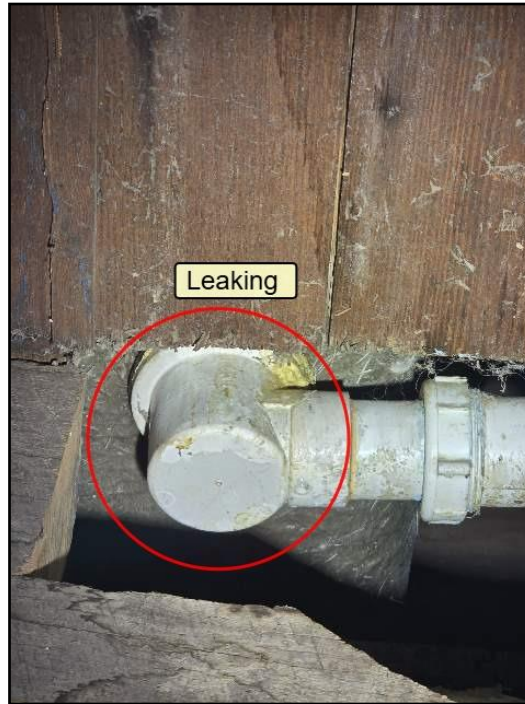
10. Condition: • [Leak](#)

The drain is currently leaking and must be repaired to prevent further damage.

51. Leak

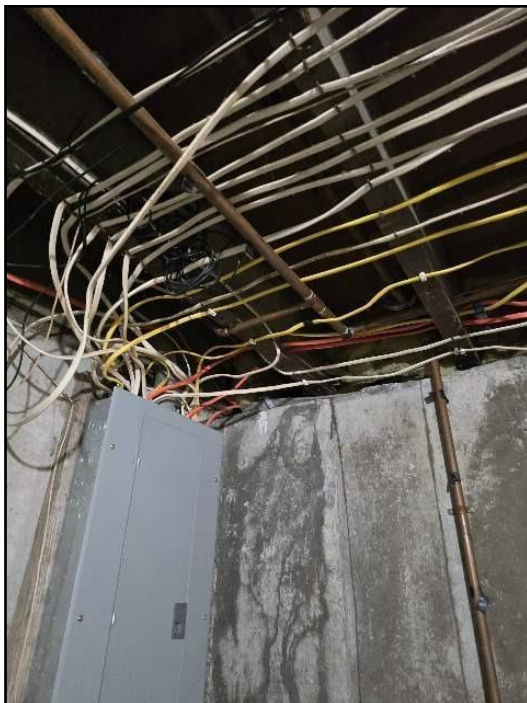
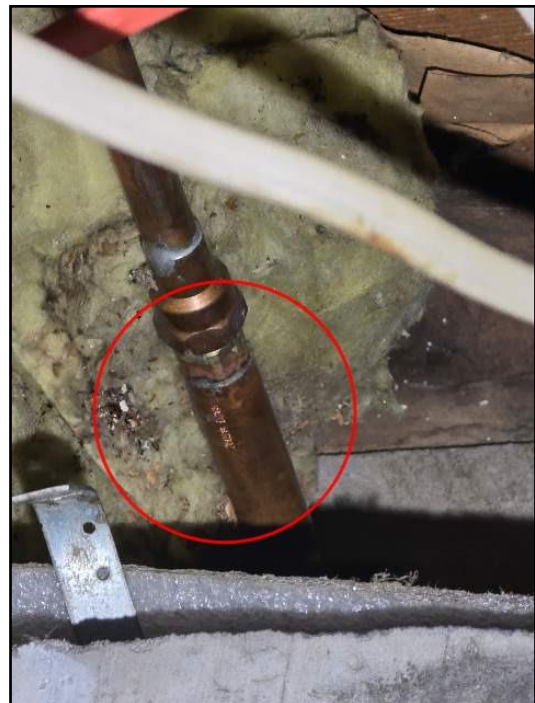
**11. Condition:** • [Pipe frozen or split](#)

The hose bibb is cracked and is currently leaking into the basement near this area.

53. Pipe frozen or split

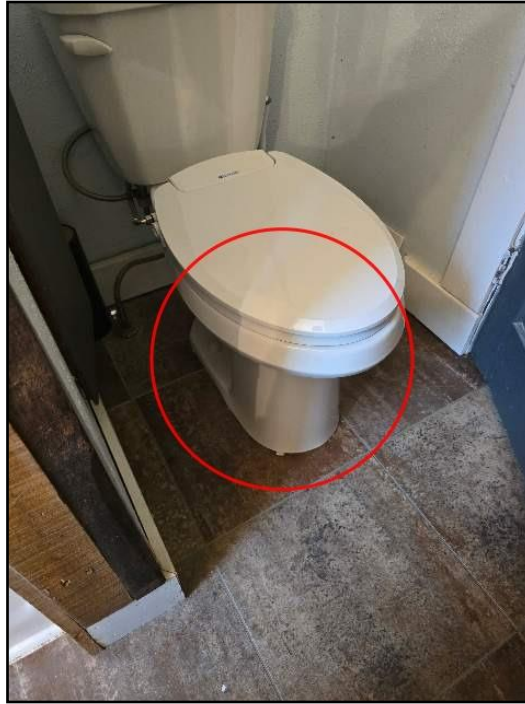
54.

### 12. Condition: • Loose

The toilet is not correctly secured, loose, and caulked around the bottom of the toilet where the flooring meets the

**Location:** Hallway bathroom

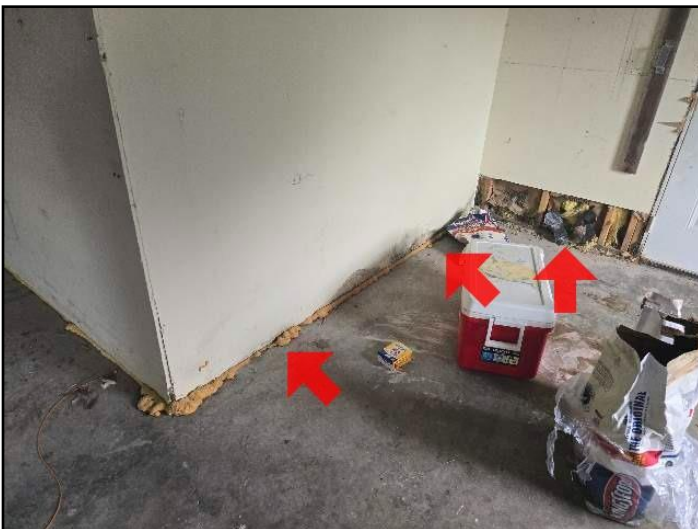
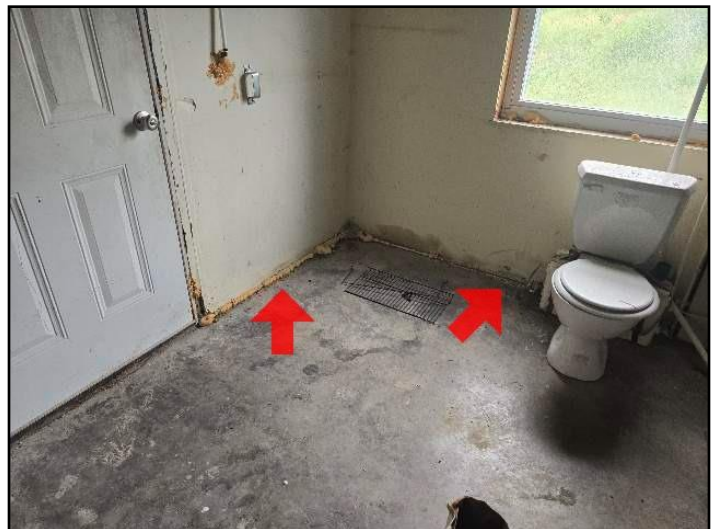
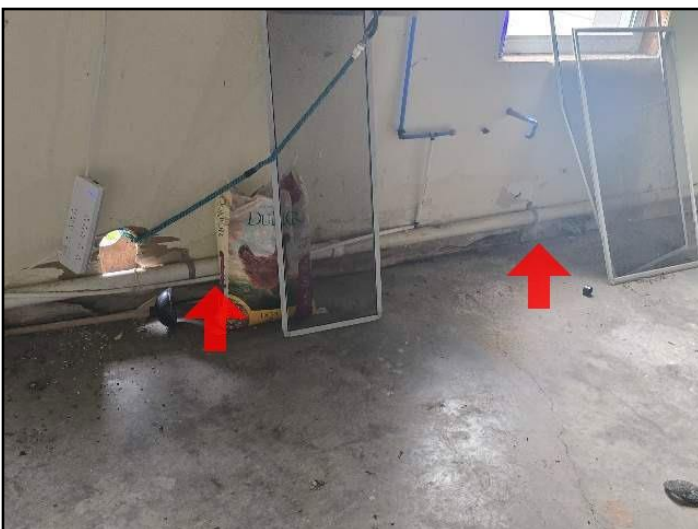
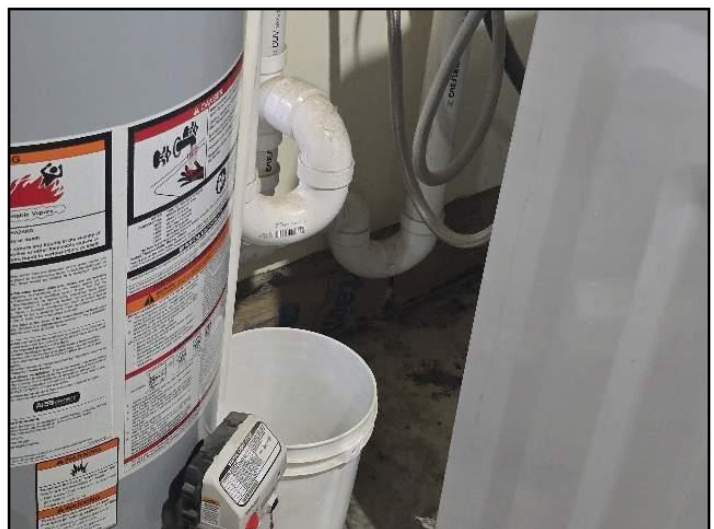
13. Condition: • Water damage

There is water damage to the surrounding area, and it will need to be repaired.

Location: Basement exterior walls

60. Water damage

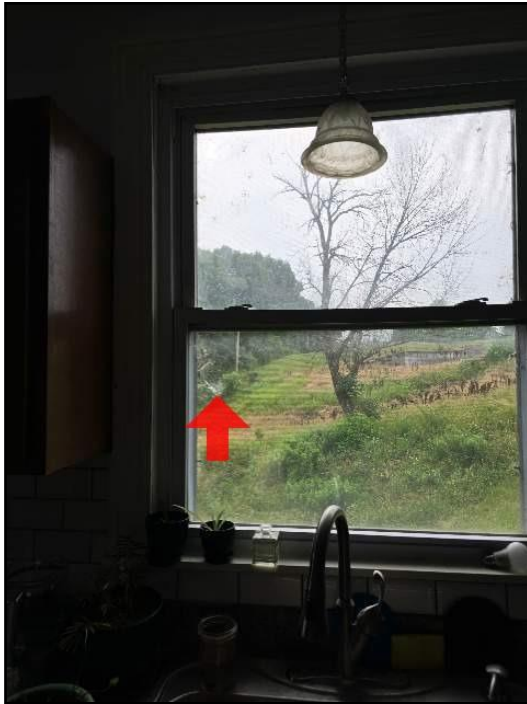
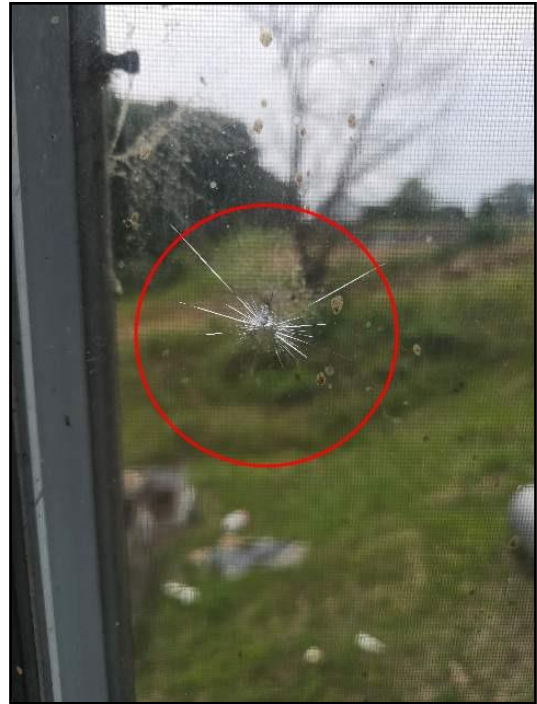
### 14. Condition: • [Broken](#)

The glass of the windows is broken and will need to be replaced.

**Location:** Kitchen

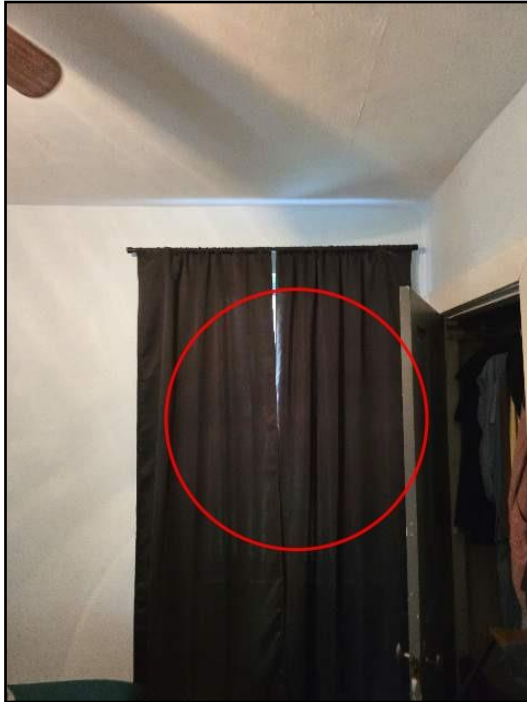
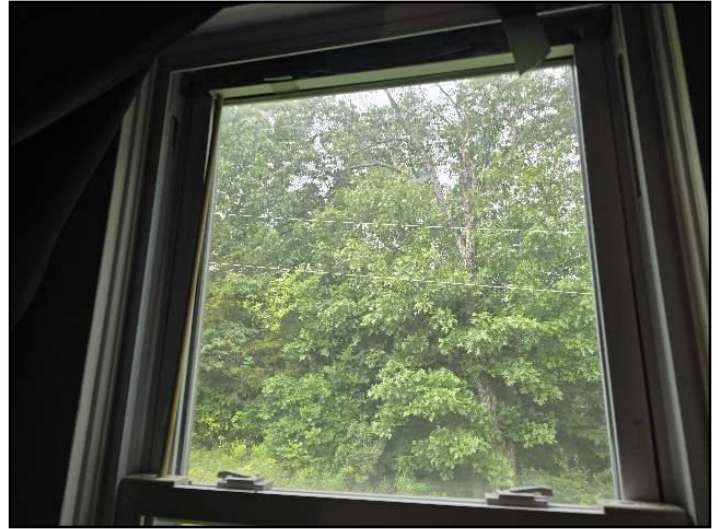
### 15. Condition: • [Broken sash cord/spring](#)

The spring of the window is broken and will need to be repaired.

66. Broken sash cord/spring

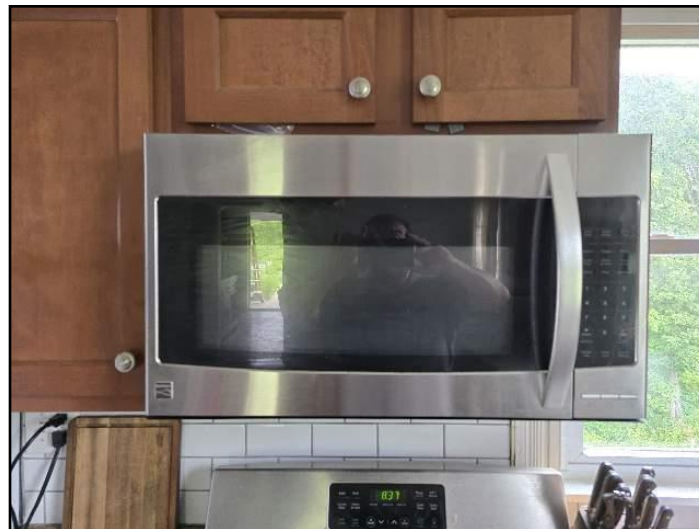
68.

The Microwave/Exhaust Fan Combo is inoperative. Although there is power at the receptacle, the microwave doesn't function.

**16. Condition:** • Inoperative
