# Property Inspection Report

422 Old Southern Rd.  
Branson MO 65616

## Gingles Inspections

| <b>Date:</b> 8/23/2023 | <b>Time:</b> 10:00 AM | <b>Report ID:</b> AG13923 |

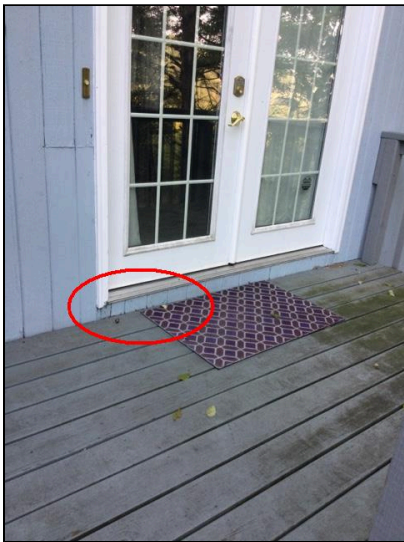
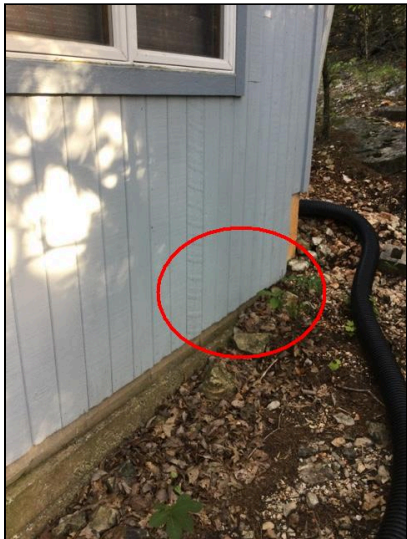
(1) **Decay, damage, signs of deterioration, incomplete construction, and/or repairs were needed to exterior surfaces.** -- Repairs to these areas may reveal concealed moisture or pest damage to framing, insulation, finished surfaces, or damage to other systems near the locations. -- Unable to determine the condition of underlying materials. I recommend addressing moisture problems, if necessary and a qualified contractor repair the exterior surfaces as necessary.

1.0 Instance of decay/deterioration/damage

1.0 Instance of decay/  
deterioration/damage

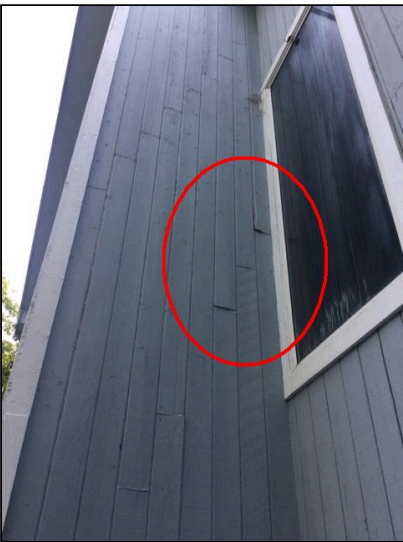
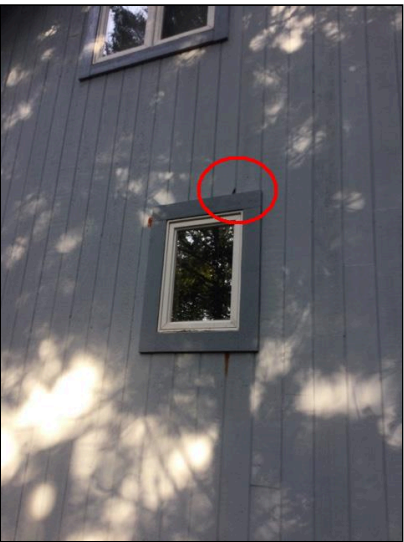
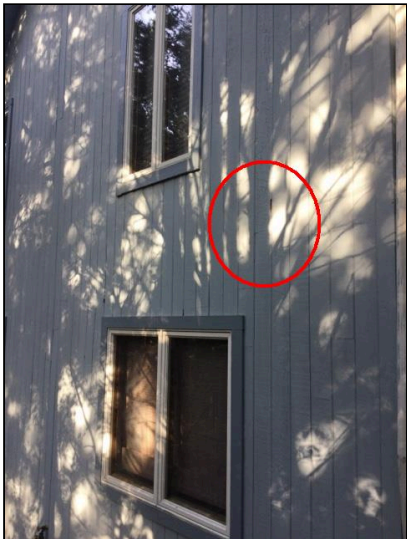
1.0 Instance of repairs needed

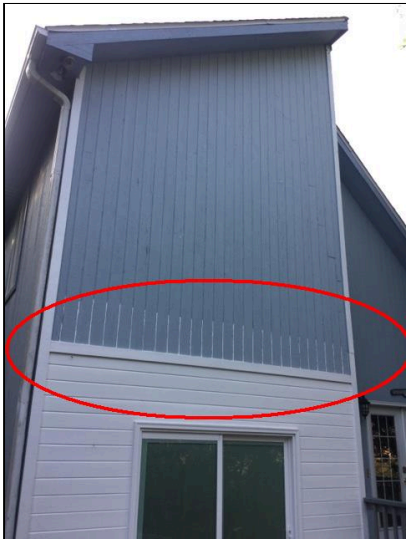
**(2) Caulk and paint maintenance at exterior surfaces was needed at this time.** Open seams and penetrations create the opportunity for weather and pests to enter the structure. Maintenance will prolong the life of the materials. I recommend sealing penetrations and gaps that required sealant with a high grade exterior rated sealant. I recommend making all repairs to the exterior as needed, prime, seal, and paint or stain as needed.

1.0 Instance of maintenance needed

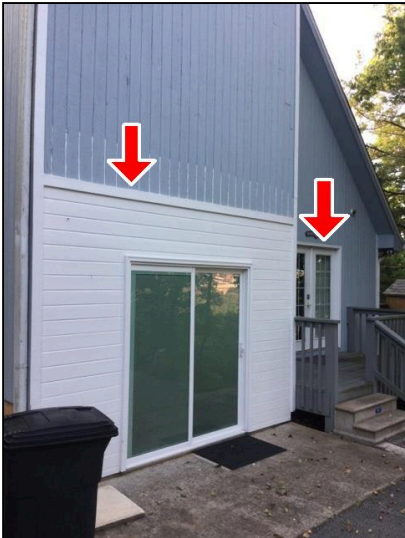
(3) Head flashing was not observed at some or all exterior transitions. The flashing is typically installed at horizontal trim boards above windows, doors, and siding transitions. In some installations, the flashing is behind the trim but at this time, I cannot confirm its presence. The lack of a flashing, or an improper installation may be a source of moisture intrusion or leakage into concealed framing - leading to moisture damage or mold growth. The current configuration requires routine caulk and paint maintenance. I recommend routine inspection and caulk & paint maintenance at all horizontal trim and transitions.

1.0 Instance of flashings not observed

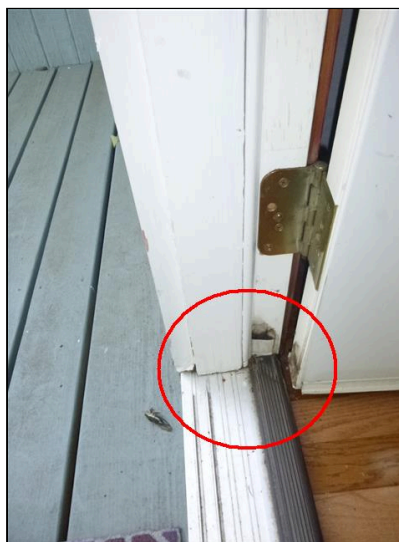
1.1 Decay/deterioration/damage

(2) At the front french doors, **The threshold/sill and lower jam area had decay or deterioration.** This is a common location for rot or decay when not protected from weather. Moisture intrusion or moisture damage promotes mold growth and wood destroying organism activity. Unable to determine condition of underlying materials. I recommend repair and replacement as necessary.. The installation of a storm door is the best action to protect this area from deterioration and moisture intrusion.

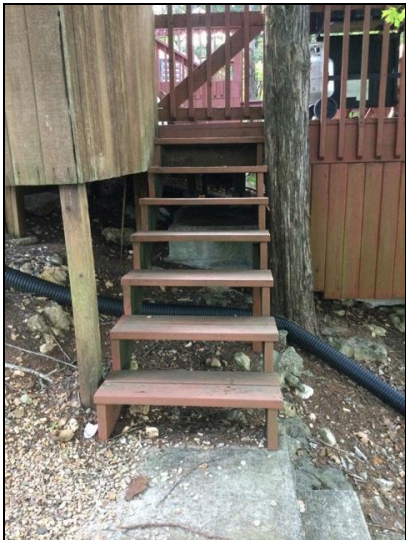
**Inconsistent or non-conforming tread height or depth was present at the steps.** Stair treads or steps that have inconsistent height or depth, or where the height of step is non-conforming is a *Potential Trip or Fall Hazard*. **The hand or guard railing installation was inadequate or in need of improvements.** Guard railing is required at surfaces 30" above the grade or floor. Openings were present that are a significant fall hazard. A graspable hand rail was not installed. Damaged, loose, or improperly installed railing components may lead to falls or injury. *Potential fall hazard*. **Trip hazards were present at the structure.** Conditions including, uneven tread height, unsecured boards, damaged treads/boards, withdrawn fasteners, or uneven planes *should be repaired for safe passage*.

1.3 Inconsistent tread height, guard railing not installed

***I recommend a qualified deck contractor evaluate and repair in accordance with present standards.*** I recommend repairs as needed.

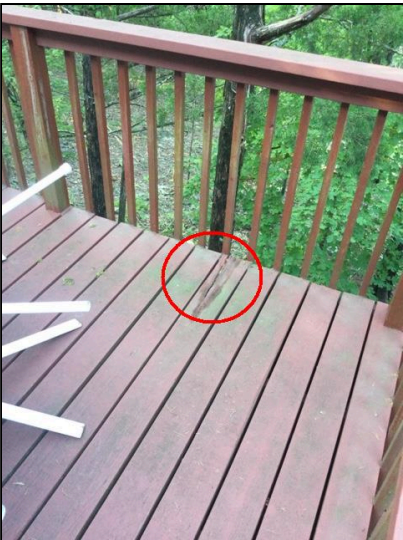
1.3 Instance of decay/deterioration/damage

**At the structure, damage, decay, or deterioration was observed.** Subsequent deterioration or damage may occur if not corrected. Unable to determine the condition of underlying materials. *The structural integrity may be compromised.* **Wood was in contact or in close contact with grade and landscaping, or had concrete poured around the posts.** Long term, moisture damage to materials may occur. This also promotes wood destroying organism activity. Improvements or repairs should be performed to provide clearance from grade, landscaping, and/or vegetation from building materials.

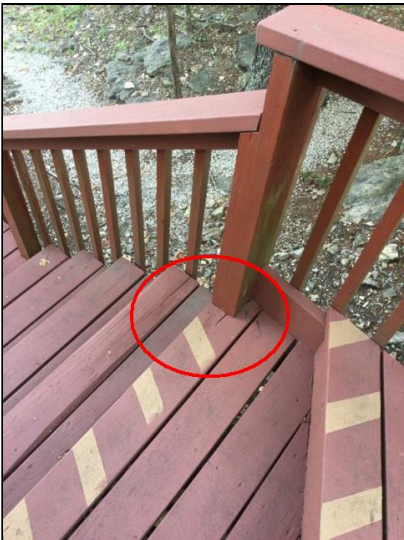
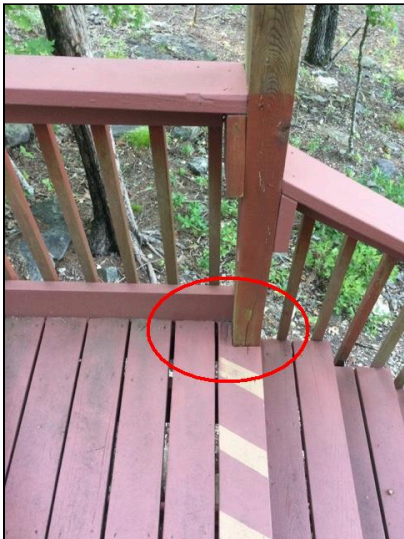
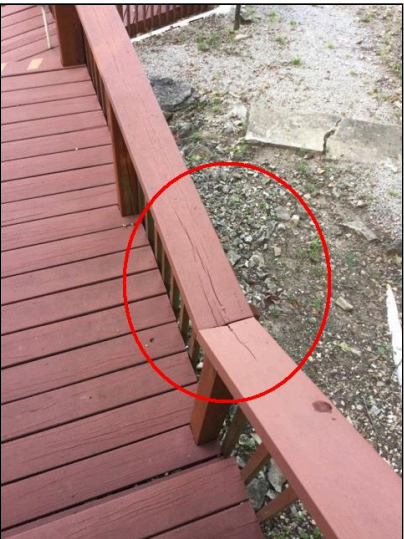
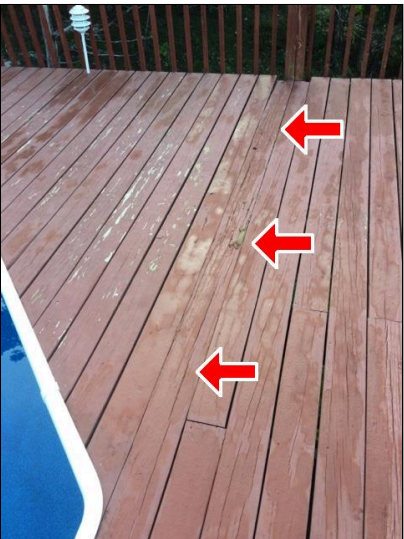
1.3 Instance of decay/deterioration/damage

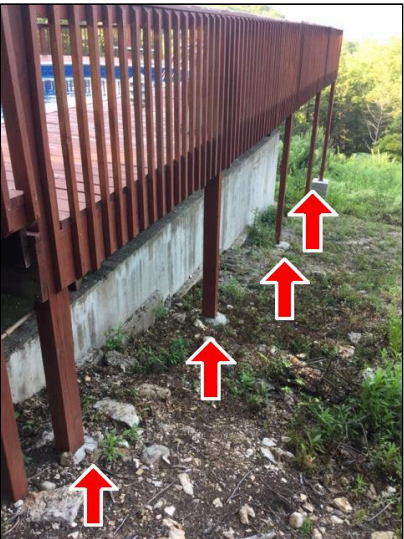
**Wood was in contact or in close contact with grade and landscaping, or had concrete poured around the posts.** Long term, moisture damage to materials may occur. This also promotes wood destroying organism activity.

1.3 Instance of concrete  
poured around posts,  
susceptible to moisture  
damage/decay

**I recommend a qualified deck contractor evaluate and repair in accordance with present standards.**

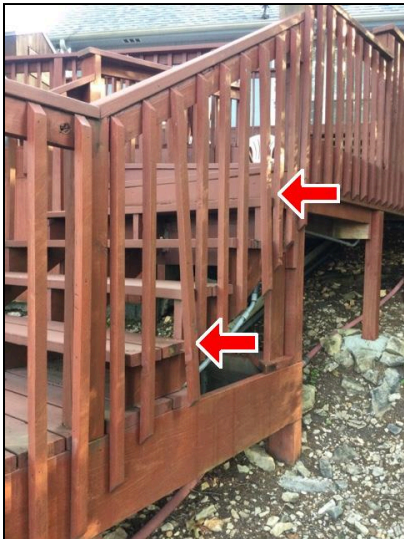
1.3 Loose railing components

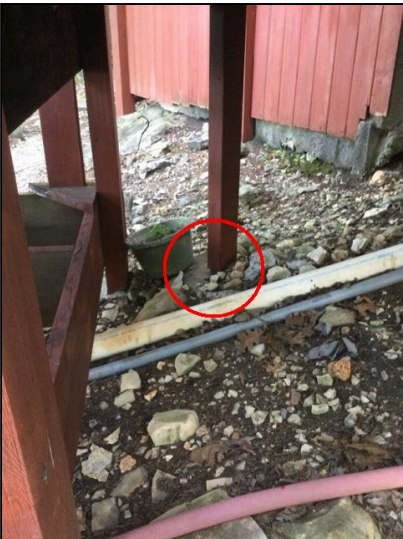
1.3 Gap between post and  
footing

**The structure uses posts or columns to transfer the load to the ground.** *Inadequate*

footings, improper installation, or improper support create a substantial load reduction that significantly limits the structures ability to support itself and live loads. A gap or space was present at the supports where concrete surfaces, blocks or footings are located. This is an indication of settlement, movement, or inadequate footings. Without repair, settlement, fatigue, or withdraw of the structure may occur. **Inadequate connections were present.** Joist hangers were not present, or not present in some areas as required. Joist hangers improve the strength of the connections and provide bearing. The installation of joist hangers are recommend.

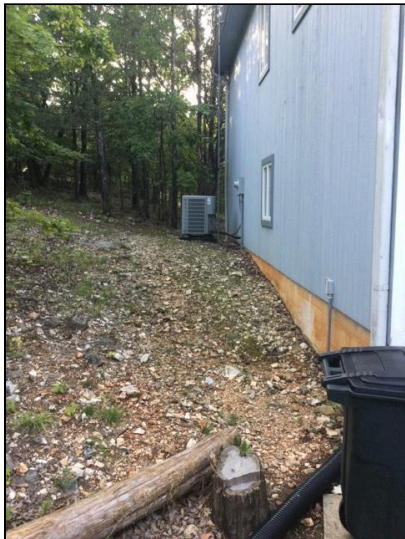
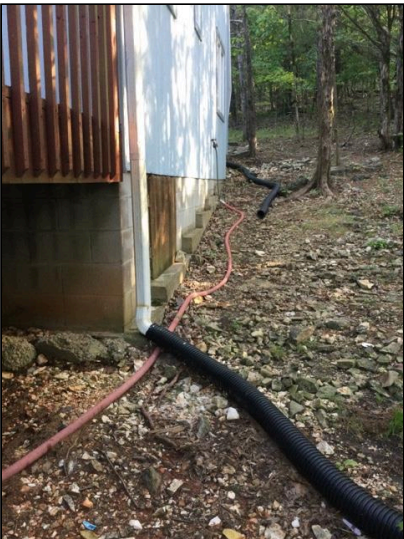
*Inadequate drainage from the structure, surfaces, or walkways promotes foundation problems, moisture intrusion, moisture damage, erosion, ponding or aggravate existing foundation problems.*

1.4 Instance of maintenance/ improvement needed

**I recommend improvements and maintenance to the grading, landscaping, and drainage as needed.** Routine inspection and maintenance of exterior grading, landscaping, and drainage is recommended.

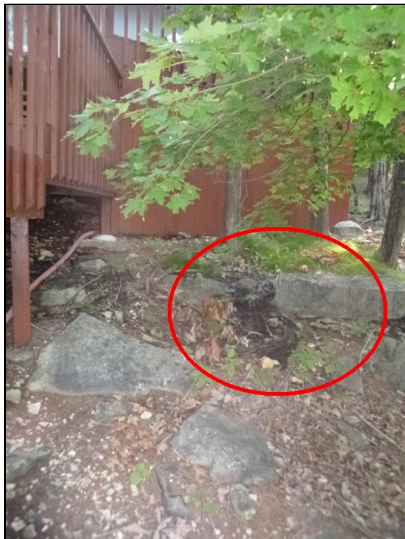
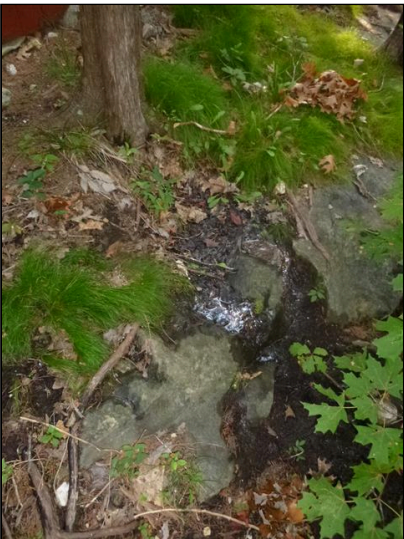
(2) **A dark greasy looking liquid was present on the ground in the back yard.** The source of the liquid could not be identified. The liquid could not be identified. *I recommend further investigation and repair or cleaning as needed.*

1.4 Greasy dark liquid

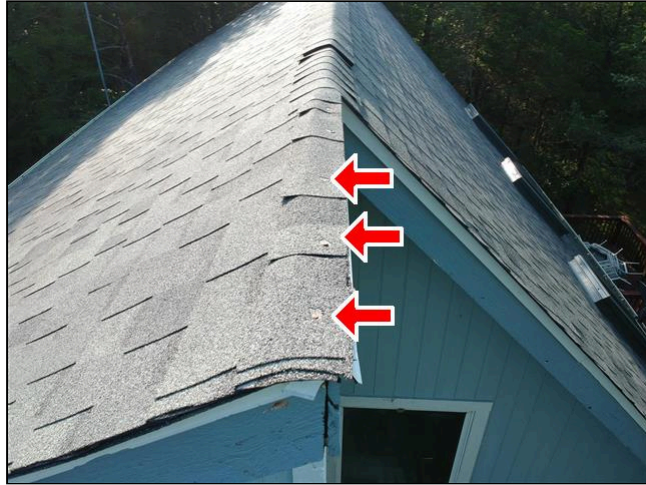
**Maintenance needed at roofing fasteners.** Exposed fasteners at the ridge cap and flashings is an accepted practice however, *I recommend sealing with a high grade elastomeric roof sealant in the course of routine maintenance.*

2.1 Instance of sealant needed at fasteners

***I recommend maintenance to fasteners at this time. I recommend routine maintenance and inspection of the roof coverings. Routine inspection and maintenance to the roof system will prolong its ability to shed water effectively.***

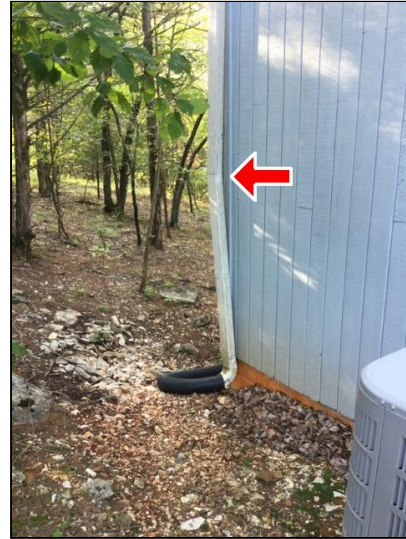
**(3) Inadequately secured guttering observed.** *Loose gutters promote poor drainage and may fall off the house in storms or with ice/snow accumulation. In some cases, loose gutters may promote drainage behind the guttering potentially leading to fascia decay. I recommend reliable repairs to the gutters and confirming leak free operation.*

2.4 Loose

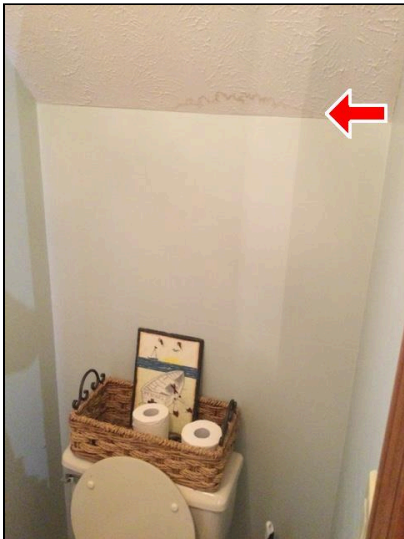
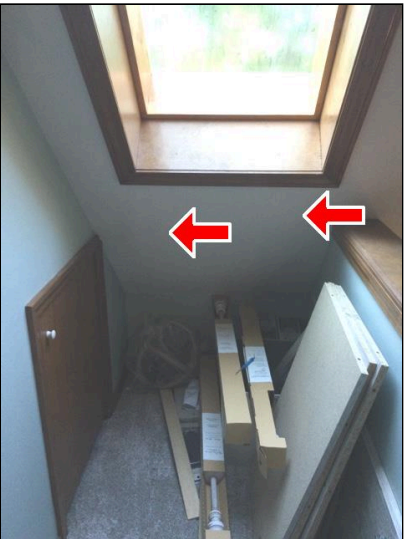
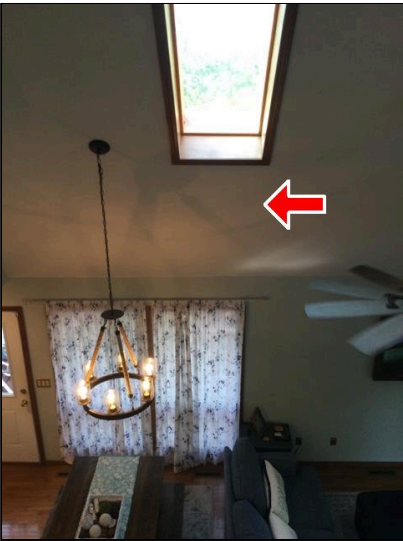
(1) Moisture stains, moisture damage, indications of moisture, or repairs at suspected moisture stains were present at finished surfaces. The areas were checked with a moisture meter or a thermal imaging camera however at this time, did not detect elevated levels of moisture or thermal anomalies. At this time, I cannot confirm if prior moisture intrusion has been repaired or addressed. The conditions at the time of the inspection did not reveal moisture content. Changes in conditions such as temperature, weather, repeated use of plumbing, pest/vermin activity, or changes in occupant activity may reveal subsequent activity. I recommend inquiring with the seller/occupant for more information or repair details.

3.2 Instance of stains - upper bathroom

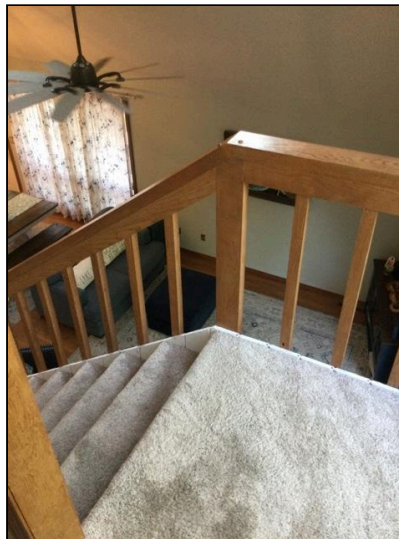
3.6 Spindle spacing in need of improvement, graspable handrailing not installed

(1) **At the interior stairs, guard railing was in need of improvement.** *Newer building standards require a tighter spacing between the spindles/ balusters to prevent falls or injury. Spacing or openings of more than 4 inches is a potential fall hazard for small children or pets. Excessive spacing or openings are a significant fall hazard. Potential fall hazard. A graspable hand railing was not installed -- hand railing promotes safe passage. Potential fall hazard. I recommend repairs as needed.*

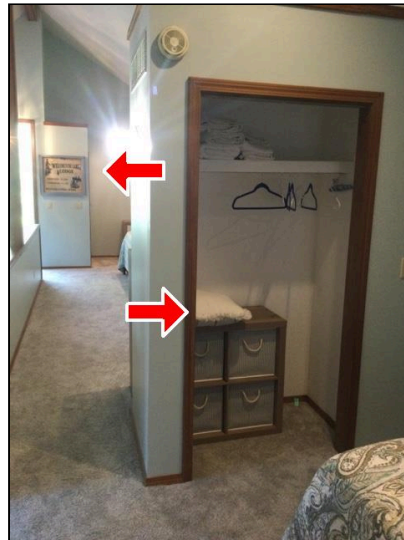
**Some of the interior doors were not present or not installed.** I recommend inquiring with the seller/occupant if the doors are stored and available. I recommend installing doors where needed in a professional manner.

3.8 Instance of doors not installed

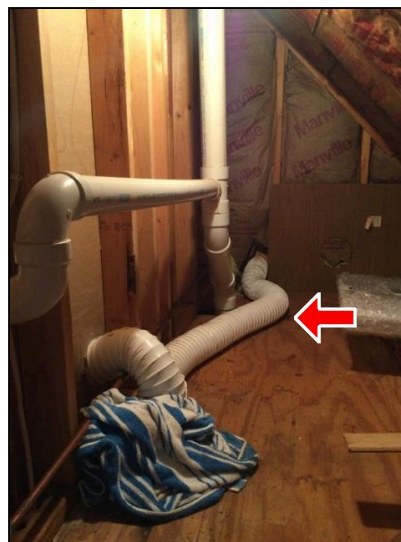
3.11 Plastic pipe

**(2) Improvements needed with the dryer ventilation system.** *The vent system had a flexible plastic vent tubing that is a potential fire hazard. I recommend replacing with a smooth wall pipe and cleaning on a regular basis.*

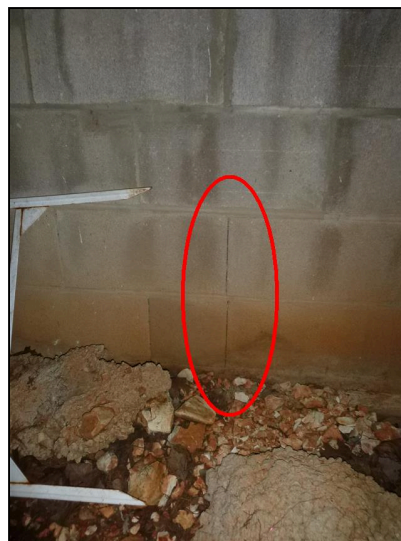
4.2 Instance of tuck pointing needed

*The foundation was visually inspected where accessible. Tuck pointing was needed at one or more foundation walls.*

**I recommend improving the grading and lot drainage at the exterior as outlined in Section 1 to improve conditions of the foundation. Improvements to the downspouts and downspout extensions is recommended to move drainage away from the structure.** *Routine inspection and maintenance of lot drainage, exterior grading, and gutter drainage is recommended to reduce moisture related problems and aggravating existing foundation problems. **I recommend a mason tuck point the foundation as necessary.***

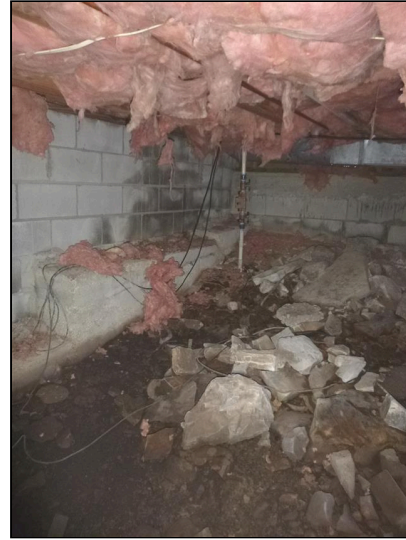
4.3 Moisture in crawlspace

**I recommend improving the grading and lot drainage at the exterior as outlined in Section 1 to improve conditions of the foundation. Improvements to the downspouts and downspout extensions is recommended to move drainage away from the structure.** *Routine inspection and maintenance of lot drainage, exterior grading, and gutter drainage is recommended to reduce moisture related problems and aggravating existing foundation problems.*

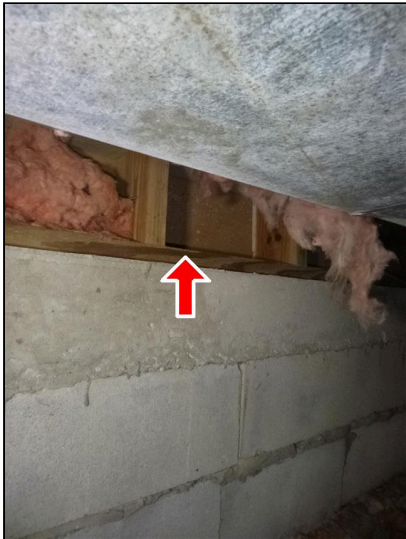
(2) **The backside of drywall for the lower bedroom was visible from the crawlspace.** This drywall is susceptible to moisture damage, mold, etc. I recommend improvements as needed.

4.5 Backside of drywall

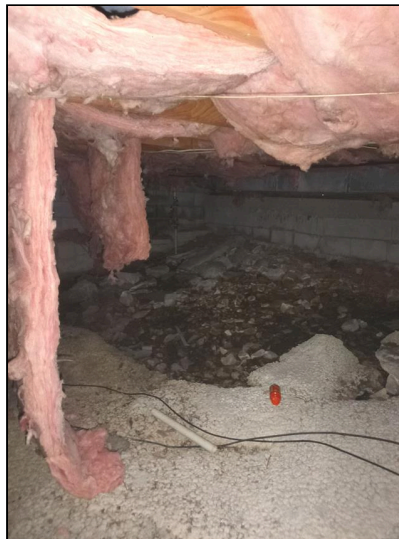
4.8 Instance of damaged/displaced insulation

**Insulation between floor joists at the crawlspace was damaged and displaced.**

Repair or improvements will increase comfort in the area and reduce energy costs. I recommend reliable repairs or improvements.

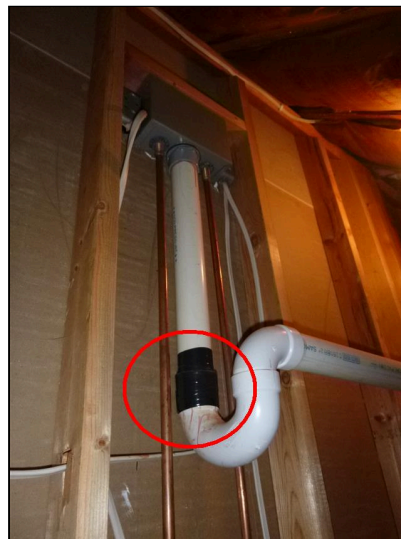
5.4 Tape over coupling

(2) **Non-typical repair attempt was observed at the drain waste plumbing system.**

*Leakage not observed at this time however, this is a potential leak concern. This is a potential source of leakage, concealed moisture damage, or a potential sanitary concern. No immediate concern. I recommend monitoring for leakage and repairing as needed.*

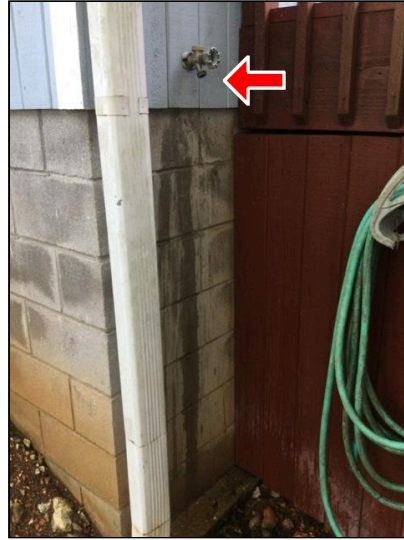
**Leakage was present at the west hose bib.** *This is a nuisance and is wasteful. I recommend repair.*

5.5 Could not turn completely off, dripped when approached

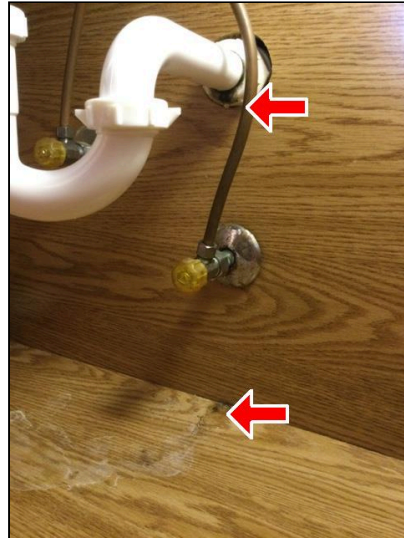
5.6 Leak

**(1) A leak was present at the right main level bathroom sink drain piping.** The opportunity for deterioration at the cabinetry and organic growth is possible if left in disrepair. **I recommend a qualified plumber evaluate and repair as necessary.**

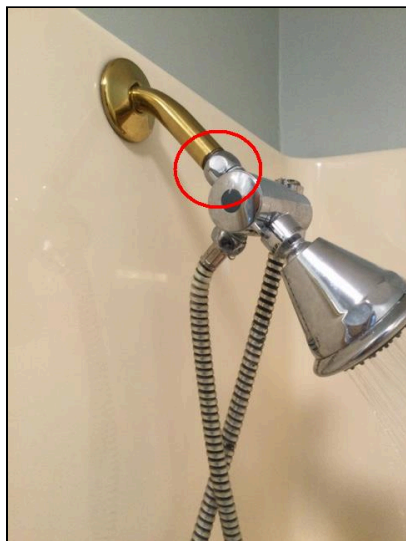
(2) **Repairs and/or maintenance needed at the main level bathroom shower head.** *The fixture leaked when in use. -- This may be a nuisance and wasteful. -- The fixture was damaged and may need to be replaced. I recommend repair or replacement and confirming proper and leak free operation.*

5.6 Drip/leak

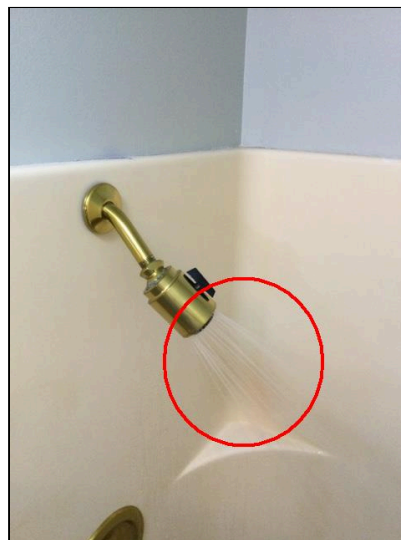
5.6 Did not spray evenly

(3) **Repairs and/or maintenance needed at the upper level bathroom shower head.** *The fixture did not spray properly, and may need to be cleaned. I recommend repair or replacement and confirming proper and leak free operation.*

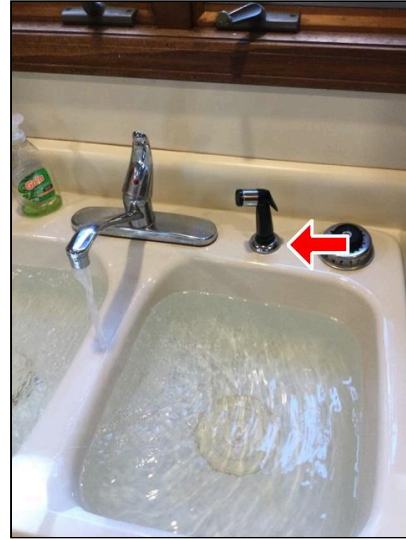
(4) **Repairs and/or maintenance needed at the kitchen sink faucet sprayer nozzle.** *The escutcheon was loose or not secure. I recommend tightening all associated hardware and confirming proper function and ease of use.*

5.6 Loose

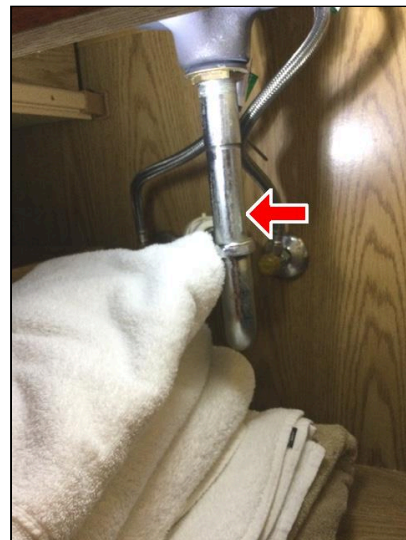
(6) *TIP: Chrome plated metal traps and associated piping was present within the structure. The material has a reputation for early deterioration, resulting in a leak. I recommend upgrading the plumbing to plastic.*

5.6 Instance of material

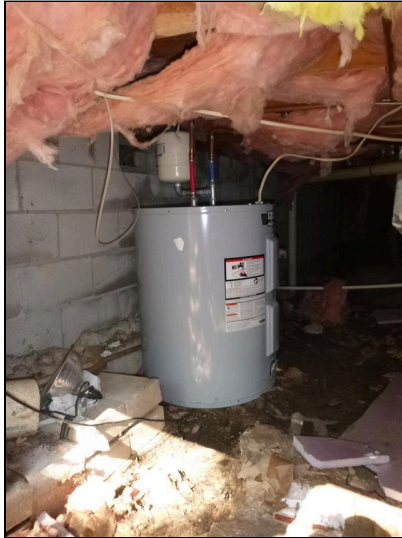
5.7 Not level, installed on dirt floor    5.7 Pipe not installed

*The water heating equipment was newer. The system was in operation at the time of the inspection. **The water heater installation was in need of improvement.** Most standards require a minimum 18" of copper material at the water heater inlet and outlet. The water heater was not level. The water heater should be leveled to prevent the unit from falling over. The water heater was installed directly on the ground. It is susceptible to rust and deterioration. **The T&P relief valve extension pipe was not installed.** In the event the valve releases pressure, scalding hot water may spray all over, potential burning an individual that may be nearby. I recommend a qualified plumber evaluate and repair or replace in accordance with present*

standards.

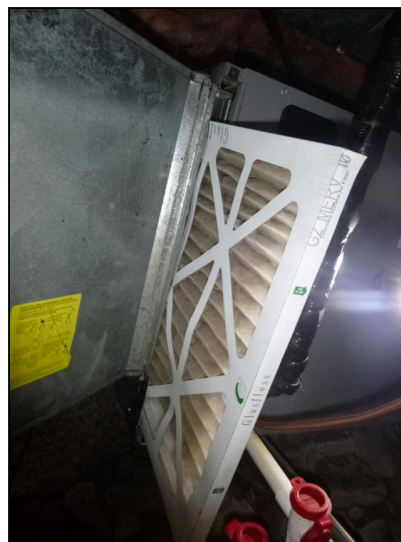
6.1 Dirty filter

**A well maintained HVAC system will prolong it's service life.** *Latent or irregular maintenance may result in failure, inconsistent operation, unsafe conditions, or decrease efficiency. A service log was not present which may be an indication of inconsistent maintenance. The system filter was dirty.*

*Annual and routine maintenance is recommended to ensure safe operation. Failure of components may occur at any time and this visual inspection of the equipment is not a guarantee of future performance. Annual maintenance and servicing should be performed by a qualified HVAC contractor.*

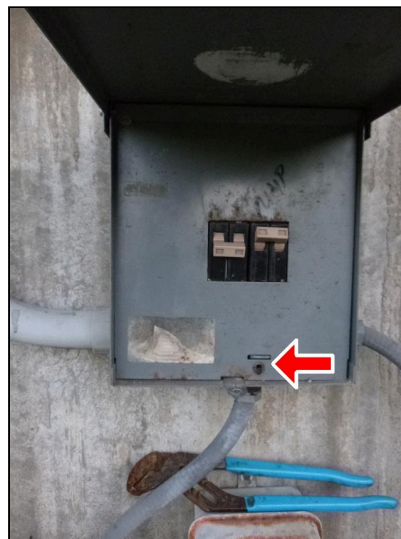
7.3 Screw not installed

(4) An inspection of the electrical system revealed improvements or repairs needed at the panelboard at the pool pump. Some screws or fasteners were not installed or were not present -- an inadequately secured cover is susceptible to pest or debris entry. I recommend securing the cover as needed.

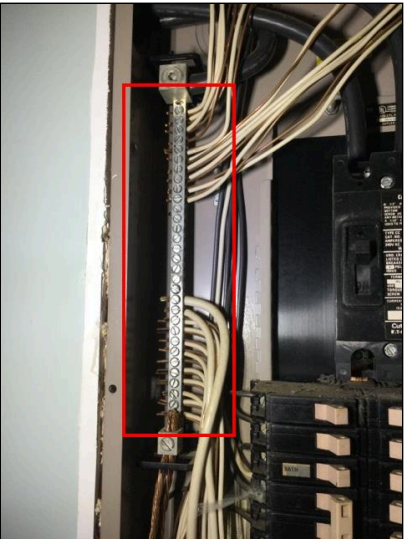
**Improper terminations were present.** Two or more wires were terminated at a screw - *Positive connection at the termination is not assured for multiple wires.* The potential for arcing between the wires at the termination increase, which could lead to a fire. *Notes: Double tapped neutrals..* **I recommend a qualified electrician evaluate and reconfigure the wiring.**

7.4 Double tapped neutrals

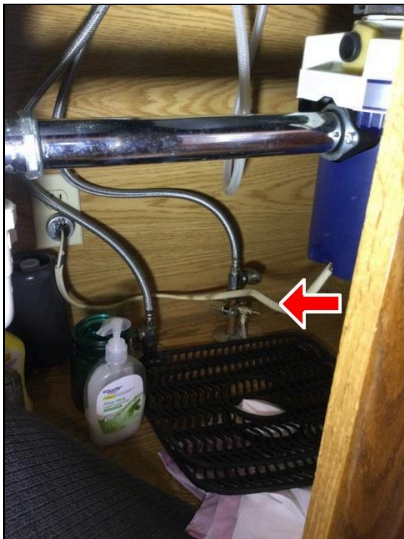
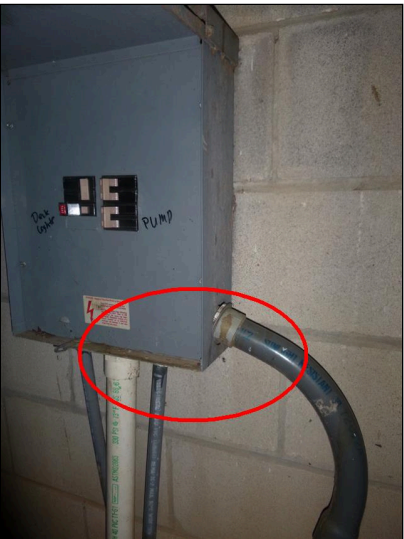
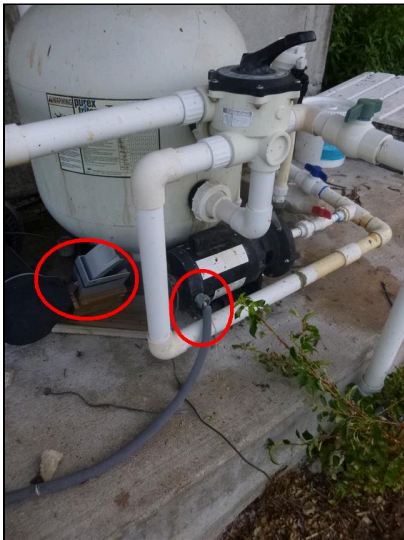
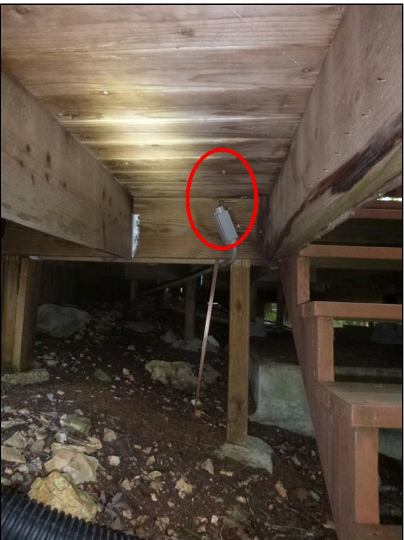
7.5 Instance of sub-standard install - kitchen disposal (romex used as appliance cord)

7.5 Instance of sub-standard install - panel under deck (damaged conduit connections)

7.5 Instance of sub-standard install - pool pump area (damaged conduit)

7.5 Instance of sub-standard install - under deck shelter/ pool room

**I recommend a qualified licensed electrician evaluate all areas of sub-standard or non-typical circuitry and repair in accordance with present standards.**

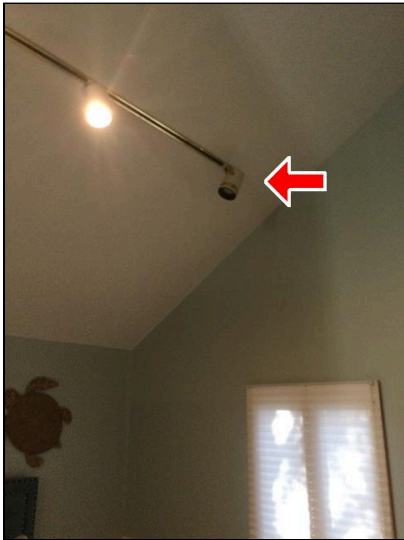
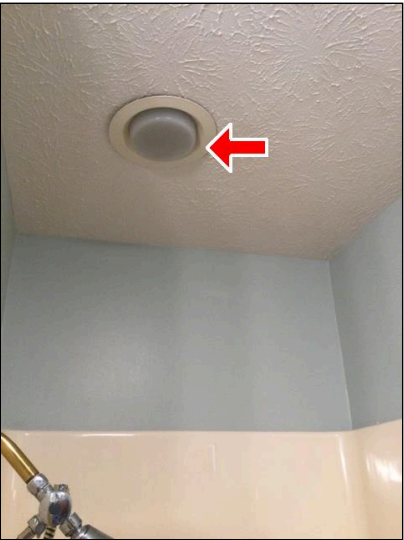
7.6 Instance of lighting that did not respond - upper level

7.6 Instance of lighting that did not respond - bathroom

*recommend a qualified electrician evaluate and repair as necessary.*

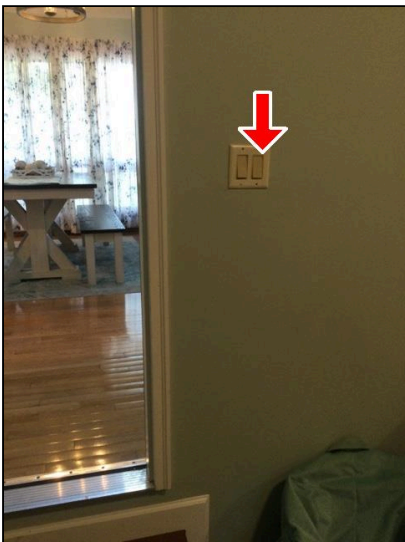
(2) There were switches and/or controls that did not easily or visually reveal a purpose. *Equipment or nearby lighting did not respond when switches were flipped on or off. Extensive investigation was not performed in the interest of time. Switches may have no purpose, may operate special functions within the structure, operate lighting or systems on opposite sides of the structure, or operate fixtures that are inoperable or have defective bulbs. I recommend inquiring with the seller/occupant to determine the function or repairing, if needed.*

7.6 Instance of function not identified - lower bedroom

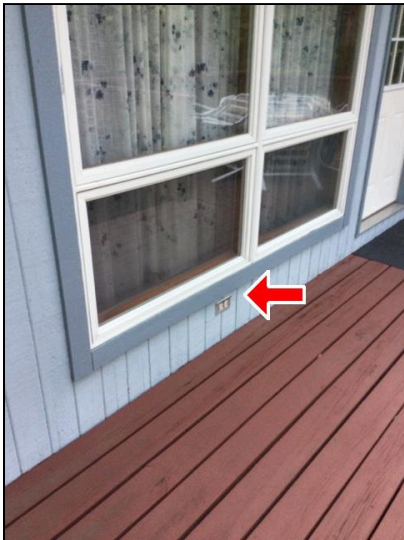
(1) **One or more outlets were in need of repairs.** Outlets should be tight to the surface and a face plate should cover the circuitry completely to prevent electrical shock. I recommend repairing loose outlets as needed and installing covers where needed.

7.7 Instance of damaged cover - deck

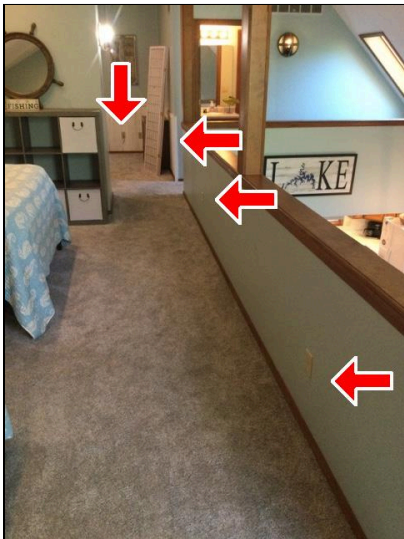
(2) **One or more outlets at the structure tested open ground or may have a weak ground present.** Outlets that are inadequately grounded do not provide the adequate shock protection, provide a false sense of safety/protection, could potentially damage sensitive electronics, and should be corrected. This may be a simple repair however, I recommend a qualified electrician test all receptacles and repair as needed.

7.7 Instance of ungrounded 3-prong outlets - upper level

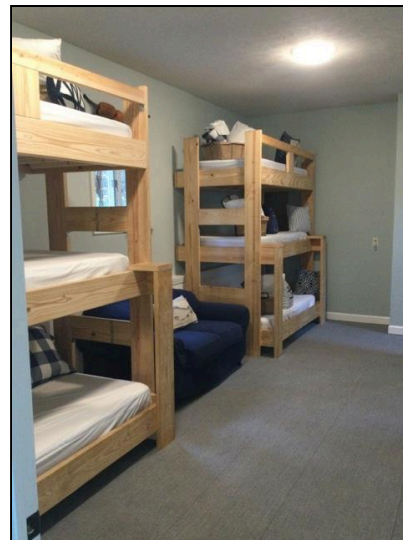
7.7 Inadequate outlets

**(3) An inadequate amount of outlets were present in lower bedroom.** The minimal outlets in the area promotes the use of extension cords which are considered potentially dangerous. *I recommend an electrician evaluate and install more outlets as needed.*

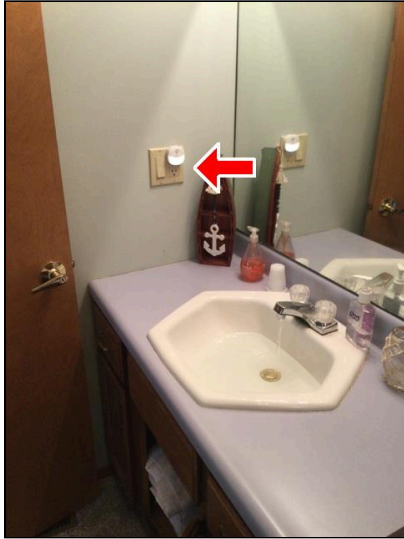
7.8 Instance of outlet lacking GFCI protection - upper bathroom

**Some outlets were lacking GFCI protection.** GFCI protection prevents deadly shock around sources of water. *GFCI protection is recommended at all kitchen countertop surfaces, all bathrooms, all exterior locations, crawlspace, and near sources of water (within 6 feet).* ***! recommend upgrading to current standards.***

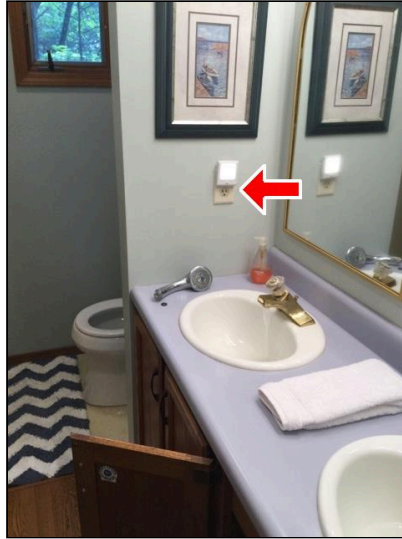
7.8 Instance of outlet lacking GFCI protection - main level bathroom

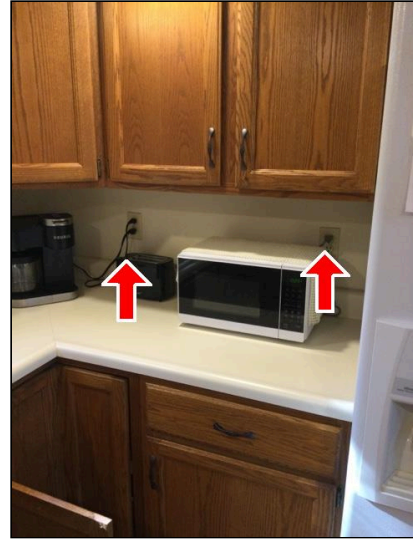
7.8 Instance of outlet lacking GFCI protection - kitchen

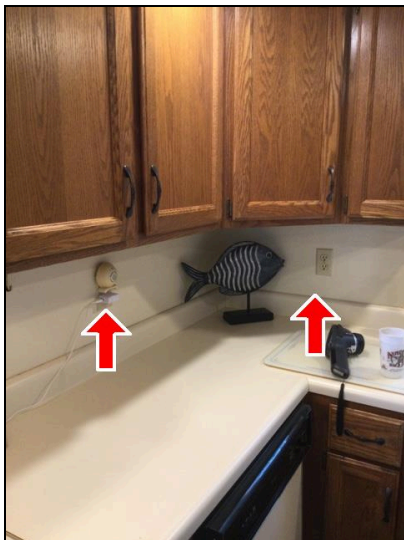
7.8 Instance of outlet lacking GFCI protection - kitchen

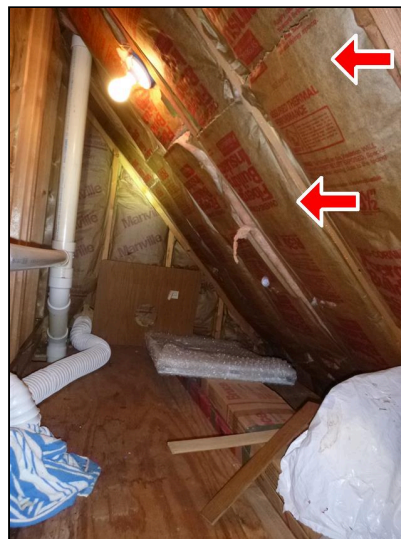
**Insulation was installed between rafters.** The insulation had a "facing" or vapor retarder. This installation of insulation at this location is acceptable however, this type of product is required to be covered with drywall or other approved thermal barrier. **I recommend reliable repairs.**

8.2 Faced insulation

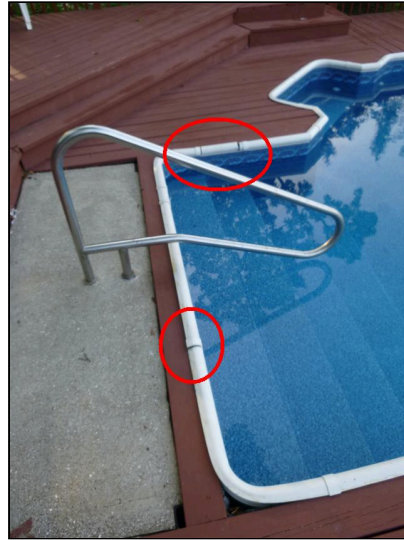
**The coping around the pool liner was damaged, incomplete, or in need of repair.** I recommend repairing as needed.

14.2 Gaps, inadequately secured

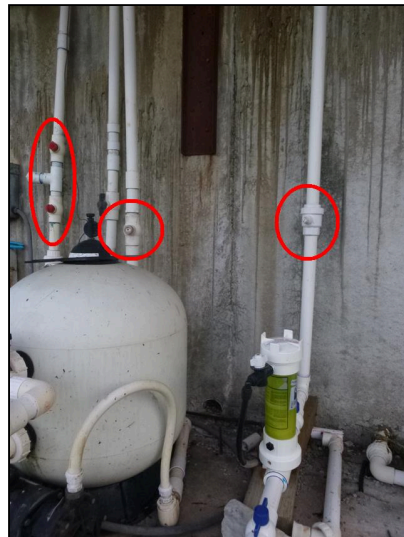
**(2) Shut off valve handles at pool plumbing was damaged.** The valves did not leak under these conditions but their operation may be hard. *I recommend repair or replacement as needed.*

14.5 Handles damaged

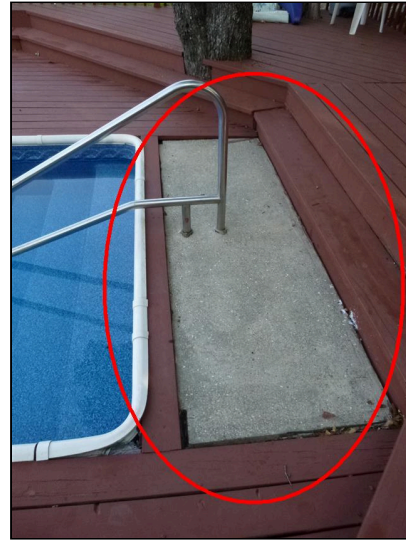
14.24 Potential trip hazards
