RESIDENTIAL REPORT

9084 Hwy HH Robertsville, MO 63072

> Andrew "Bo" Tierney JANUARY 29, 2024

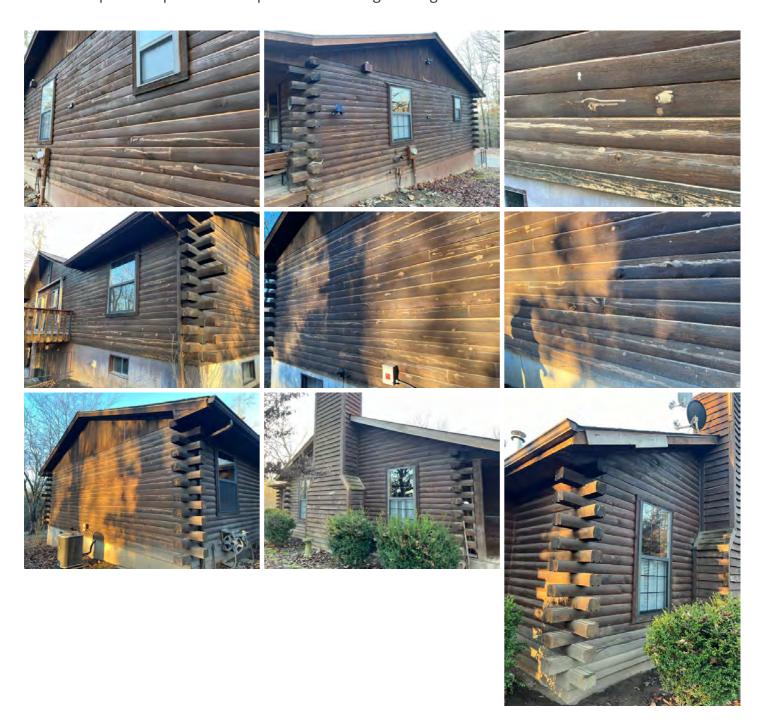
SIDING

3.1.2 Siding, Flashing & Trim

PREVIOUS REPAIRS

Previous repairs are present to carpenter bee damage throughout the exterior.

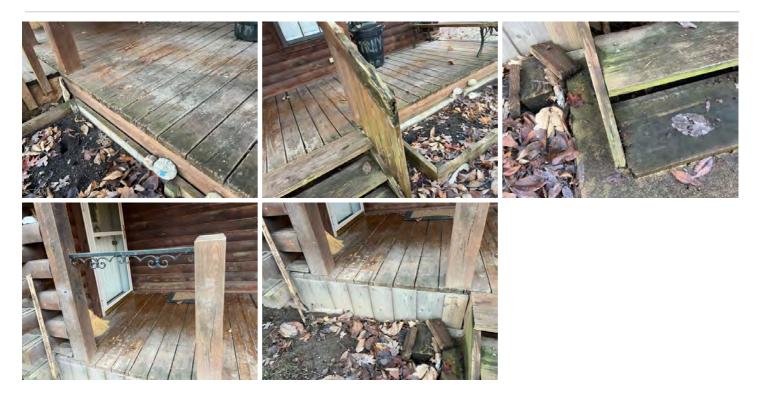
FRONT PORCH

3.4.2 Decks, Balconies, Porches & Steps

DAMAGED COMPONENTS

General deterioration, weather damaged components, and poor wood the earth clearance are present in the front porch and stairs. Recommended maintenance or replacement to prevent further deterioration.

Recommendation

Contact a qualified professional.

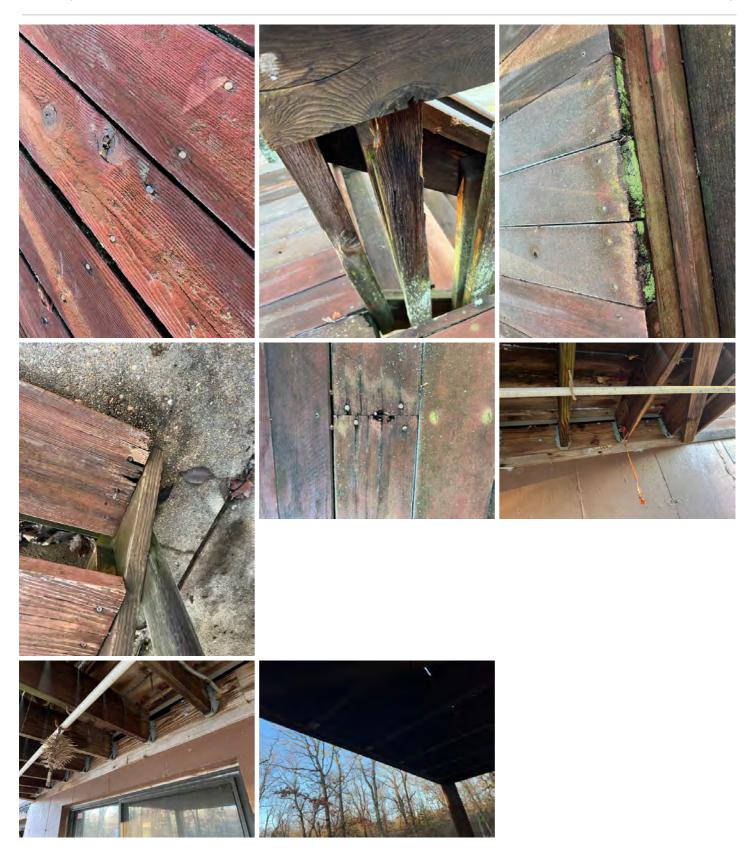
DRCK

3.4.3 Decks, Balconies, Porches & Steps

DECK MAINTENANCE

Deck floor boards and rail components are deteriorated and in need of replacement.

Recommendation

Contact a qualified professional.

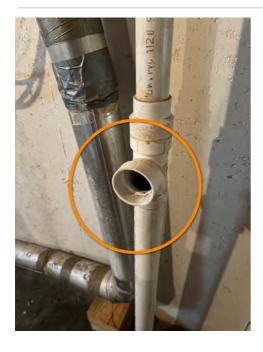
BATHTOOM

5.2.3 Drain, Waste, & Vent Systems

SEEPAGE

Evidence of previous seepage is present at the drain connection.

Recommendation

Contact a handyman or DIY project
