RESIDENTIAL REPORT

170 Brown Rd Hermann, MO 65041

Trophy Properties Merchant Team AUGUST 1, 2024

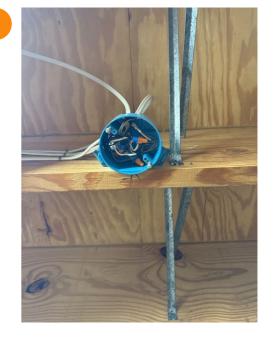
OPEN JUNCTION BOX

BASEMENT

Open junction box(es) present. Recommend enclosing for safety purposes.

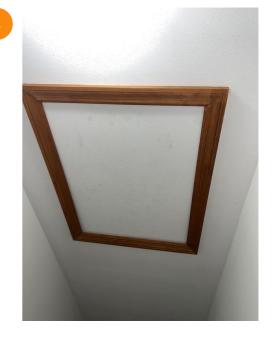
11.1.1 Attic Insulation

SCUTTLE INSULATION

Attic entrance cover is missing insulation. Recommend installing for efficiency purposes.

Contact a handyman or DIY project

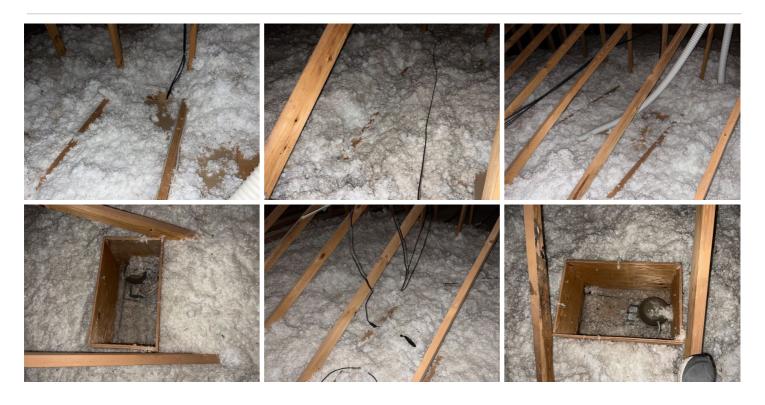
11.1.2 Attic Insulation

UNEVEN DISTRIBUTION

Insulation has been removed for wiring and not returned to the original state in several areas, and is excessively matted due to foot traffic. Can lights are not properly insulated and ceiling drywall is visible in several areas. Recommend additional insulation for efficiency purposes.

Contact a qualified insulation contractor.
