NPI MISSOURI INC

RESIDENTIAL REPORT

11821 Co Rd 3410 Saint James MO 65559

Trophy Properties
JUNE 24, 2021

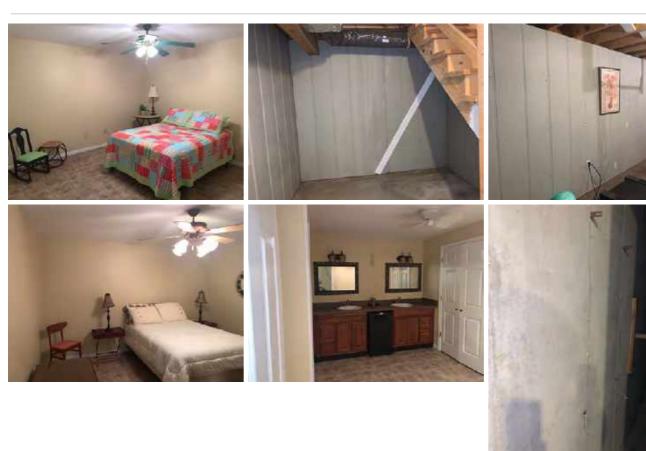
2.1.1 Foundation, Basement & Crawlspaces

LIMITED VISIBILTY

BASEMENT

Visibility of foundation was extremely limited due to finish material.

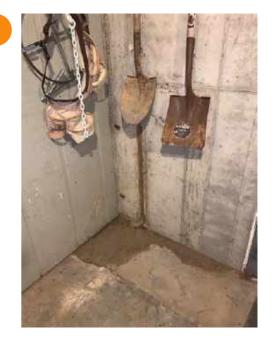
2.1.2 Foundation, Basement & Crawlspaces

WATER INTRUSION

NORTHWEST CORNER

Water intrusion is evident in the foundation wall at the Northwest corner. Recommend further evaluation by a waterproofing contractor.

Contact a qualified professional.

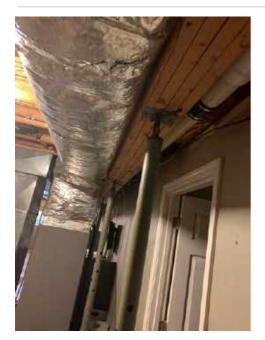
2.2.2 Floor Structure

IMPROPER INSTALLATION

SUPPORT POST

Support posts for the central beam are not on footings and not secured to the beam.

Contact a qualified professional.

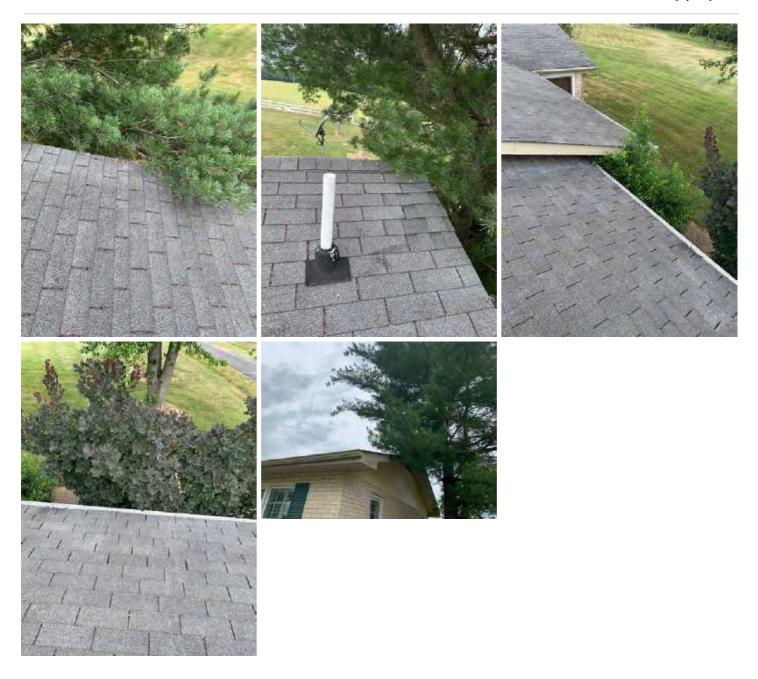
3.5.1 Vegetation, Grading, Drainage & Retaining Walls

TREE OVERHANG

ROOF

Trees observed overhanging and in contact with the roof in several areas. Conditions may result in damaged roof components.

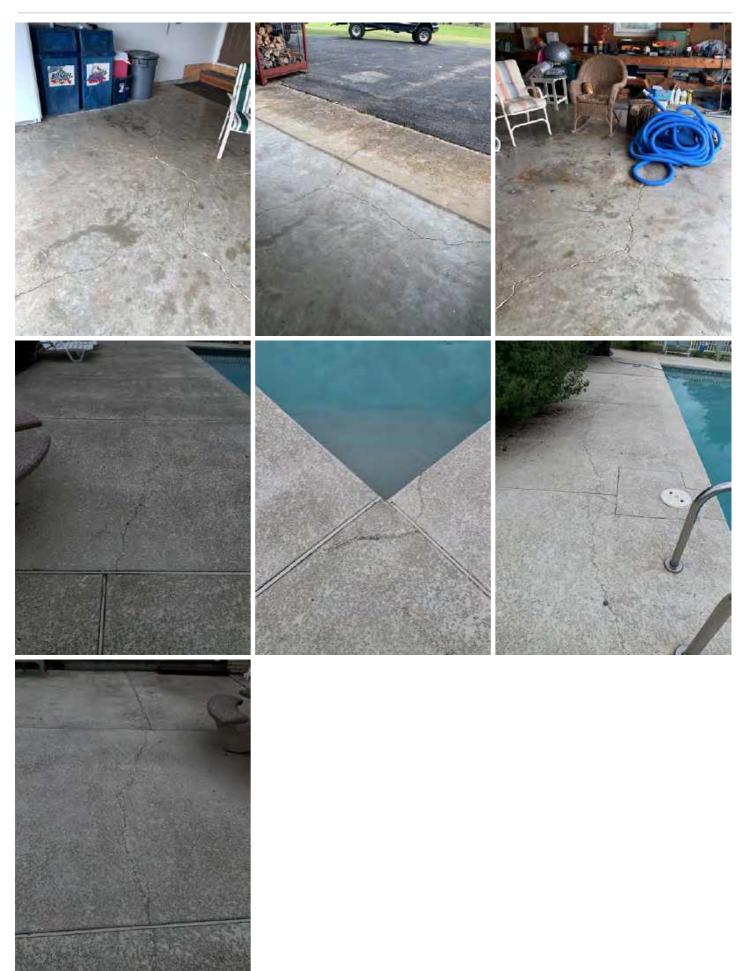
3.6.2 Walkways, Patios & Driveways

CRACKING AND SETTLING

SIDEWALKS, GARAGE FLOOR, POOL APRON

Typical cracking and settling are present in the concrete flatwork.

Contact a qualified professional.

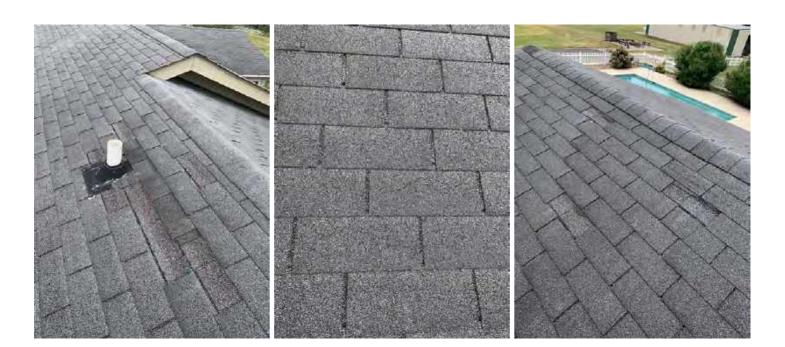
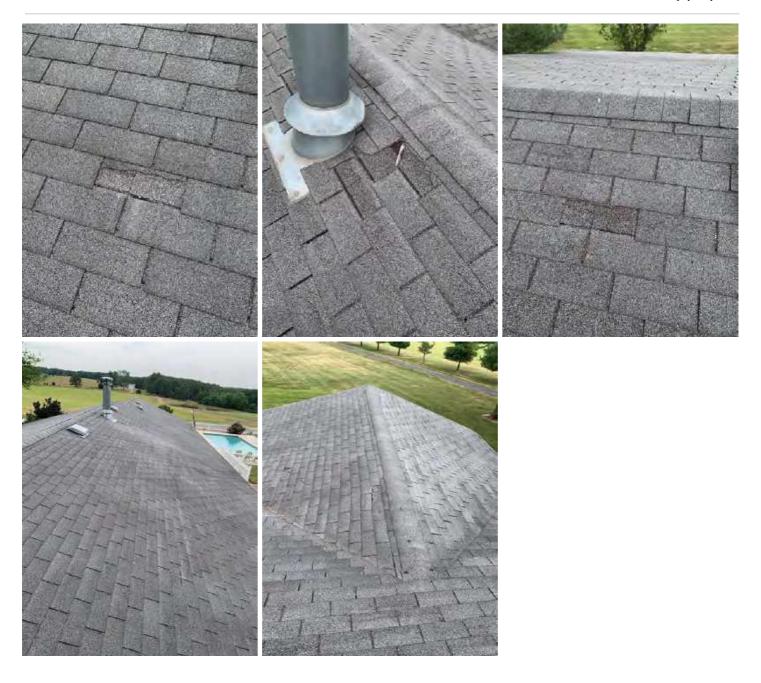
4.1.1 Coverings

Roof is well beyond designed life with several damaged and missing shingles. Recommend removal of

BEYOND DESIGN LIFE

existing coverings and replacement.

ROOF COVERING

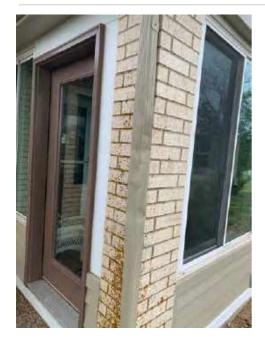
4.2.3 Roof Drainage Systems

DAMAGED DOWNSPOUT

FRONT PORCH

Replacement required to the section of damaged downspout.

Contact a qualified professional.

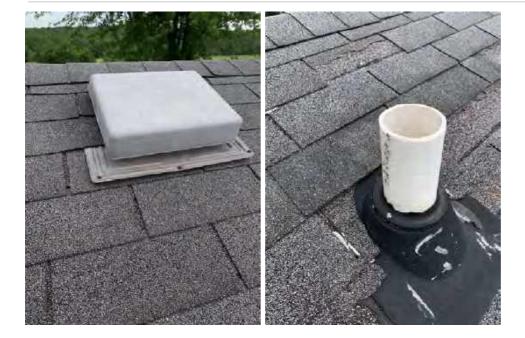
4.3.1 Flashings

REPLACE

Contact a qualified professional.

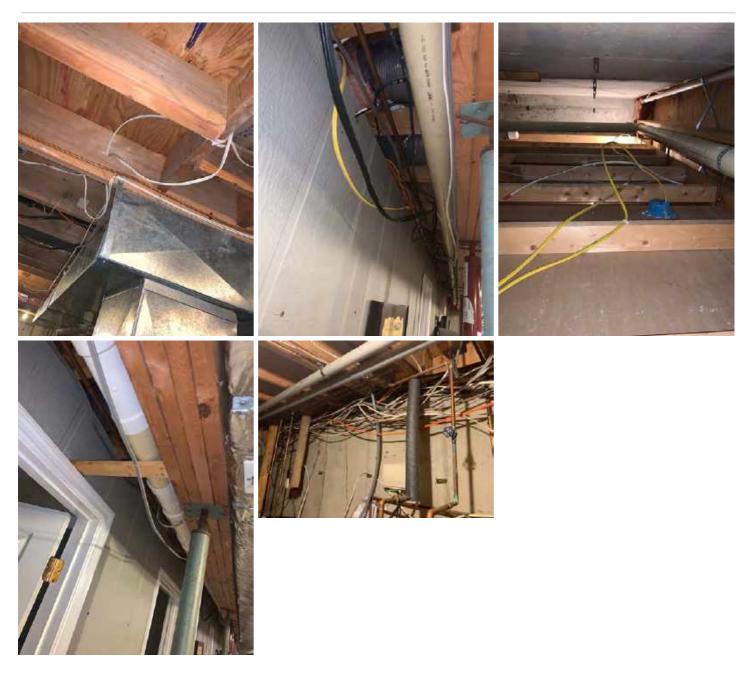
6.4.2 Branch Circuit Conductors, Overcurrent Devices and Compatibility of Their Amperage & Voltage

LOOSE WIRING

BASEMENT

Maintenance recommended to all loose, unsecured, and hanging electrical wires for safety purposes.

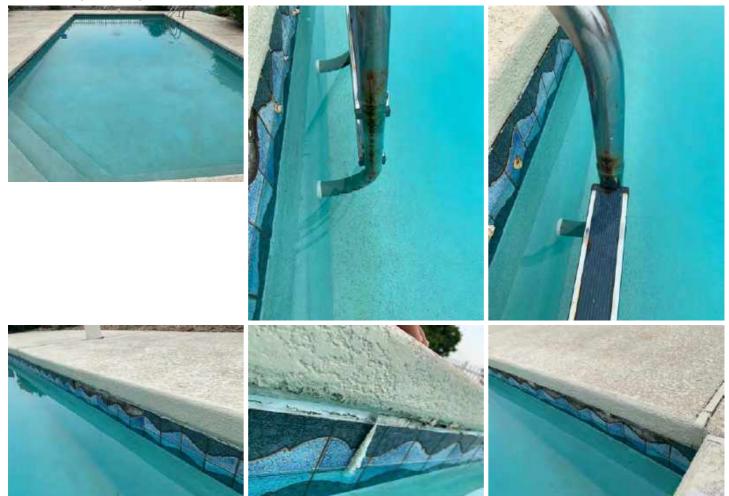
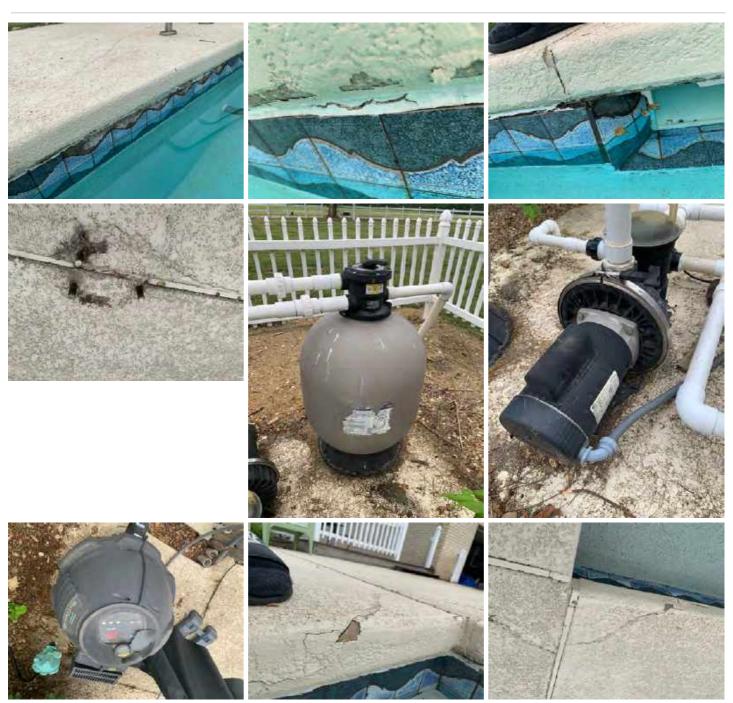
13.1.1 Pool Maintenance

REQUIRED POOL MAINTENANCE

deteriorated and missing in several areas, typical cracks are present in the concrete apron, apron coating is delaminating at the corner cracks, and the ladder is excessively rusted. Proper grounding is not present at the pump, heater and gas line. Heater was not operational at the time of the inspection. Recommend removing the unused diving board bolts anchored in the apron for safety purposes. Recommend all repairs be performed by a professional pool contractor.

Contact a qualified professional.
