# Property Inspection Report

403 Old Southern Rd.  
Branson MO 65616

4 Arrows Ranch, LLC

## Gingles Inspections

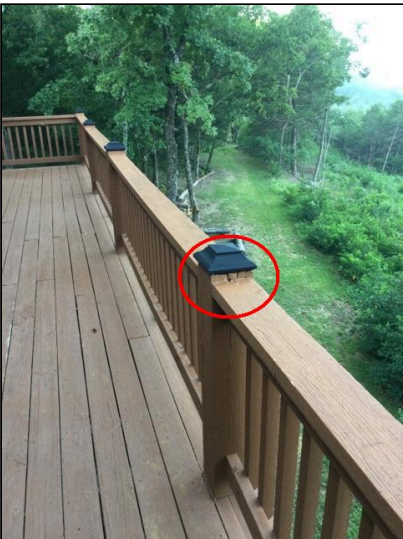
**At the structure, damage, decay, or deterioration was observed.** Subsequent deterioration or damage may occur if not corrected. Unable to determine the condition of underlying materials. *The structural integrity may be compromised.*

1.3 Instance of decay/deterioration/damage

**I recommend a qualified deck contractor evaluate and repair in accordance with present standards.**

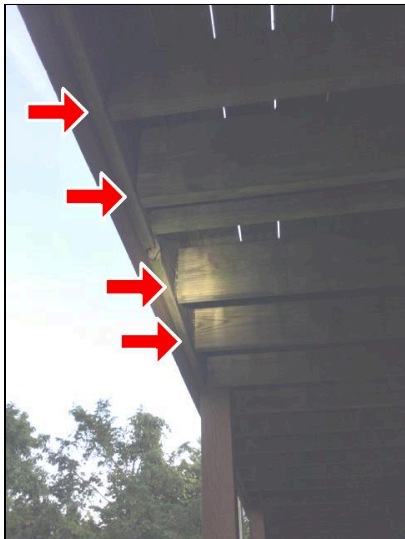
provide bearing. The installation of joist hangers are recommend. Joist hangers were improperly installed or not installed in accordance with typical manufacturers. Approved fasteners are required at all holes in a joist hanger. Some fasteners were improper, inadequately driven, withdrawn, or not installed. Improper installation of joist hangers result in a significant load reduction. Structural connections were damaged, not installed, or were inadequate.

1.3 Instance of joist hangers not installed, withdrawn connections

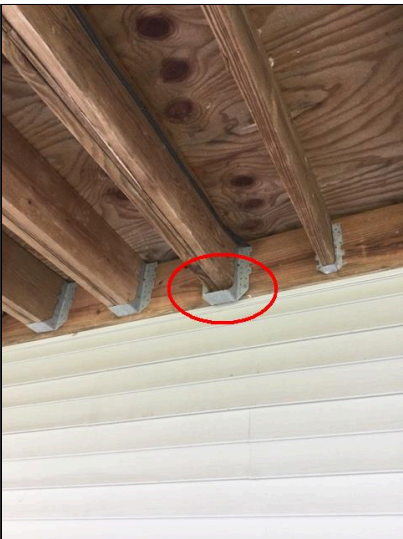
1.3 Improper joist hanger

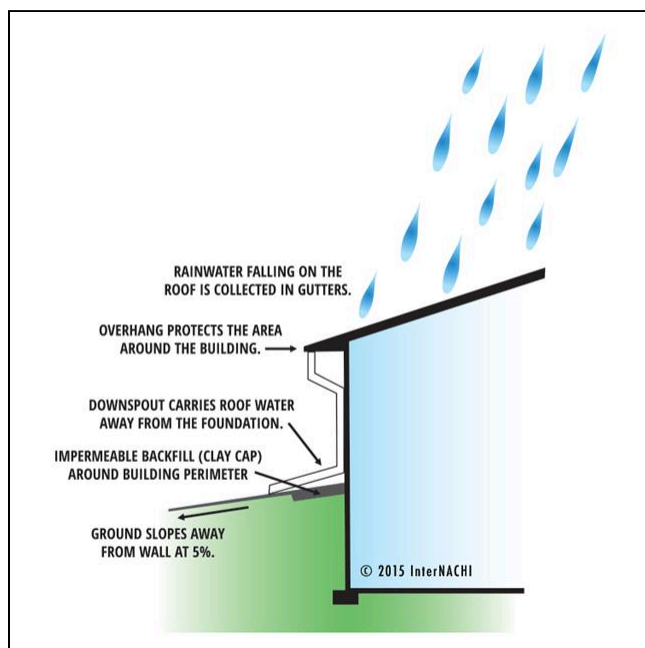
*-- Typical recommendations or standards for grading around a structure is a 6 inch drop at 10 feet away. Recommended siding to landscape/grade clearance is 6 inches --*

1.4 Typical recommendations

**I recommend improvements and maintenance to the grading, landscaping, and drainage as needed.** Routine inspection and maintenance of exterior grading, landscaping, and drainage is recommended.

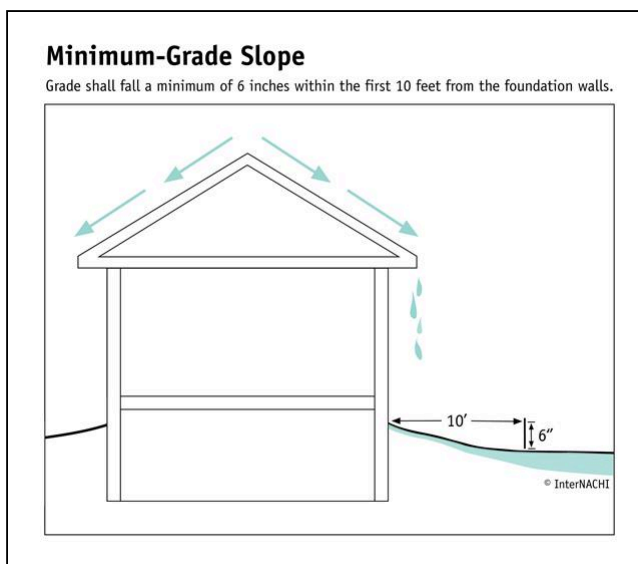
1.4 Typical recommendations

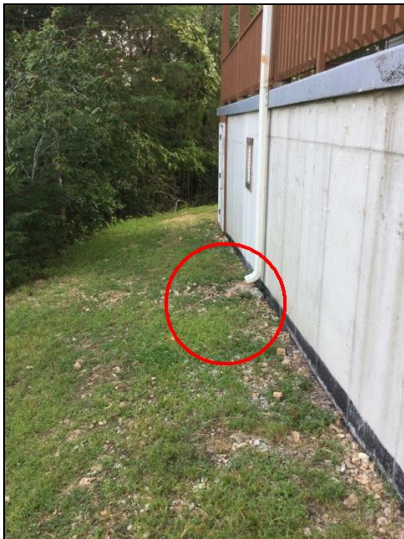
*Inadequate drainage from the structure, surfaces, or walkways promotes foundation problems, moisture intrusion, moisture damage, erosion, ponding or aggravate existing foundation problems.*

1.4 Instance of maintenance/ improvement needed

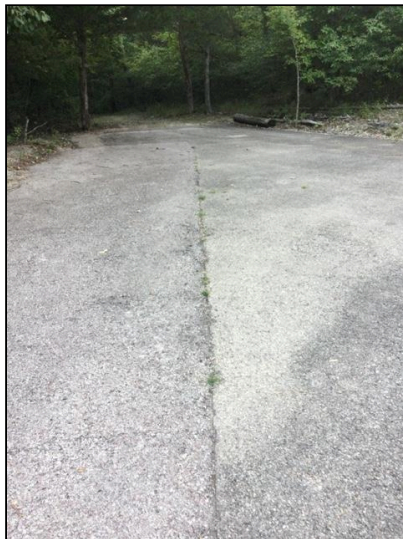
(1) **The driveway was in need of repairs.** *Cracks should be sealed to prevent subsequent cracking or damage. The surface was weathered and should be sealed to prolong its service life. I recommend sealing the cracks and the surface with appropriate sealer. Sealing the surfaces as needed is recommended to prolong the life of the surfaces.*

1.5 Instance of crack, weathered surface

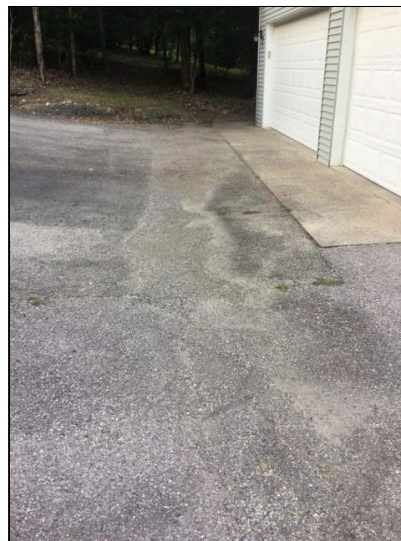
(2) **The driveway had indications of poor drainage.** *Ice or slick spots may be present in cold weather. Potential fall/slip hazard. If not corrected, drainage accumulation may lead to foundation problems, moisture intrusion, erosion, settlement or aggravate existing problems. I recommend improvements to the surface or area to promote drainage.*

1.5 Drainage in need of improvement

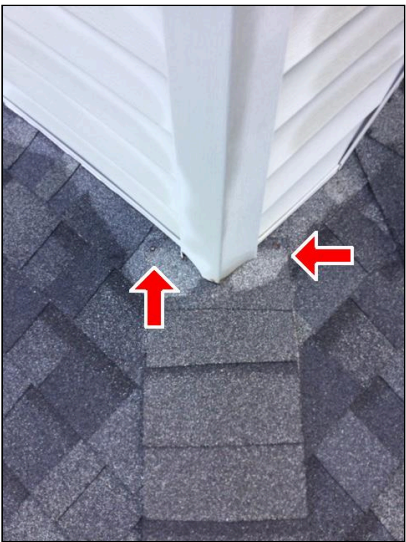
2.1 Instance of exposed nail

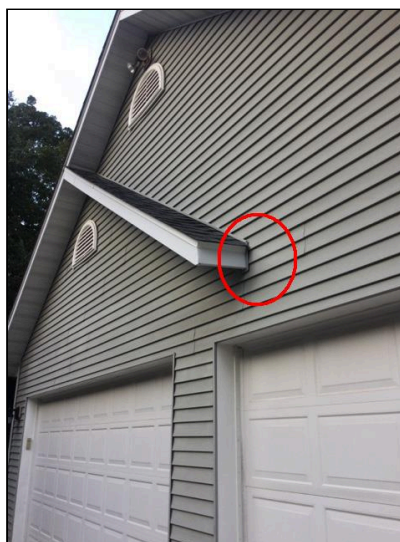
**Flashings where roof lines meet side walls may be ineffective or not present.** Properly installed kickout flashings where roof edges meet side walls prevent roof runoff from draining behind the siding surfaces into concealed framing. A kickout flashing also directs runoff into the guttering for effective drainage. **I recommend a qualified roofer evaluate all locations and make improvements for reliable drainage away from the structure.**

2.2 Instance of inadequate flashings

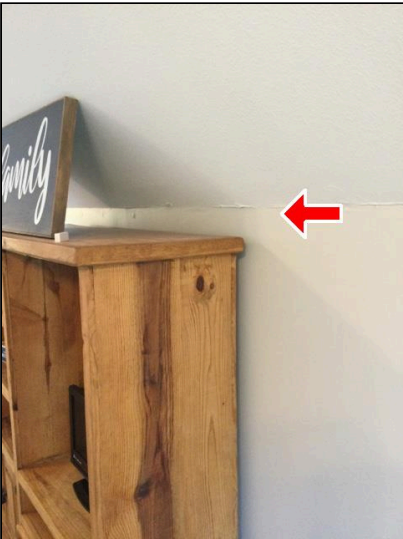
3.2 Instance of nail pops - upper loft

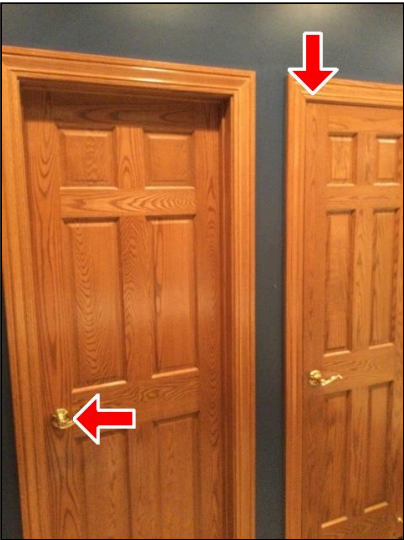
3.8 Instance of maintenance/ adjustments needed - master bath (closet door did not latch, linen door rubbed jam)

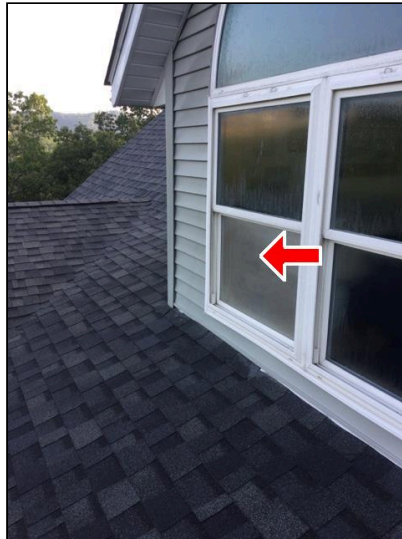
3.9 Instance of moisture/cloudy panes

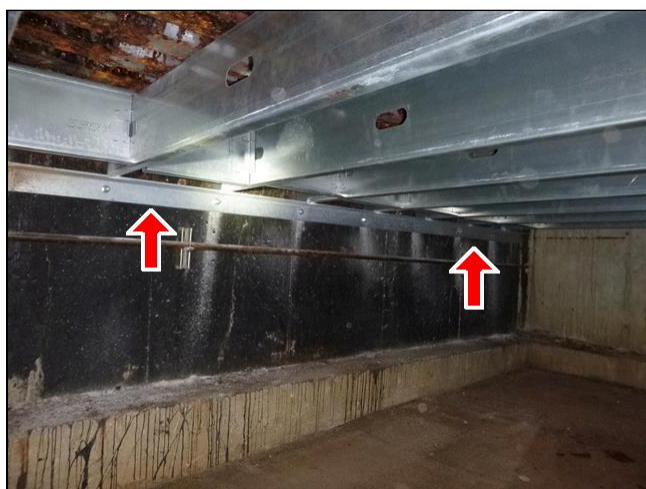
4.6 Metal structure installation

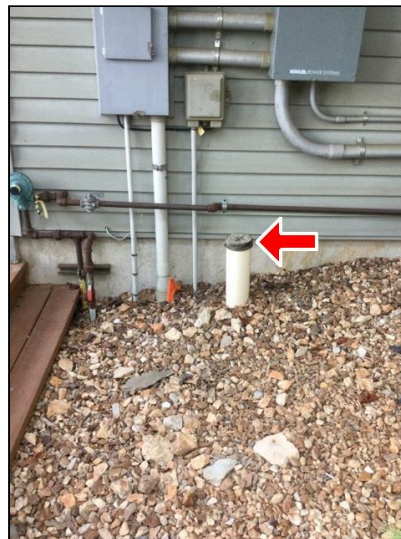
(2) **There were openings at the drain and waste plumbing that lacked a cap or had an inadequate cap.** *This allows smelly sewer gases to escape, enter the equipment or the structure. Potential health hazard.* This is also a potential source of leakage. I recommend capping or terminating all open plumbing in accordance with present standards.

5.4 Cap with holes in it

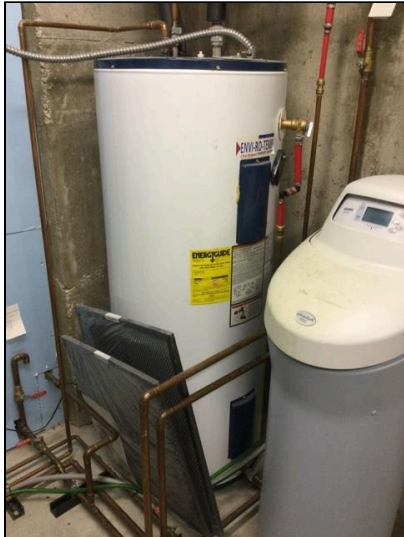
The water heating equipment was older or near the end of its typical life expectancy. The system was in operation at the time of the inspection. **Rust streaks, stains, or indications of prior leakage was present near and/or around the water heating equipment.** The source of rust stains and/or streaks may be from a prior failed water heater installation or prior leakage from plumbing components not related to the water heater. Leakage was not observed at this time. No immediate concern. I recommend inquiring with the seller/occupant for more information. No immediate concern at this time. I recommend monitoring for defects or leakage at this time.

5.7 Unit

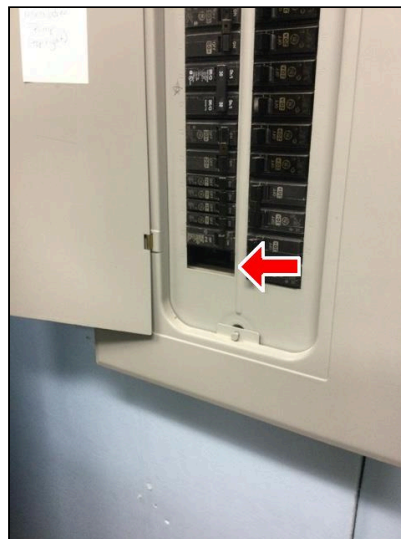
**(2) Openings were observed at the equipment.** *Uncovered openings at the equipment allow the opportunity for individuals to come in contact with energized components, leading to electrical shock. The potential for pests or debris to enter is a potential fire a hazard. Proper sized fillers and blunder plugs should be installed as needed.*

*Some screws or fasteners were not installed or were not present -- an inadequately secured cover is susceptible to pest or debris entry. Proper blunt head screws should be installed.*

7.3 Opening

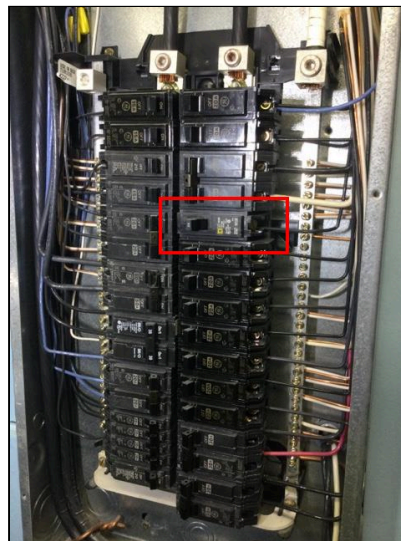
*Further investigation by a qualified electrician is recommend to determine if the installed breakers are specified of classified for use. -- Breakers not specified of classified for use are susceptible to reliability issues, arcing, overheating, or damage.*

7.4 SQUARE D breaker in GE panel

*Potential fire hazard. -- Specified breakers are typically listed on the panelboard label. -- **I recommend further review by a qualified electrician.***

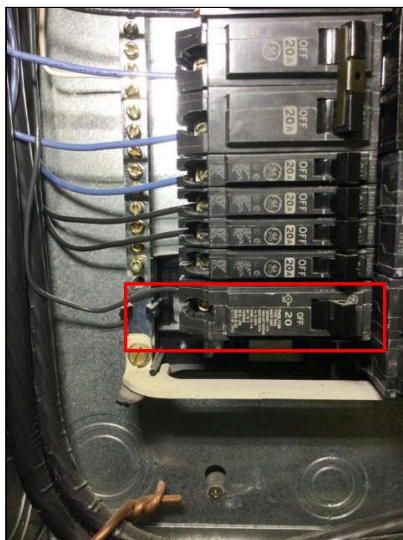
7.4 Over amp breaker

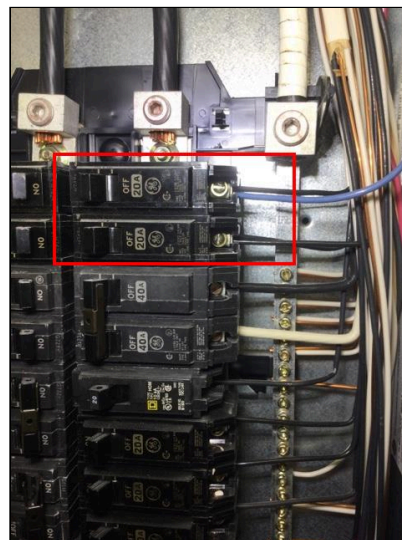
(2) **Improper terminations were present.** Two or more wires were terminated at a screw - *Positive connection at the termination is not assured for multiple wires.* The potential for arcing between the wires at the termination increase, which could lead to a fire. *Notes: Double tapped neutrals. Double tapped breakers. **I recommend a qualified electrician evaluate and reconfigure the wiring.***

7.4 Double tapped breaker

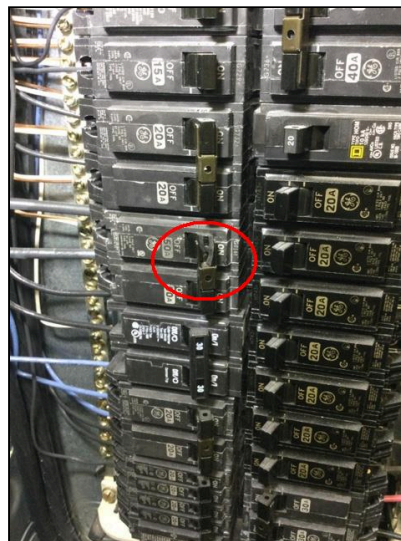
(3) **Damaged breakers observed in the equipment.**

The damage may be isolated to the exterior casing however, may be indications of concealed damage. A determination of reliability or proper function cannot be made. Potential safety or fire hazard. I recommend further review or opinions from a qualified licensed electrician and repair or replacement as necessary.

7.4 Damaged trip handle

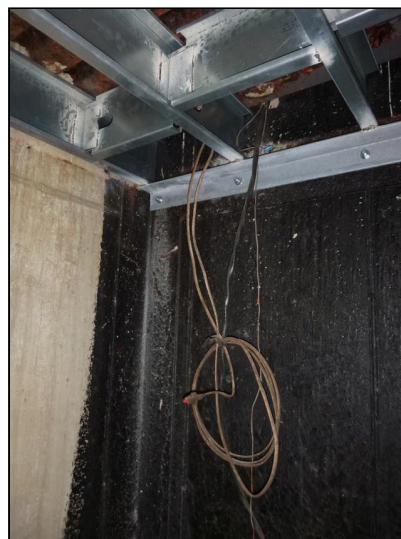
**Sub-standard or non-typical circuitry was present at the structure.** -- Circuitry installations that lack safety details or that do not conform to best practices is potentially dangerous. -- Improper terminations, unsecured circuitry, lack of bushings or connectors, exposed conductors, damage, or other deficiencies should be repaired.

7.5 Instance of sub-standard install - under patio room (exposed wires)

**I recommend a qualified licensed electrician evaluate all areas of sub-standard or non-typical circuitry and repair in accordance with present standards.**

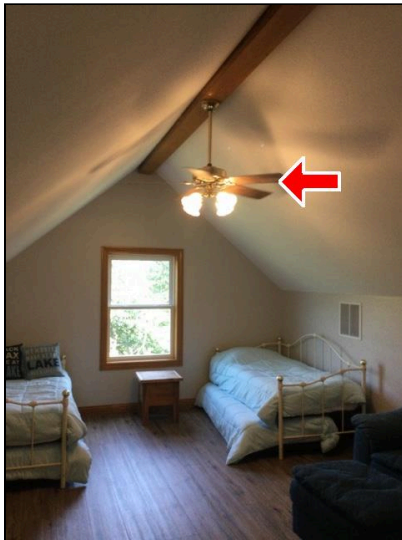
(2) **Some of the ceiling fans were excessively noisy at a low speed.** Further diagnosis or repair needed. I recommend repair or replacement.

7.6 Instance of noisy fan - upper level

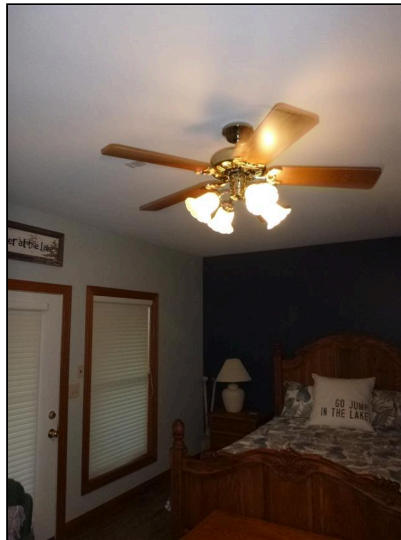
7.6 Instance of noisy fan - master bedroom

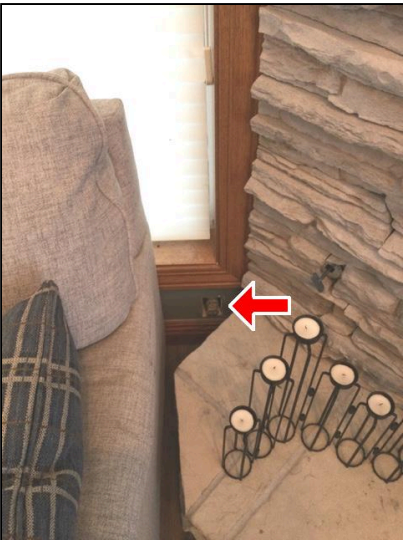
(1) **One or more outlets were in need of repairs.** Outlets should be tight to the surface and a face plate should cover the circuitry completely to prevent electrical shock. I recommend repairing loose outlets as needed and installing covers where needed.

7.7 Instance of cover not installed - living room

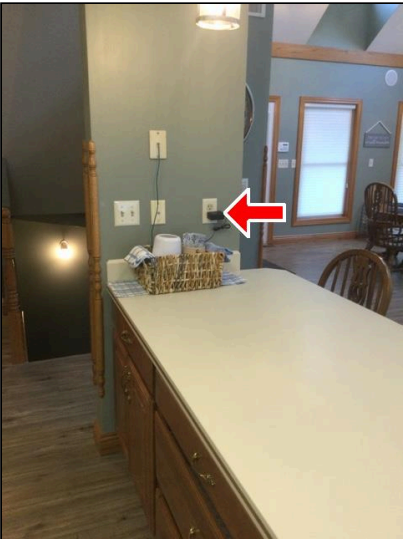
(1) **Some outlets were lacking GFCI protection.** GFCI protection prevents deadly shock around sources of water. *GFCI protection is recommended at all kitchen countertop surfaces, all exterior locations, laundry area, unfinished basement, and near sources of water (within 6 feet).* ***I recommend upgrading to current standards.***

7.8 Instance of outlet lacking GFCI protection - kitchen

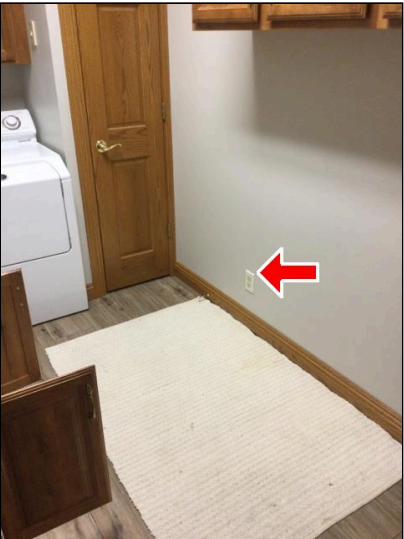
7.8 Instance of outlet lacking GFCI protection - laundry

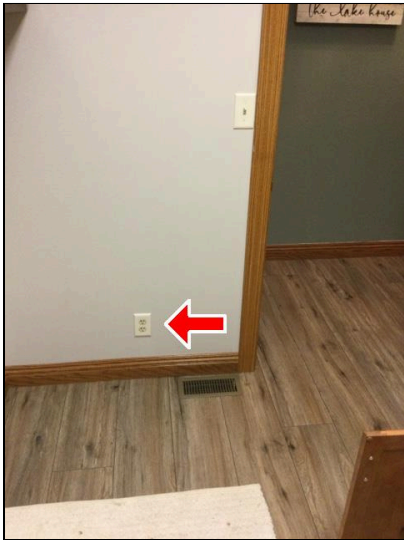
7.8 Instance of outlet lacking GFCI protection - laundry

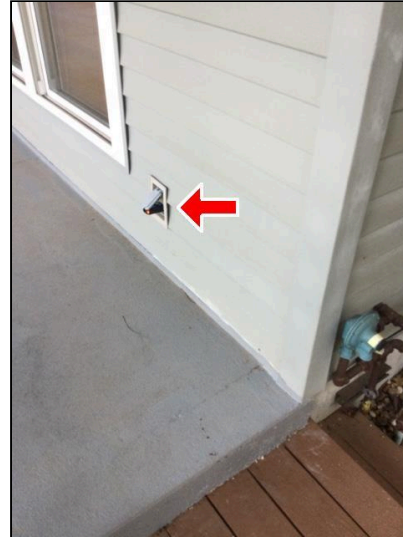
**(2) GFCI breaker(s) were present in electrical equipment.** *The test button was pushed and the breakers did not trip. The circuitry that provides the GFCI protection within the breaker(s) can fail with time. The breaker will still supply power to the circuit however, provides a false sense of safety. I **recommend a qualified electrician evaluate and replace all defective GFCI breakers.***

7.8 GFCI did not trip - lower rear exterior

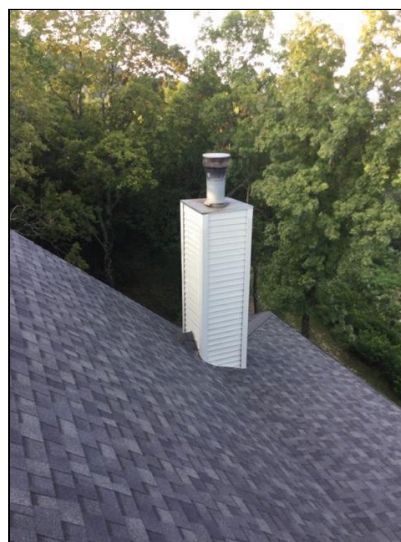
**Indications of ponding at the chimney cap flashings, or significant rust was present.**

The cap flashing should be pitched to shed water to the sides of the chimney, not towards the center where the flue penetrates the flashing. *Without correcting, long term, severe deterioration or rust may occur which could lead to moisture intrusion into concealed areas.* I recommend repairs or improvements to the flashings to promote drainage and/or prime and seal as necessary.

9.1 Cap flashing inadequately pitched to shed drainage
