# Inspection Report

418 Elizabeth Ave  
Palmyra MO 63461

**Integrity Home Inspection**

<b>Date:</b> 8/21/2025	<b>Time:</b>	<b>Report ID:</b> 2025/8/21pm
<b>Property:</b> 418 Elizabeth Ave Palmyra MO 63461	<b>Customer:</b> Mark & Jim Woodall	<b>Real Estate Professional:</b> Jason Chinn Trophy Properties and Auction

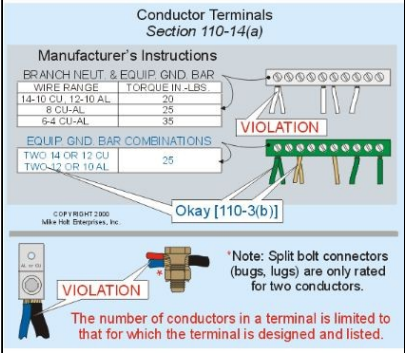
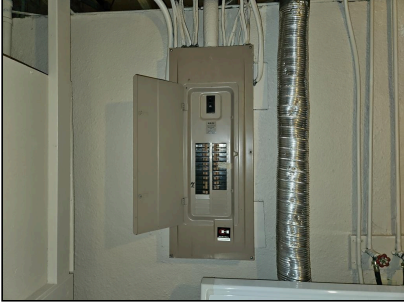
double tap ill.

VIOLATION

The number of conductors in a terminal is limited to that for which the terminal is designed and listed.

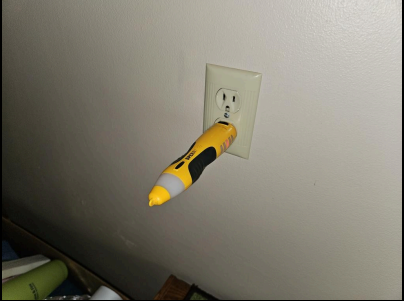
Living room

grounded outlet
