PAUL BENDYK & ASSOCIATES LLC

Inspection Report

July 14, 2025

Site Address:
20305 Highway M
Curryville, MO.63339

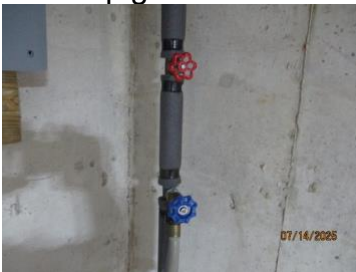
Blue Main Water Valve

The main water line is an inch PVC Schedule 40 plastic line routed through the front foundation wall. We tested this valve and found to be in working order. We did note some rust at the union, not active leakage was noted but eventual replacement will be needed. The remaining water lines are copper and were found to have been professionally installed, these were also tested and found to be in good working order. We also tested a number of shut-off valves and also found them to be in good working order tested except as noted at the exterior water spigots.

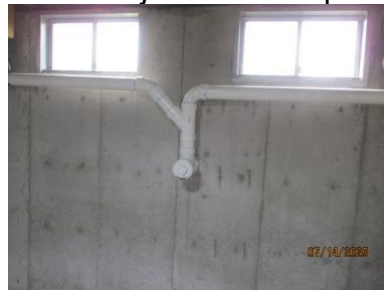
Main Stack(s) Exit

The waste lines consist of PVC Schedule 40 plastic lines and p-traps the man stacks due contain clean-outs and directed out the west wall of the foundation. We tested all fixtures and found all to have been professionally installed although a leak was noted at the second-floor bath and is need of attention. We noted all sink stoppers in the are in need of adjustment to open fully.

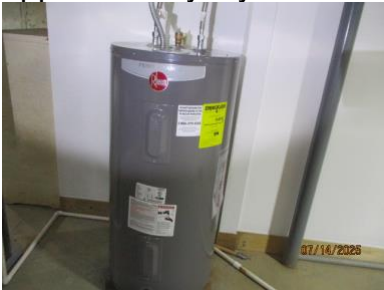
Water Heater

A an updated, single, 50-gallon, Rheem brand, electric water heater is located in the basement adjacent to the furnace. This system was not tested. The system did contain, the correct size and rated TPR valve with drain line, a water shut-off valve and a pressure tank and all were found to have been professionally installed. The unit was tested and did respond as needed. The unit is approximately 2 years old.

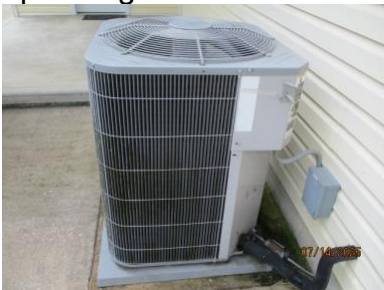
Condensing Unit

The updated air conditioner is a Carrier brand system rated approximately 3 tons of cooling capacity. The condensing unit is located at the north elevation of the home and was found to have been professionally installed. Freon lines and the electrical components were found to be in good working order. Reinsulating the Freon line is recommended. The system was tested and an acceptable temperature drop was noted between the supply and return lines. Temperature drop was minimal from the first floor to the second floor which is impressive. The system appears to be approximately original to the home but was found to be in operating condition and very well maintained.

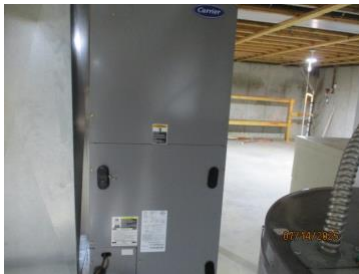
Furnace

Heating for the home is also a Lennox brand, single, forced air gas fired system. The system is located in the basement and rated at approximately 20 KW input capacity this system is rated all areas of the home, the basement if finished will need approved duct system. We removed the front cover and noted where visible the electrical components appeared to be in good working order. We did note a large amount of black material and recommend the system be serviced and the duct work cleaned. The insulation on the access panel was loose therefore not reinstalled. Electrical components and drain lines were without concerns and professionally installed. The system was tested and did respond to the demands of the thermostat located in the hall.

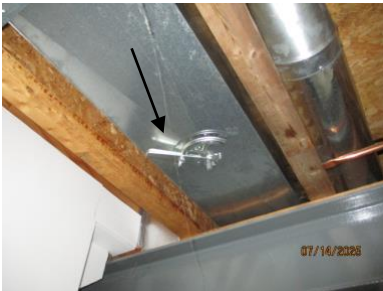
Damper

The galvanized steel ductwork system was found to have been professionally installed with an adequate amount of supply and return vents; a damper was installed at the main trunk line to adjust the air flow. No HVAC is provided at the second floor bath.

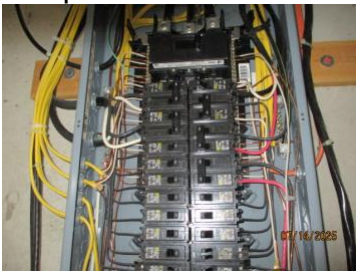
Exposed Main Panel

The home is supplied by a 200-ampere main circuit breaker style located in the basement on the north wall. A main disconnect was installed in panel. The main over-head service and meter are also located at the north elevation was found to have been professionally installed with no concerns noted. We removed the cover of the panel and noted all circuits were thong pronged grounded copper with the main feed being aluminum which is a common practice. This Square D brand panel contained; 31 total circuits, 7-220 ampere and 3 slim line breakers which hold 2 circuits. Expansion is only available with the use of sub-panel. We tested the majority of light fixtures and outlets in the home and noted all to have been professionally installed with no concerns noted, we do recommend GFCI outlets be installed in the garage. Exterior dusk to dawn and motion detectors lights were not tested. See report on sump pump wiring. Electrical components for the out-buildings will be addressed latter in this report.

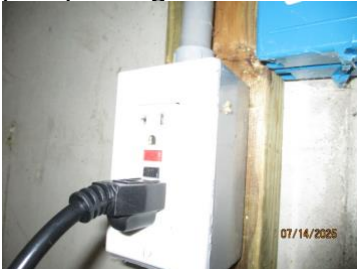
The 4x12 inch engineered joist 5x8 inch steel beam with four-inch supporting post were found to be in sound condition with no concerns noted. The OSB plywood decking has been glued and nailed and found also to be in good condition with no structural concerns noted. Fire-flashing has not been installed at the at the plumbing runs and we recommend it be installed. The poured concrete walls were found to be in sound condition with a minimal of shrinkage cracks which are common with poured concrete. No indication of settlement or active water leakage was noted. It had rained the previous day. A professionally sump pump with an exterior drain has been installed at the north the west floor area. Two pumps are installed one in use with the circuits of the home and one for use with a generator. You will note the outlet for the system is a GFCI protected outlet and if tripped during a storm the pump will not operate. The pump using the home's circuit was test and found to be in working order.

GFCI Outlet At Pump

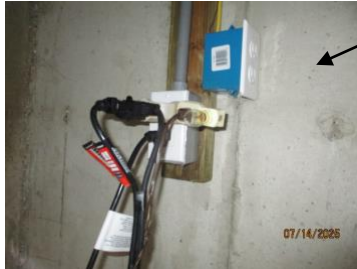
Reinstalled Sumps Electrical
Generated Outlet Identified

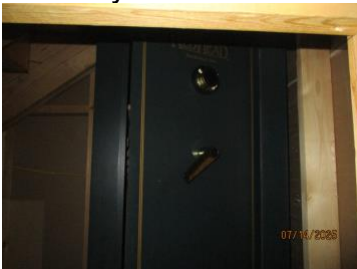
Gun Safe

A gun safe is located under the stair case, the area is enclosed in drywall. Assure you obtain the combination.

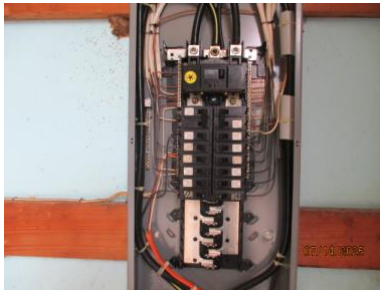
Exposed Panel

The first metal constructed building is supplied by a 200-ampere main circuit breaker style located on the east wall. A main disconnect was installed in panel. The main over-head service and meter are also located at the north elevation was found to have been professionally installed with no concerns noted. We removed the cover of the panel and noted all circuits were throng pronged grounded copper with the main feed being aluminum which is a common practice. This Square D brand panel contained; 16 total circuits, 2-220 ampere circuits that were not in use 12 additional 110 ampere circuits. Expansion is available. We tested the majority of light fixtures and outlets and noted all to be in working order and GFCI protected. We did note a circuit on the front wall that was serviced by and extension cord, missing and a Romex connector at the metal junction box and the use of extension cords at the light fixtures.

Replace extension cords with permanent wiring in both buildings.
Install a Romex connector at the metal junction box. Pg.14

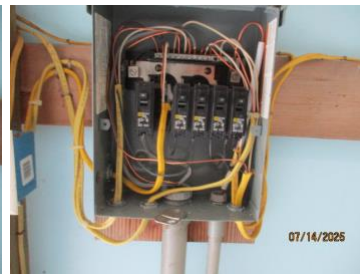
Exposed Panel

The second metal building contain a 100 ampere Square D brand sub-panel. The main disconnect is at the first building. The system contains, 5-110 circuit breakers. We tested the majority of light fixtures and outlets and noted all to be in working order we do recommend GFCI outlets be installed.
