Home Inspection Report

2187 Quaethem Drive
Wildwood, MO 63005

Date of Inspection: 07/27/2021

Inspection No. 551034-5952

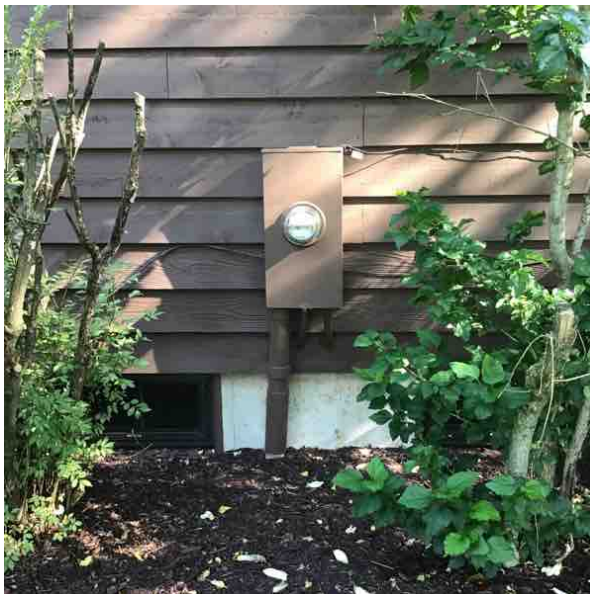
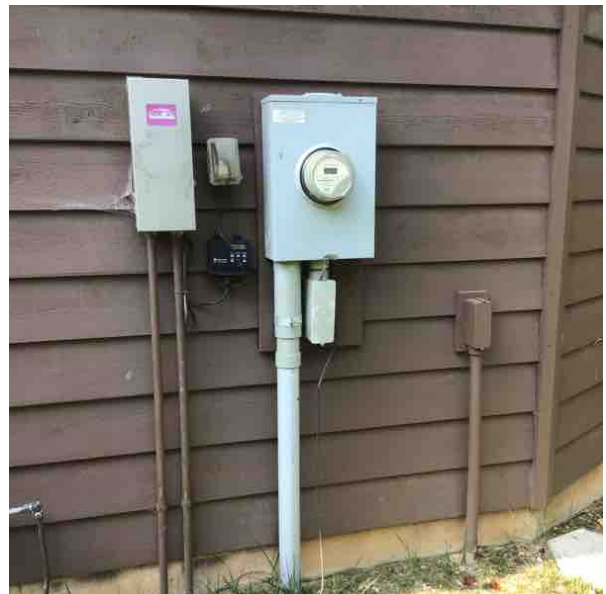
8.3.2 The electric meter and service entrance located: right side, pool house

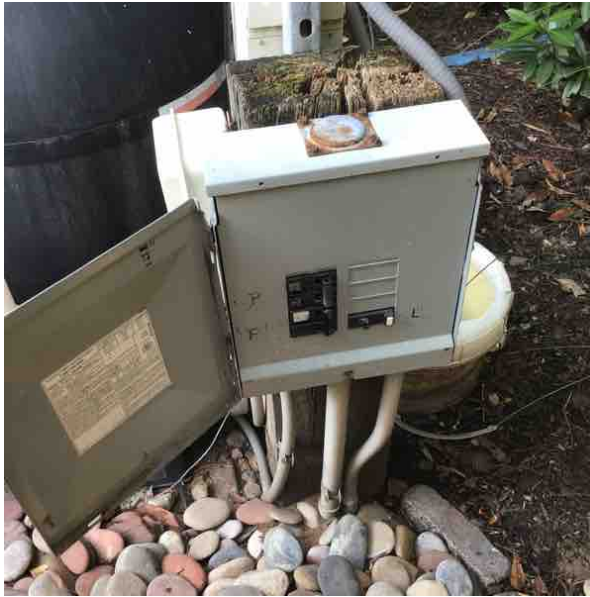
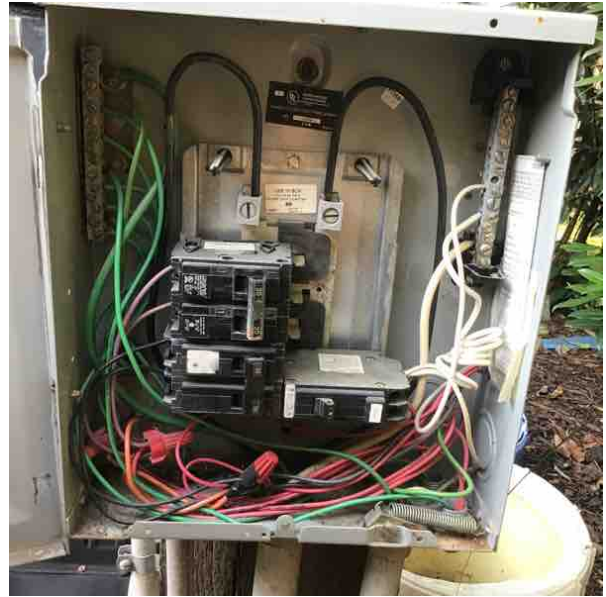
8.7.4 Sub-Panel location: pool equipment

Sub-Panel service size: 60 amp

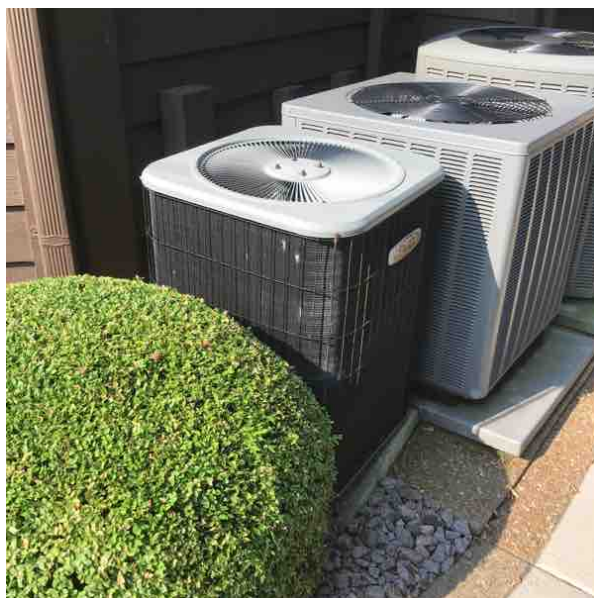
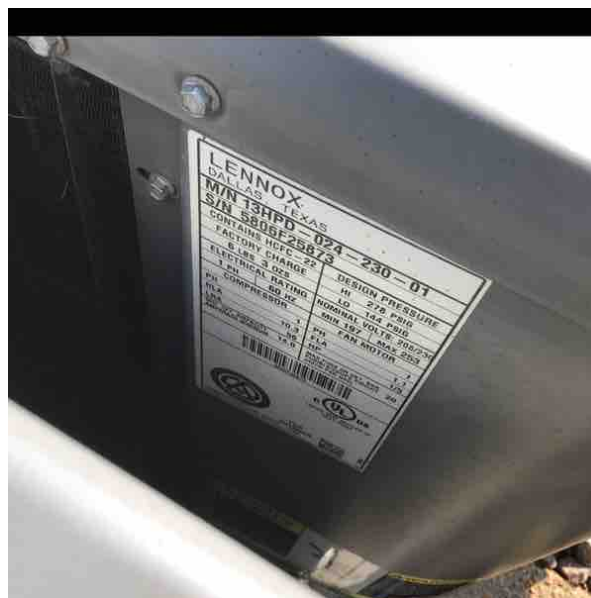
Split AC system(s) identified was/were operational at the time of inspection. The temperature split was 17-20° at the time, which is within normal limits. Have the system serviced annually prior to each cooling season.

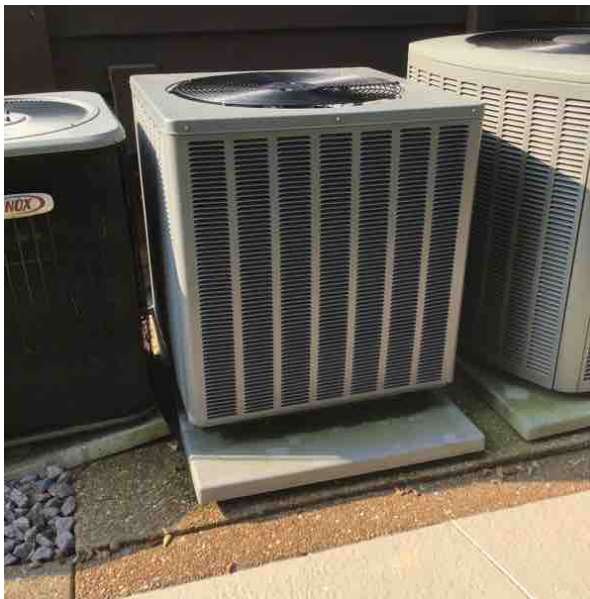
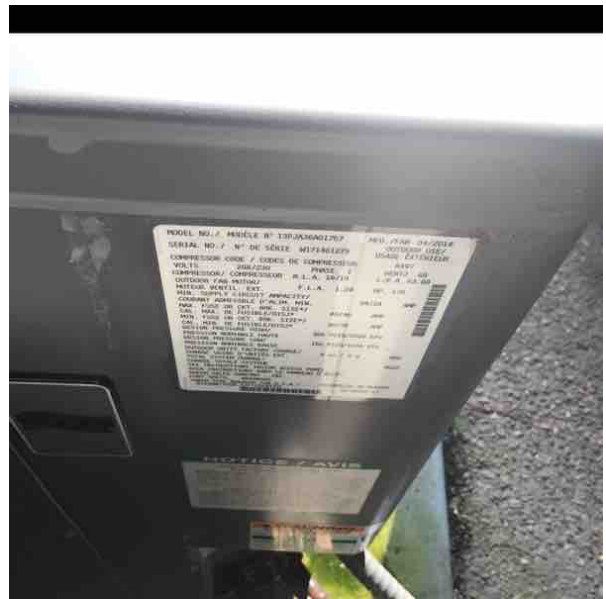
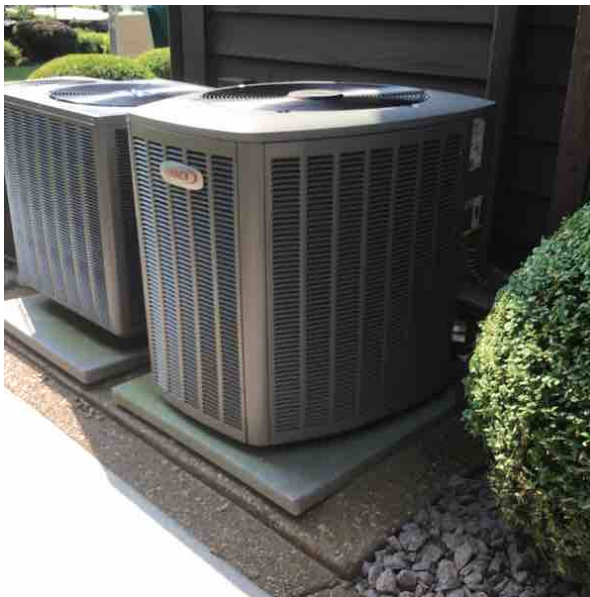
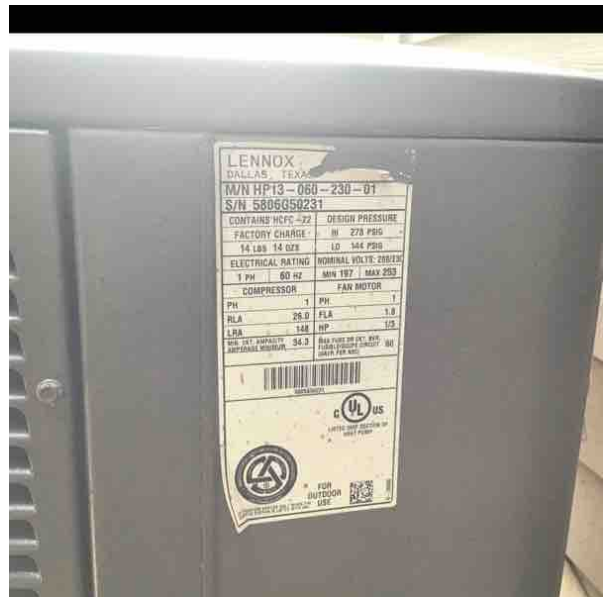
9.5.3 Model- 2012

Split AC system(s) identified was/were operational at the time of inspection. The temperature split was 18° at the time, which is within normal limits. Have the system serviced annually prior to each cooling season.

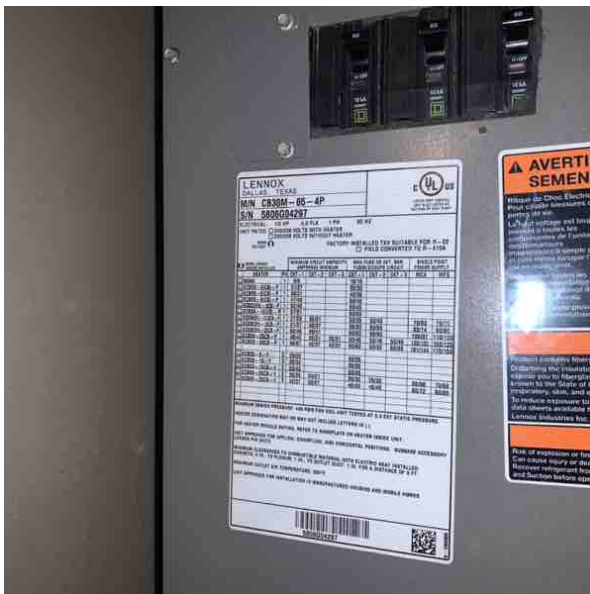
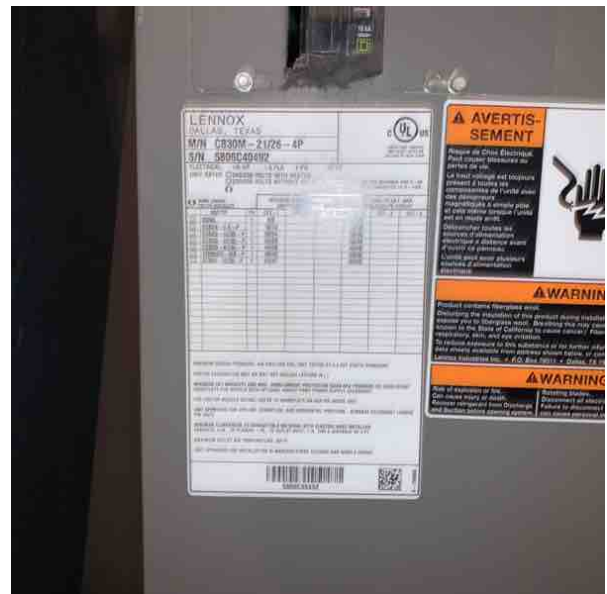
9.6.2 Model- 2006 x2

9.5.4 The 2006 air conditioner(s) has exceeded its typical life expectancy. You may want to consider getting a home protection plan and/or budget for the eventual replacement.

Forced air furnace(s) identified and was operational at the time of inspection. Have the system(s) serviced annually prior to each heating season.

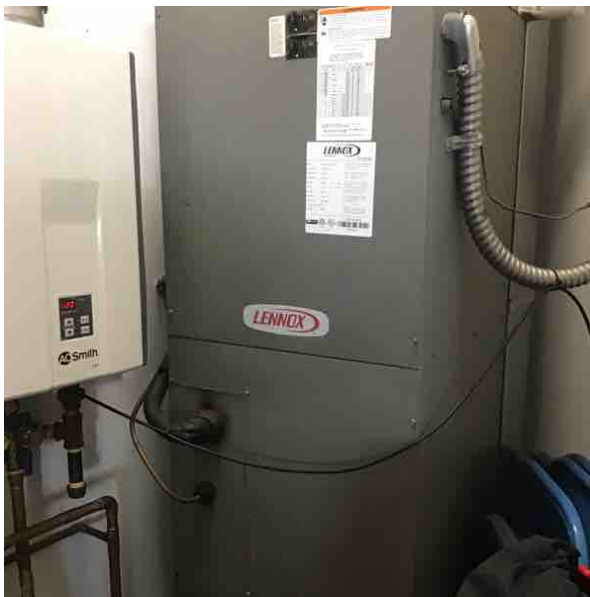
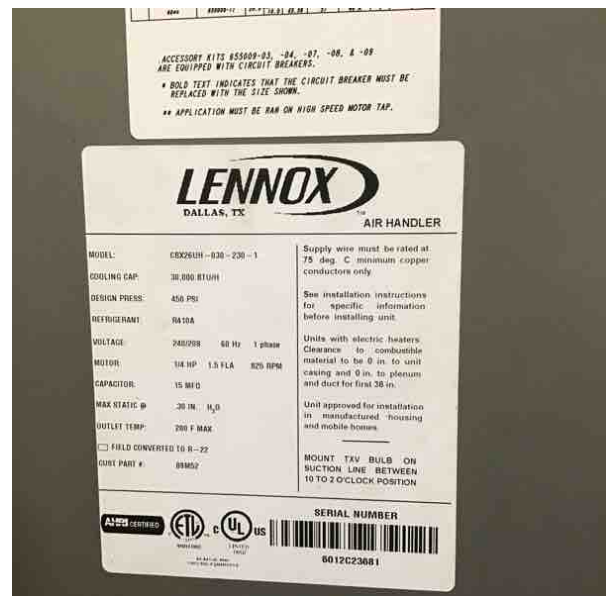
9.6.5 Model- 2012

Forced air furnace(s) identified and was operational at the time of inspection. Have the system(s) serviced annually prior to each heating season.

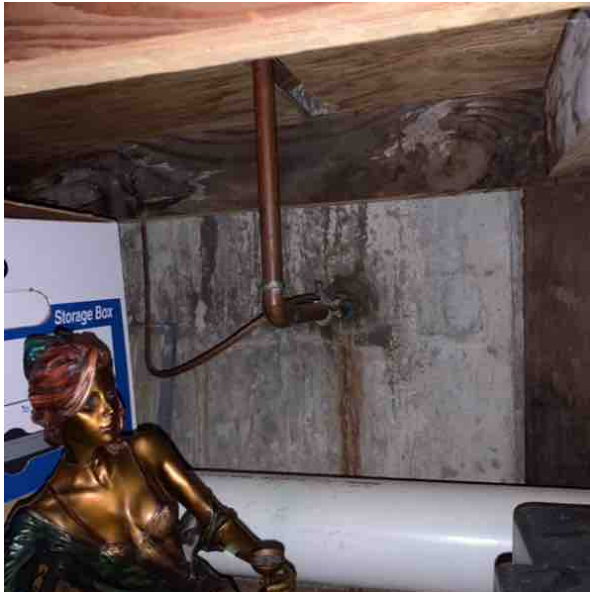
10.3.2 Main water shutoff is located: basement wall.

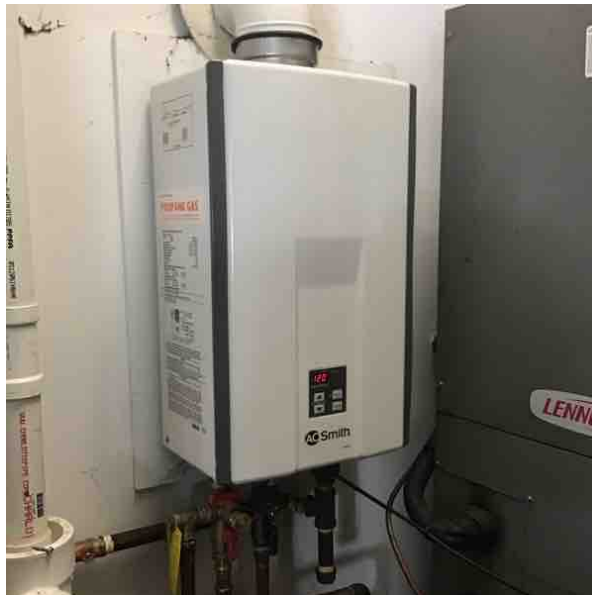
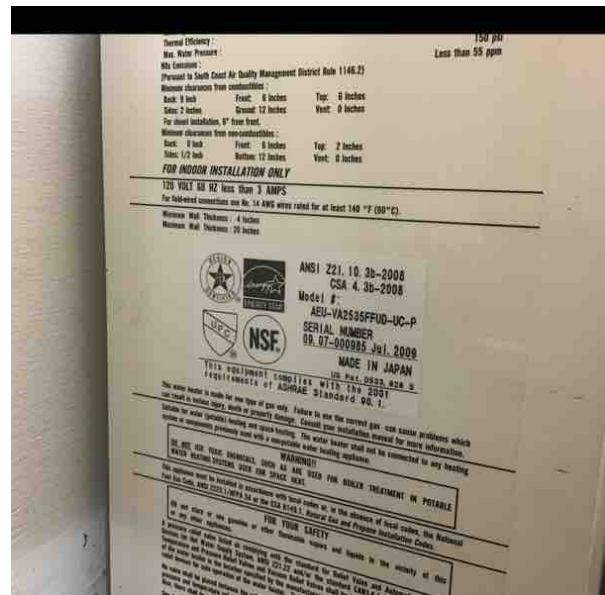
Water heater identified and is operational.

10.6.4 The tankless water heater is leaking. Have this repaired to prevent water damage. (Garage)

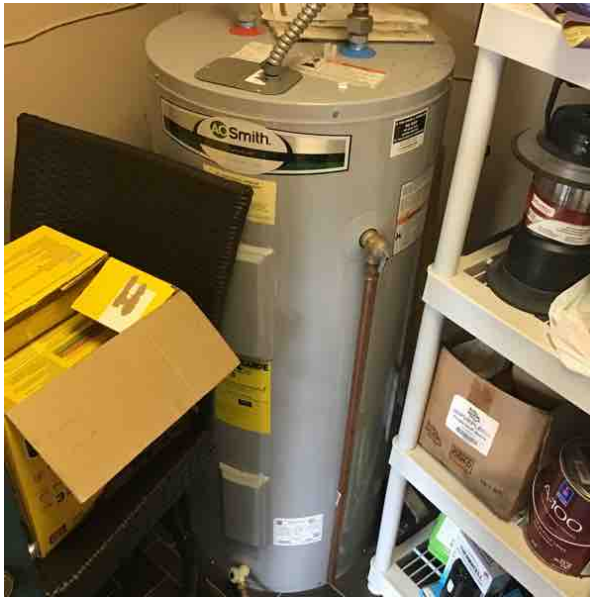
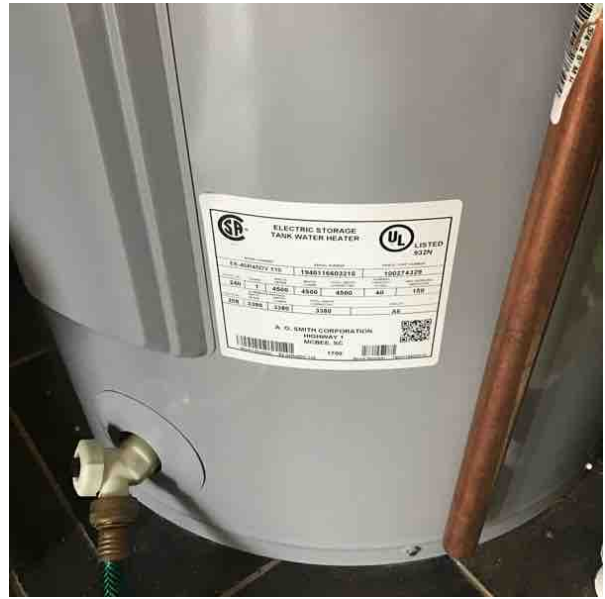
Water Heater size: 80 gallons x2, 40 gallons

Water heater identified and is operational.

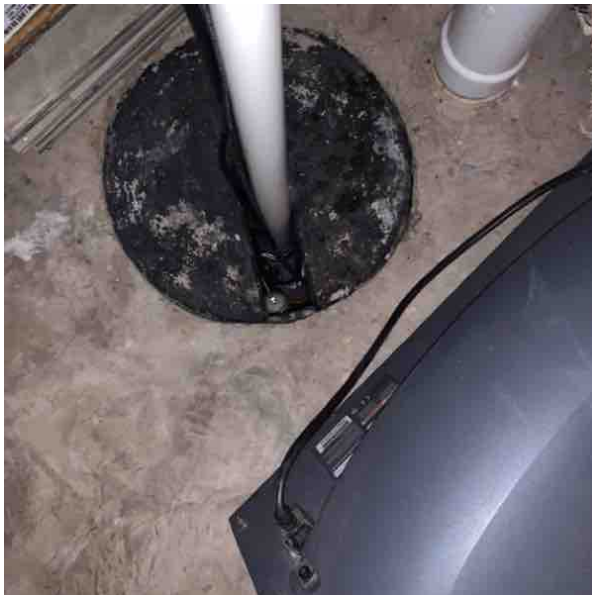
10.11.2 A sump pit was identified. Pit was dry and pump was operational at the time of the inspection. Monitor / test monthly.
