# Your Inspection Report

105 northview drive  
Rhineland, MO 65069

RE: Report No. 3588  
105 northview drive  
Rhineland, MO  
65069

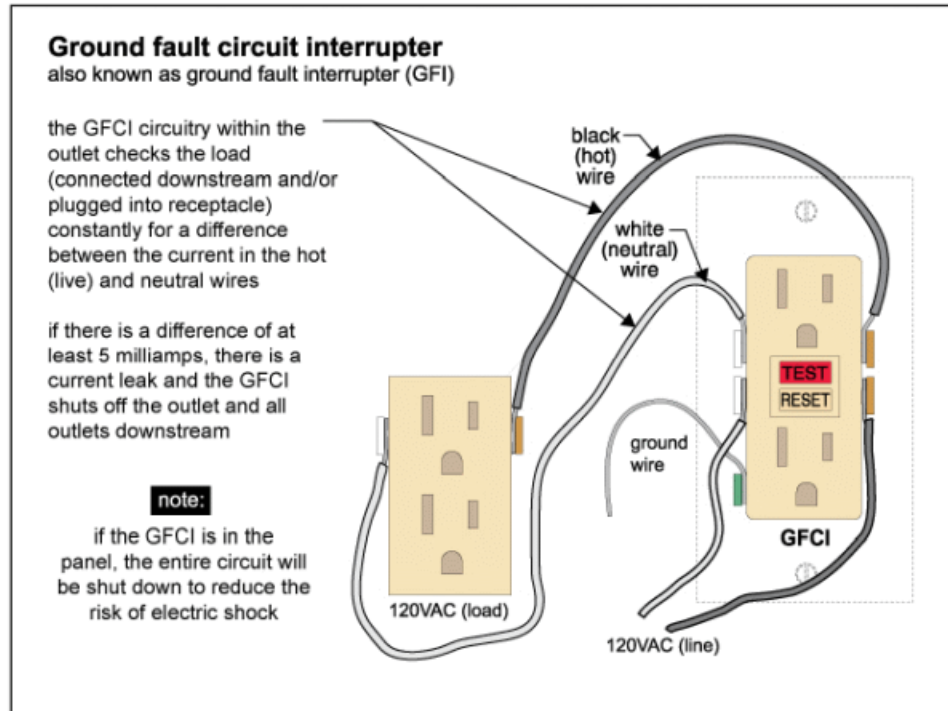
24. GFCI/GFI needed (Ground Fault Circuit In

**Location:** Basement

**Task:** Repair
