MY HOME INSPECTOR PRO

MHIP DEFAULT RESIDENTIAL REPORT

67 N Dade 237
Walnut Grove, MO 65770

Waylon Martin
09/27/2024

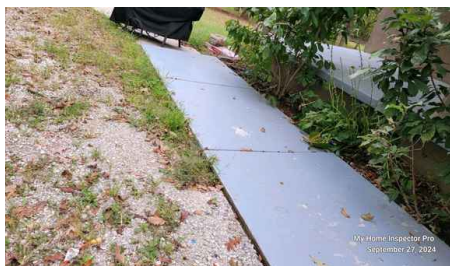
Driveway and Walkway Condition: Typical Settlement / Shrinkage Cracks

Settlement / shrinkage cracks were present on the concrete surface (<1/4 inch wide). These can typically be from standard settlement, from admixtures or the composition of the concrete, or weather conditions when the concrete was poured. I recommend sealing these cracks at a minimum, to prevent further damage from freezing water in winter months.

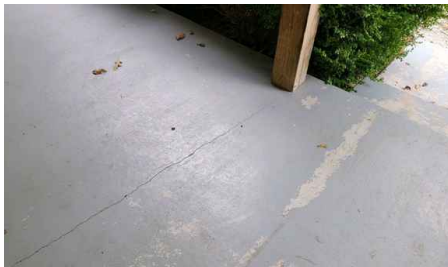
Porch(es): Typical Settlement / Shrinkage Cracks

There was typical settlement / shrinkage cracking (<1/4" width) present on the concrete slab porch. I recommend sealing these cracks with a flexible masonry sealant to prevent further damage from water infiltration and subsequent freezing of the water in winter months.

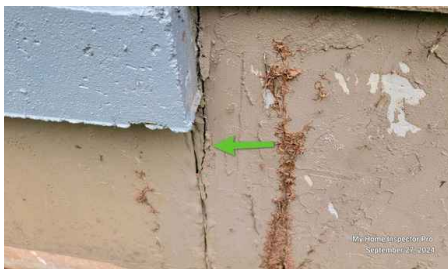
Foundation exterior view: Typical Cracking

Typical cracking was noted at the foundation. This is common as concrete ages and shrinkage surface cracks are normal. Recommend monitoring for more serious shifting/displacement.

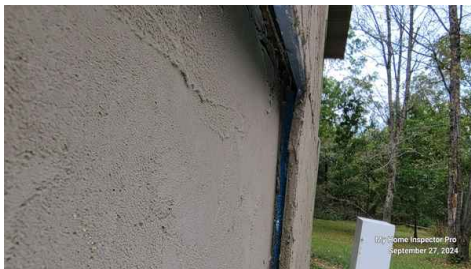
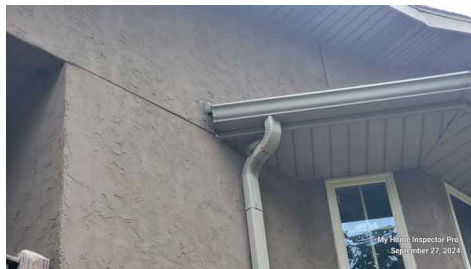
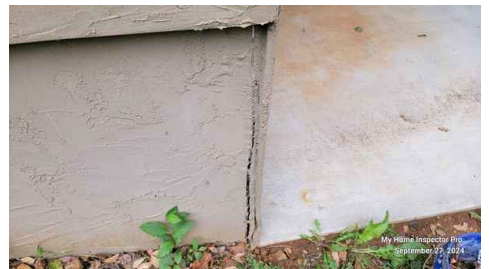
3.1.2 Wall-Covering, Flashing & Trim

CRACKS - MASONRY

Contact a qualified masonry professional.

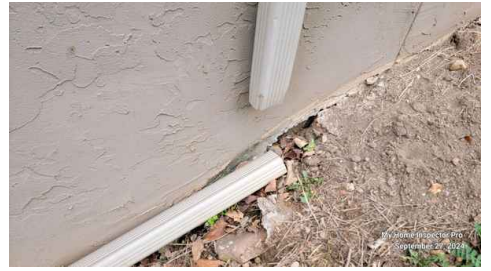
3.1.4 Wall-Covering, Flashing & Trim

STAINING, POSSIBLE MOISTURE ENTRY

Contact a qualified professional.

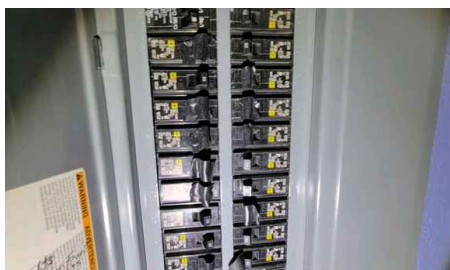
Breakers: Breaker(s) Taped

There were breaker(s) present that were taped. I recommend consulting with the seller(s) as to why this was done.

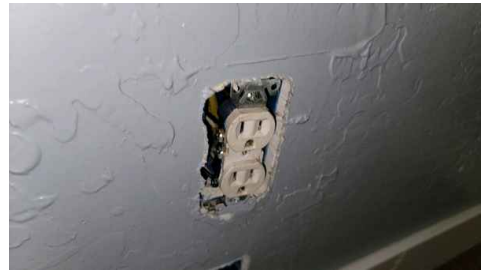
7.2.1 GFCI Protection

GFCI PROTECTION NOT PRESENT/FOUND

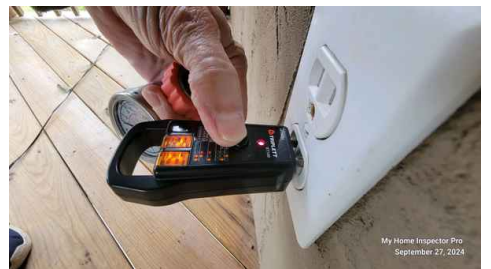
GFCI protection was not present/found at the referenced area(s), at the time of inspection. GFCI protection is recommended to be present for the exterior, garage, basement, laundry area, and crawl space receptacles for safety, as well as kitchen and bathroom receptacles within 6 feet of a sink's edge. Repairs or upgrades as needed to ensure GFCI protection is present at all recommended locations for safety is recommended to be performed by a licensed electrician.

Recommendation

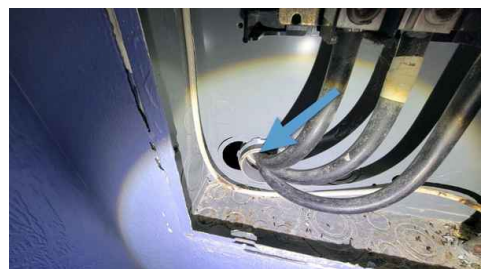
7.6.1 Service Equipment / Electrical Panel

OPEN KNOCKOUTS/BUSHINGS MISSING

Open knockout(s) and/or missing bushings were present in the electrical panel. Knockout caps and/or bushings should be installed to keep mice out of the panel box, and to avoid potential electrocution hazard. The installation of knockout caps or bushings is recommended to be conducted by a licensed electrician or other qualified person.

Recommendation

Contact a qualified electrical contractor.

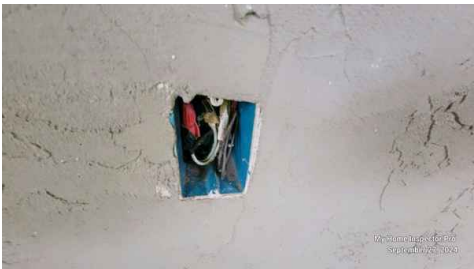
There were exposed wiring present in the listed locations. Recommend evaluation of the noted wiring with corrections as needed by a licensed electrician.

Recommendation

Contact a qualified electrical contractor.

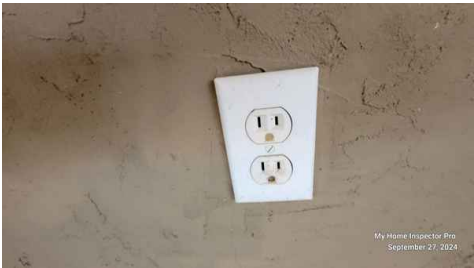
7.9.1 Receptacles

MISSING WEATHERPROOF COVERS

There were exterior receptacle(s) in a wet or damp location that had missing weatherproof covers. The installation of proper covers is recommended to be conducted by a licensed electrician or other qualified person for safety.

Recommendation

Contact a qualified electrical contractor.

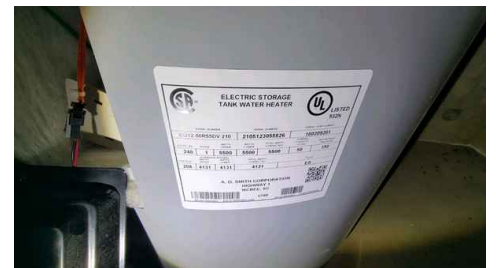
8.1.1 Water Heater Condition

FYI - The unit was at or past its typical service life. Major repairs or replacement should be anticipated in the future due to the age of the unit alone. Depending on prior maintenance and other factors the unit could last anywhere from months to years, the remaining life is undeterminable.

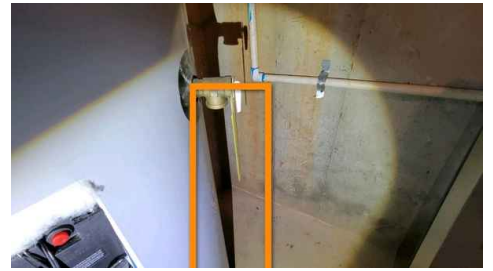
8.3.1 TPRV Discharge Pipe

TPRV DISCHARGE PIPE MISSING

A TPR valve discharge pipe was not present. A copper, CPVC, or Pex pipe with a 3/4 inch I.D. should be connected to the TPR valve and terminate no more than 6 inches from the floor. The installation of this pipe is recommended to be conducted by a licensed plumber or other qualified person.

Recommendation

Contact a qualified plumbing contractor.

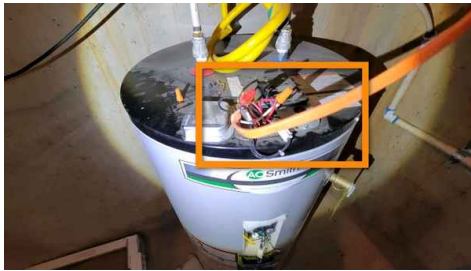
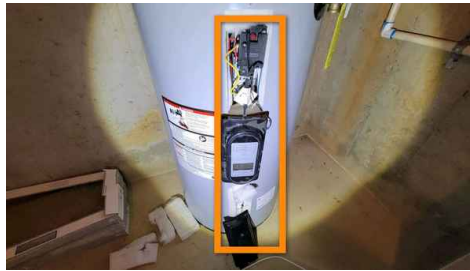
8.5.1 Exposed Electrical Connection

EXPOSED CONNECTION

The water heater Electrical connection is exposed, covers not installed properly or missing strain relief connector. Recommend installation of the provided cover/connector for safety reasons.

Recommendation

Contact a qualified professional.

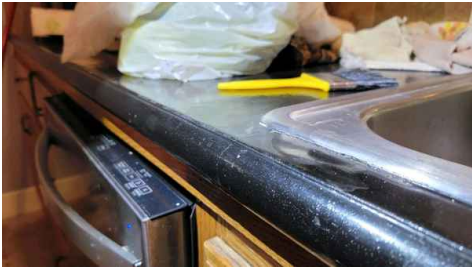
The countertops and/or cabinets are in need of a refinishing or replacement.

Recommendation

Contact a qualified professional.

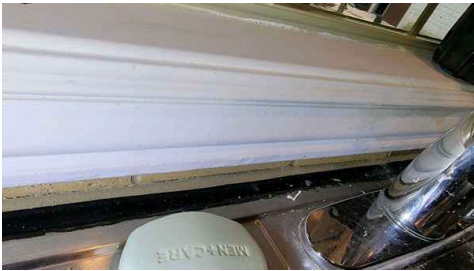
10.8.2 Countertops & Cabinets

POOR/MISSING CAULK

Countertop was missing sufficient caulk/sealant at the wall. This can lead to water damage. Recommend adding sealant at sides and corners where counters touch walls.

Recommendation

Recommended DIY Project

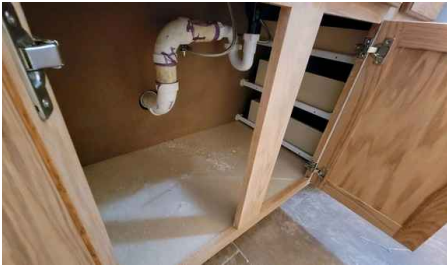
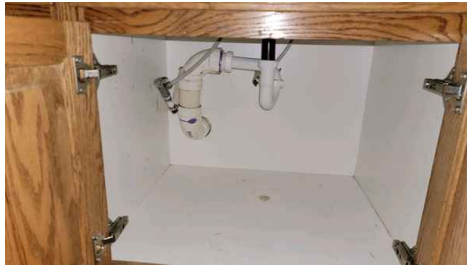
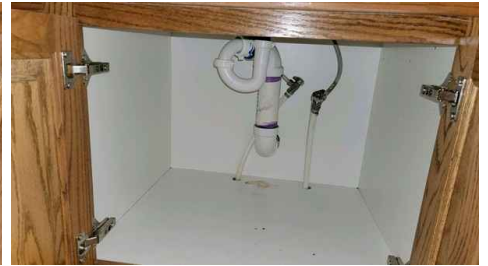
**Plumbing Components: Previous Leak Under Vanity Noted**

There is evidence of a previous leak from the drain piping. No leak was detected at time of inspection.

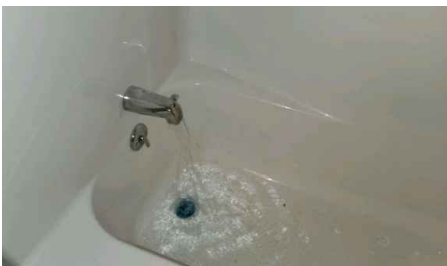
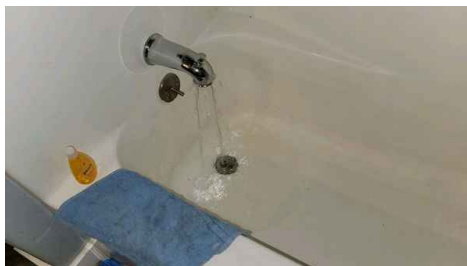
Fixtures Installed: Bath Tub Status

Functional Flow, Slow to Drain, Functional Drainage

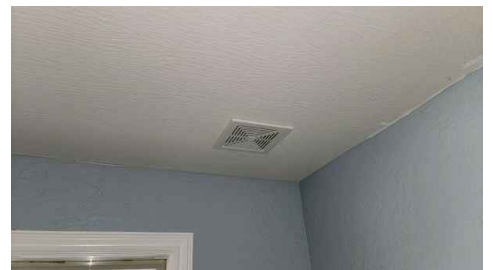
11.3.1 Ventilation

Bathroom ventilation fan is noisy, possible motor failure shortly I recommend a qualified contractor to repair or replace as needed.

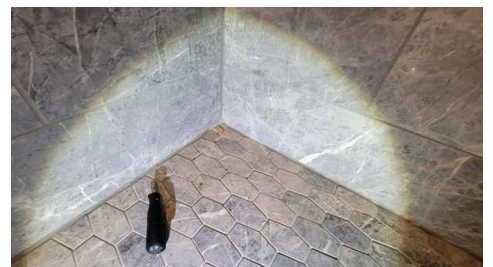
11.5.1 Fixtures Installed

SHOWER/TUB AREA CAULKING AND GROUTING

Caulking/grout in shower/Tub area is in need of maintenance to prevent possible moisture damage, hidden damage may exist. Recommend qualified contractor to repair.

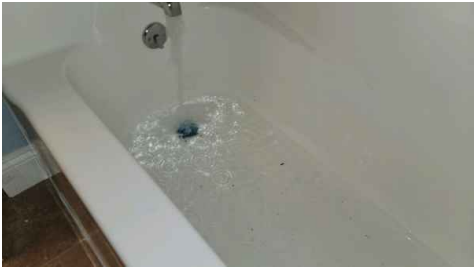
11.5.2 Fixtures Installed

BATHTUB(S) - POOR DRAINAGE

Bathtub(s) had slow/poor drainage. Recommend a qualified plumber repair.

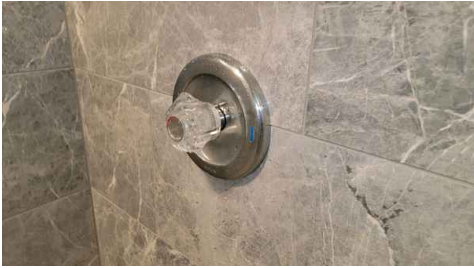
11.5.3 Fixtures Installed

SHOWER HANDLE TURNS 360 DEGREES

The shower handle turns over 360 degrees, while still shutting off and turning on the shower, turning 360 degrees is not typical behavior for a plumbing control. Recommend repair or replacement.

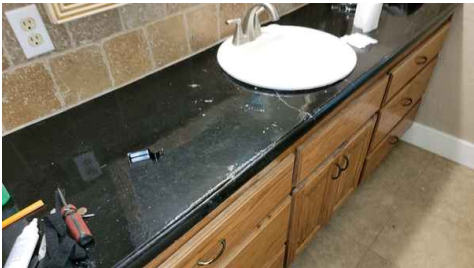
11.7.1 Countertop and Cabinets

VANITY CONDITION

The countertops and/or cabinets are in need of a refinishing or replacement.

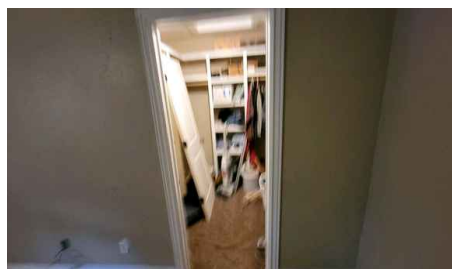
Interior Doors: Some Doors Not Installed

Some doors were not installed. The operation of these doors are excluded from this inspection.

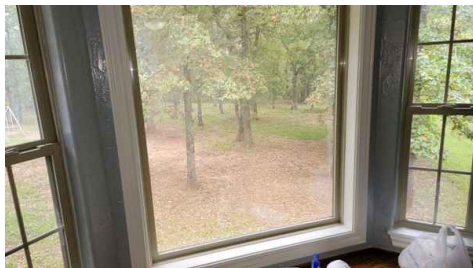
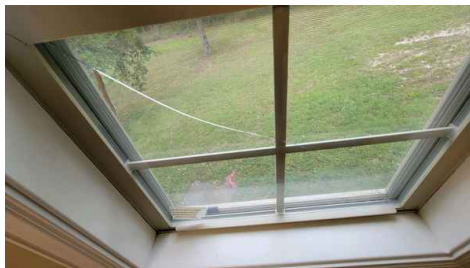
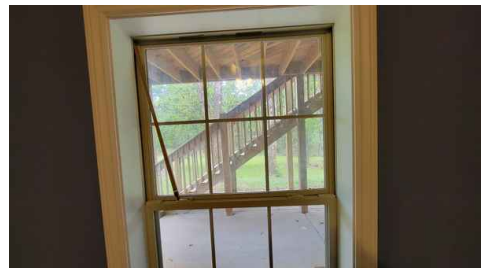
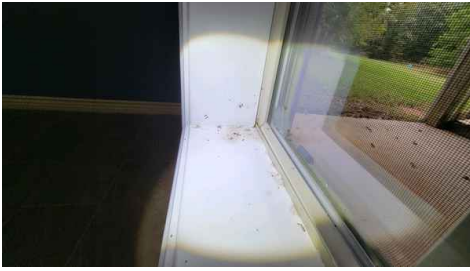
GENERAL - FULL WINDOW EVALUATION RECOMMENDED

Due to multiple deficiencies being present with multiple windows, a full evaluation of the windows in the home is recommended to be conducted by a window contractor with repairs or replacement made as needed for proper operation. The following list should not be construed as a full list of the defects.

i.e. - Seal failure, broken glass, damage, evidence of moisture entry around windows and frames, missing or damaged screens.

Contact a qualified window repair/installation contractor.

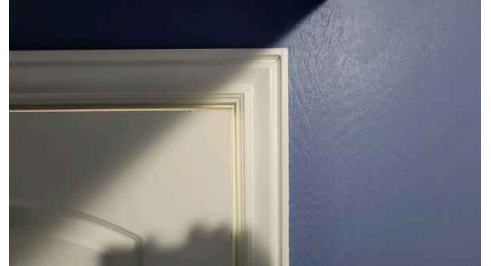
12.5.1 Interior Doors

DOOR OPERATION - BINDING

There were door(s) that were binding / rubbing on an adjacent surface. Adjustments or modifications are recommended to be conducted by a qualified person as needed for proper operation.

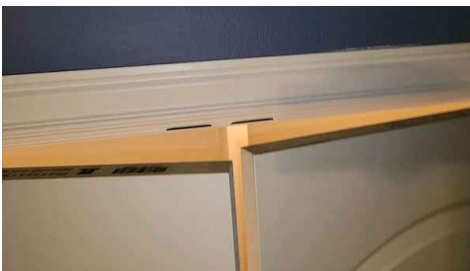
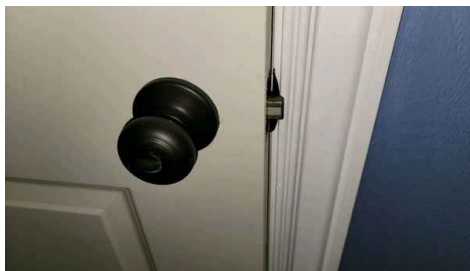
12.5.2 Interior Doors

DOOR OPERATION - NOT LATCHING PROPERLY

Door(s) not latching properly. Adjustments or modifications as needed for proper operation is recommended to be conducted by a qualified person.

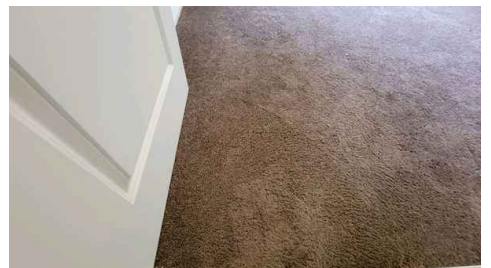
12.5.3 Interior Doors

GENERAL - SLAB RUBBING ON FLOOR

The referenced door slab was rubbing on the floor when operated. Repairs to the door for proper operation is recommended by a qualified person.

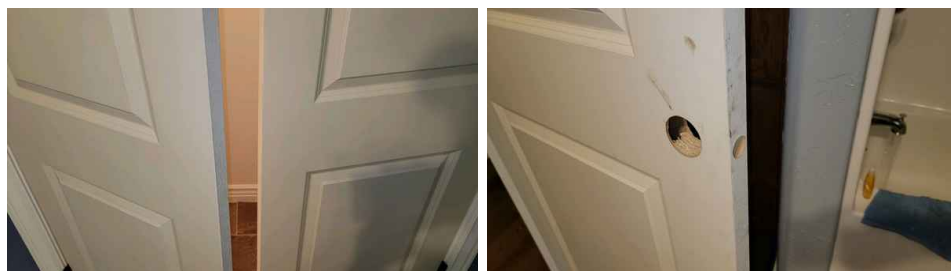
HARDWARE - MISSING

The referenced door(s) were missing hardware; this can include: handle sets, strike plates, fasteners, hinges, etc. The installation of missing parts as needed to achieve proper operation is recommended to be conducted by a qualified person.

Contact a qualified professional.

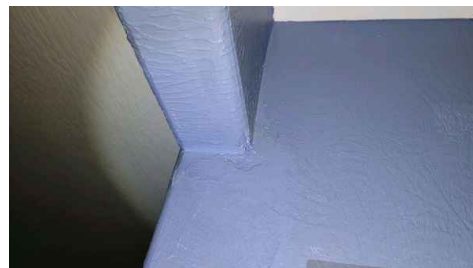
12.6.1 Surfaces - Overall

DRYWALL CRACKING

FYI - There were indications of what appeared to be settlement and/or expansion and contraction present in areas. This may include minor cracking, separation between moldings and surfaces, drywall tape visible at wall to ceiling transitions, settling, nail pops, etc. I recommend re-sealing or repairs to these areas as needed by qualified trades people and to monitor the areas for further cracking and separation, with the understanding that if continual movement is observed. Further evaluation and/or repairs may be needed.

Contact a qualified professional.

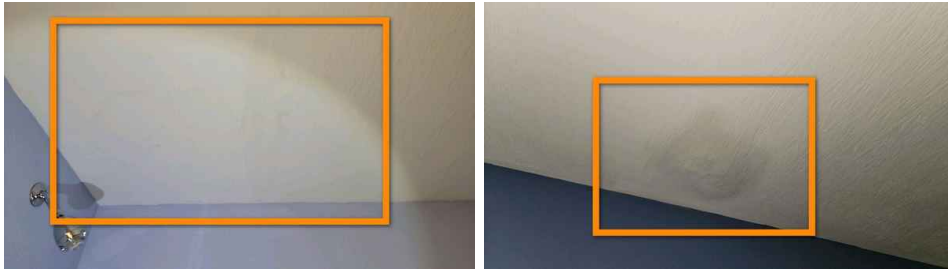
12.6.2 Surfaces - Overall

UNDETERMINED STAINING

Contact a qualified professional.

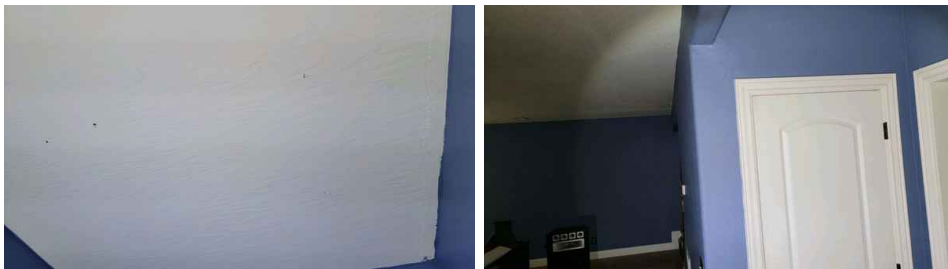
12.6.3 Surfaces - Overall

COSMETIC DEFICIENCIES

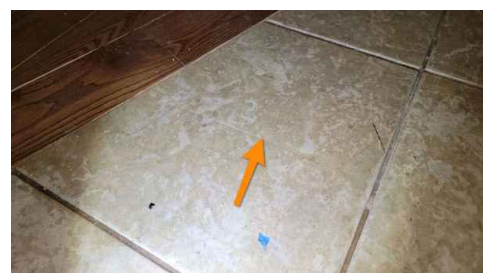
12.7.1 Floor Condition

TILE FLOORING - DETERIORATED GROUT WITH LOOSE AND/OR CRACKED TILES

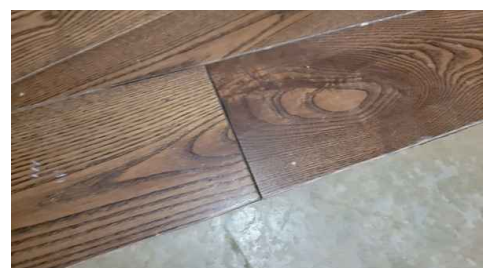
12.7.2 Floor Condition

GAPS IN FLOORING STRIPS

There are gaps where the flooring pieces meet on the ends and sides. Recommend repair by a qualified contractor.

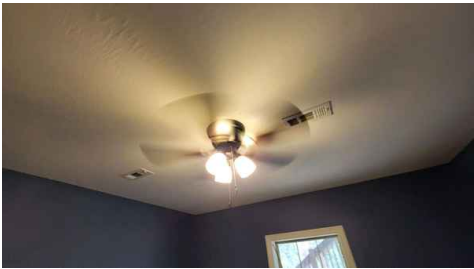
12.9.1 Ceiling Fan

WOBBLING - MINOR

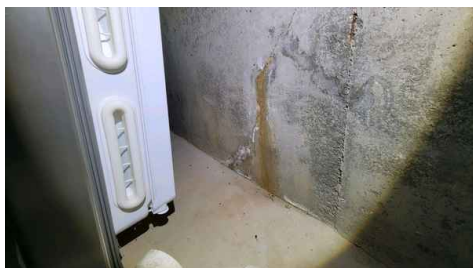
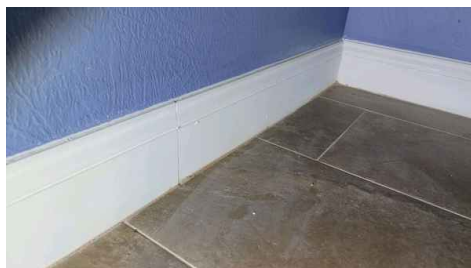
14.4.1 Moisture Presence

INDICATIONS OF WATER SEEPAGE THROUGH FOUNDATION CRACKS

Contact a qualified professional.

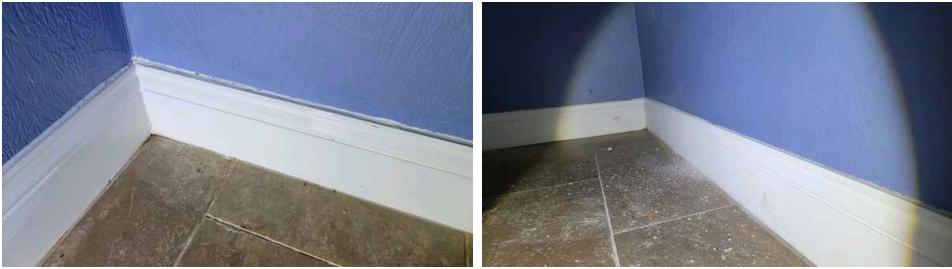
14.4.2 Moisture Presence

FINISHED AREAS - INDICATIONS OF PAST/PRESENT MOISTURE INFILTRATION

Evaluation by a foundation or grading contractor is also recommended to determine the exact source of the moisture, with repairs made to prevent or manage any future moisture infiltration.
