NPI MISSOURI INC

RESIDENTIAL REPORT

3824 Michigan Ave Saint Louis, MO 63118

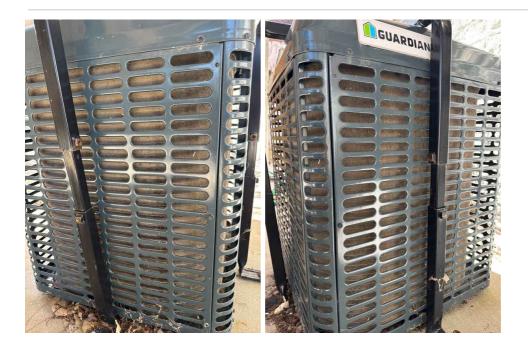
8.1.1 Cooling Equipment

MAINTENANCE AND CLEANING

AC UNIT

System is in need of maintenance and cleaning. Exterior coils are dirty.

Recommendation

Contact a qualified HVAC professional.
